Rail Accident Report

Serious operational irregularity at Balham 20 April 2019

Report 01/2020
February 2020

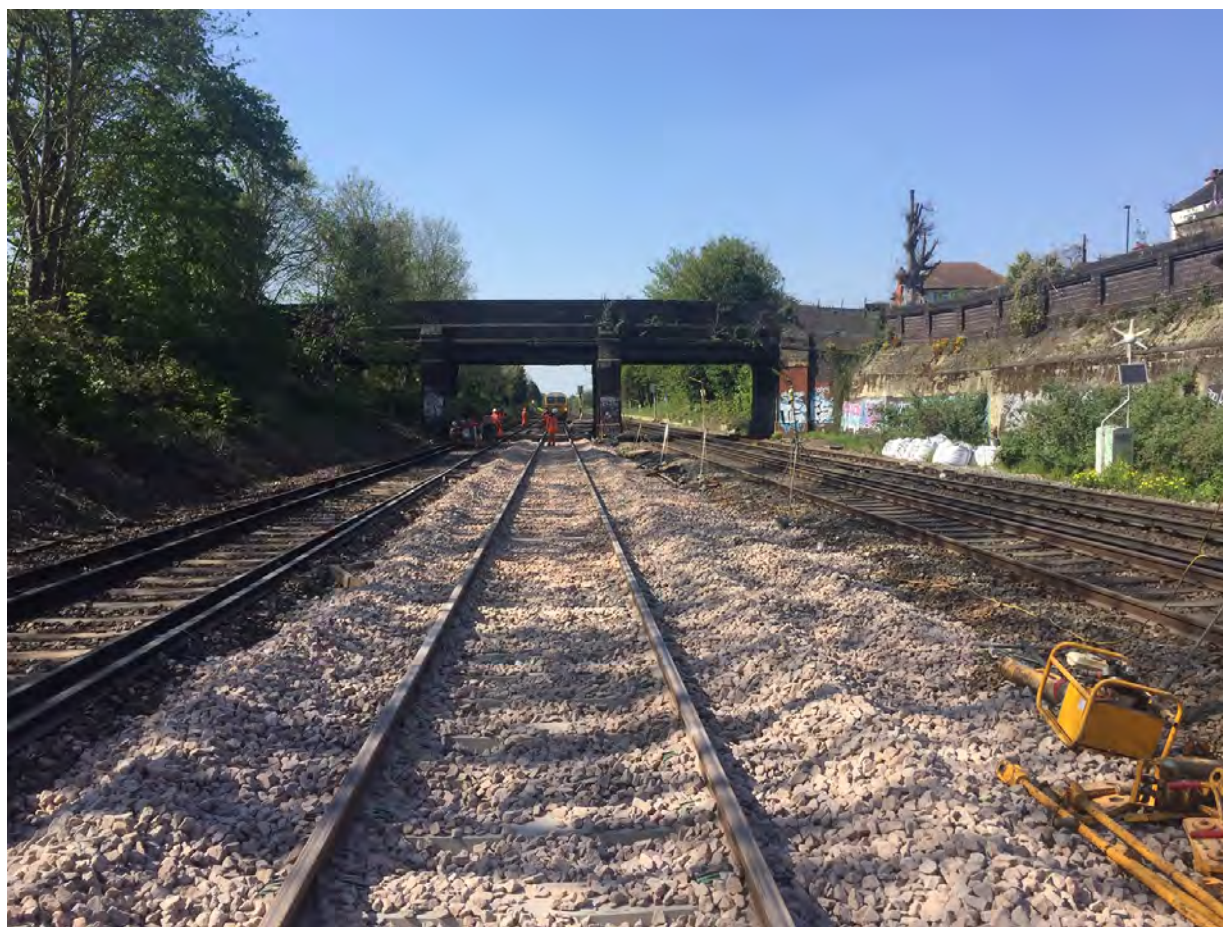
- 35 The possession continued through Saturday morning, with train 9 entering the possession on the up Brighton fast line during the early hours. At 04:01 hrs, train 6J91, referred to as the tamper for the remainder of this report, entered the southern end of the possession on the down Brighton fast line, before entering worksite B. It was due to work in worksite B on the down Brighton fast line from south to north, colloquially referred to as 'Country to London' (C-L, see figure 5), the opposite direction to the normal use of this line (also sometimes referred to as running 'bang road'). The tamper was the only engineering train working on the down Brighton fast line.

Figure 6: Train 6J91 within worksite B on the down Brighton fast line at Thornton Heath

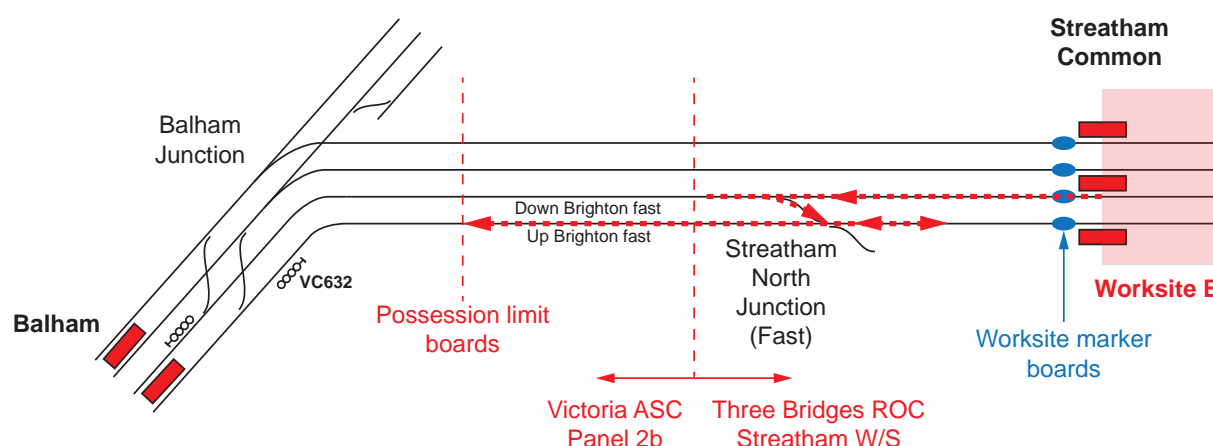
- 41 As the boundary between the area of control of Victoria ASC and Three Bridges ROC (figure 7) was within the possession, the day PICOP would have needed to contact the signaller on the Streatham work station at Three Bridges ROC to arrange for the planned move of the tamper over points 334 from the down Brighton fast line to the up Brighton fast line. At 17:04 hrs the day PICOP called that signaller to enquire if the up Brighton fast line from signal TVC 660 at Streatham Common was clear to the northern limit of the possession and signal VC 632. The signaller confirmed that as far as he knew the route was clear, and requested the day PICOP to instruct the tamper driver to observe and check any points in the route.

Figure 7: The planned route of train 6J91

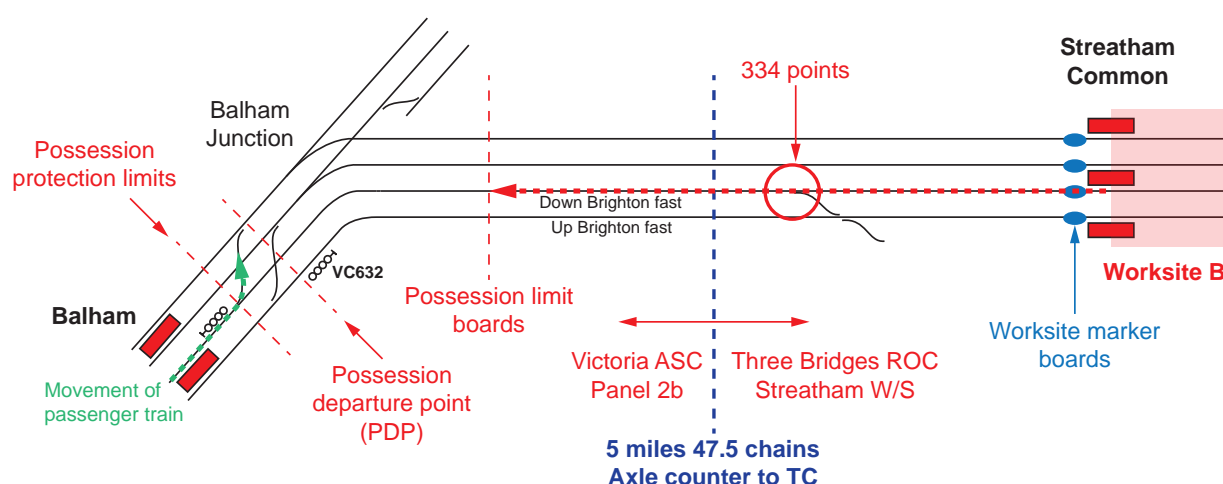
- 43 At around 17:24 hrs, the ESA called the day PICOP, who returned the call at 17:33 hrs. The ESA passed his phone to the conductor driver, who had now taken charge of the movements of the tamper. The day PICOP instructed the conductor driver to proceed to the detonator protection once the worksite marker board was lifted. The ESA moved the worksite marker board and the tamper left worksite B at 17:34 hrs travelling in the up direction on the down Brighton fast line, arriving at the PLBs south of Balham Junction at 17:40 hrs (figure 8). When it arrived there, there was no COSS or possession support assistant present. The tamper was not scheduled to leave the possession until 19:00 hrs.

Figure 8: The actual route of train 6J91

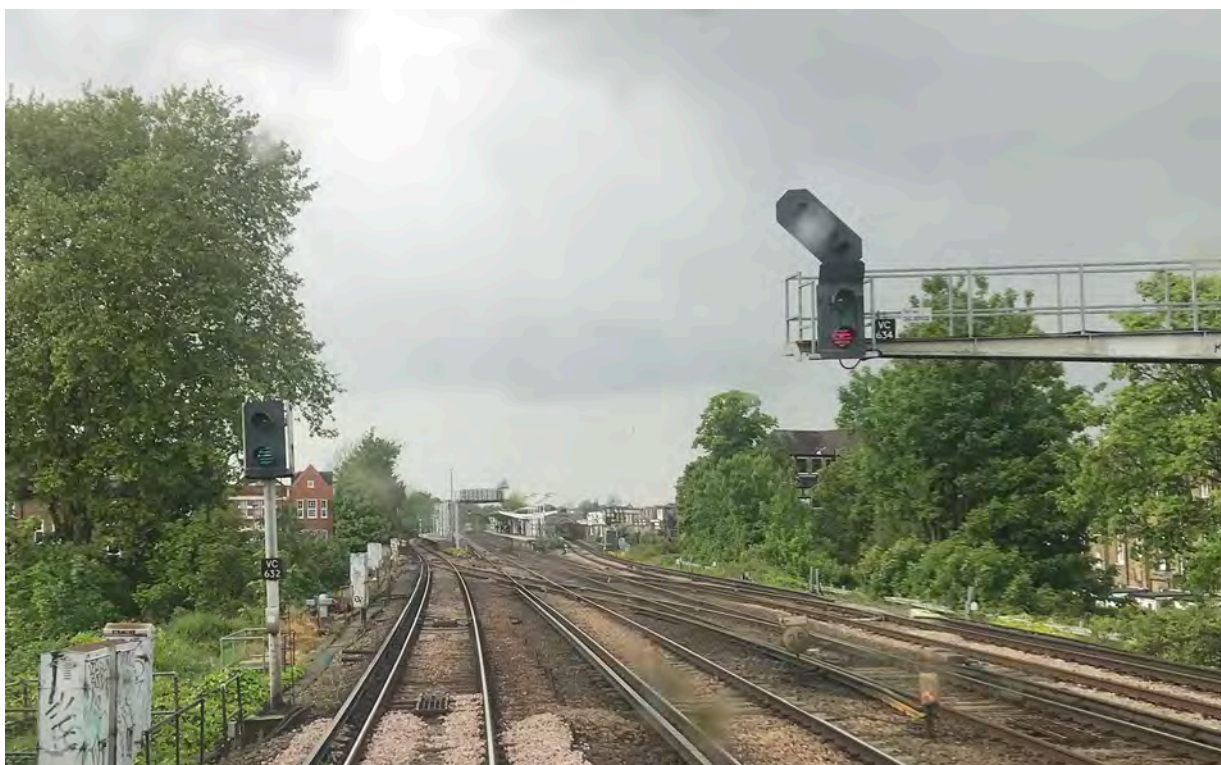
- 74 When the tamper arrived at the PLBs, there was an opportunity for its correct location to have been identified. The conductor driver's phone calls did not meet Network Rail's requirements for safety critical communications, as was evident from the recordings of his conversations with signallers 1 and 2, and when he received the instructions for the tamper to leave the possession (paragraphs 134 to 135). Although he evidently referred to the train running document during his conversation with signaller 2 (figure 11), he did not identify that the tamper had not been crossed over to the up Brighton fast line as planned. The conductor driver and tamper driver did not challenge the signallers, and followed the instructions they were given. However, the conductor driver could not explain why he did not notice signal VC 632 on the adjacent line or instruct the tamper driver to stop adjacent to it (figure 14). RAIB considers that this may have been because signal VC632 did not apply to the line that the tamper was on, and so the conductor driver did not consider that it was likely to be relevant to him.

Figure 14: View looking north towards Balham station, with signal VC 632 on the up Brighton fast line (left) and VC 634 on the up Brighton slow line (right)
