Rail Accident Investigation Branch

Rail Accident Report

**Train overspeeding at Spital Junction,
Peterborough
17 April 2022**

Report 06/2023
v2 August 2024

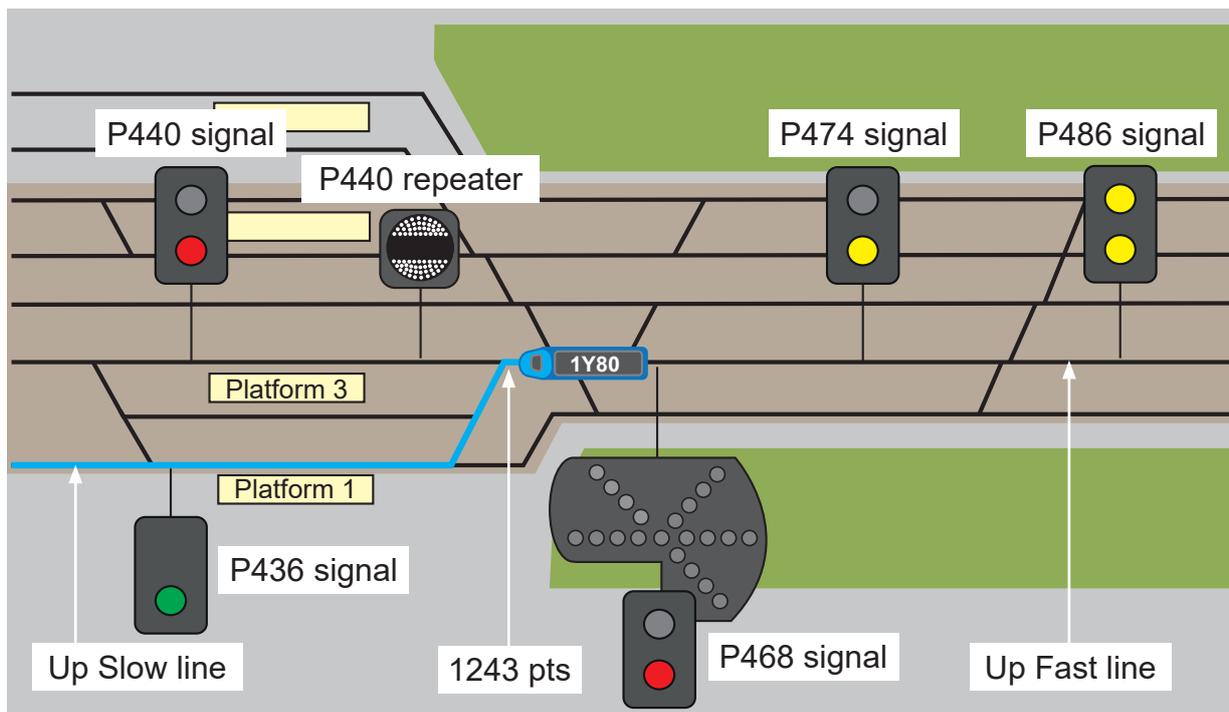
- 75 At 10:20:08 hrs, the train was approximately 160 metres from 1243 points and had reached around 77 mph (123 km/h). The driver stated that they saw the platform banner repeater signal at the north end of platform 3 was 'on', indicating that the route for the Up Fast line through platform 3 was not set. They reacted by applying a full service brake (figure 17).

Figure 17: The position of train 1Y80 at 10:20:08 hrs.

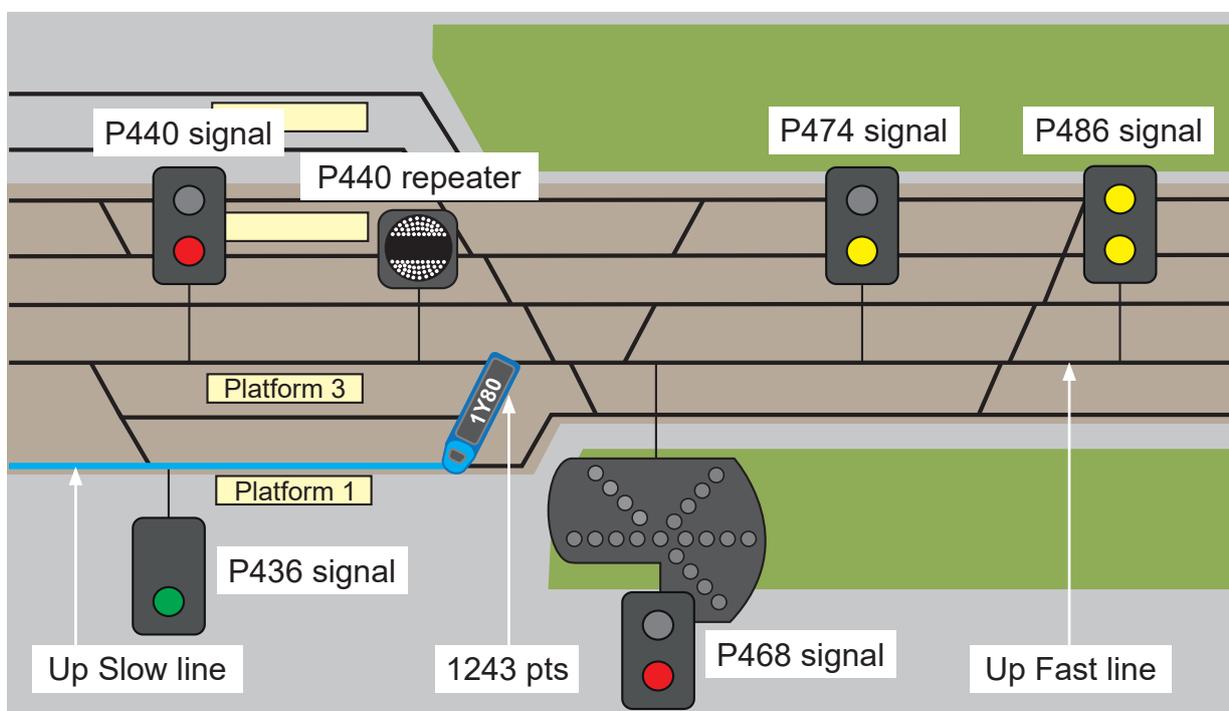
76 At 10:20:11 hrs, the train reached 1243 points at the junction while it was still travelling at around 76 mph (122 km/h) (figure 18). The driver made an emergency brake application around nine seconds later, after the train had passed over all of the points and while it was travelling at around 60 mph (97 km/h).

Figure 18: The position of train 1Y80 at 10:20:11 hrs.

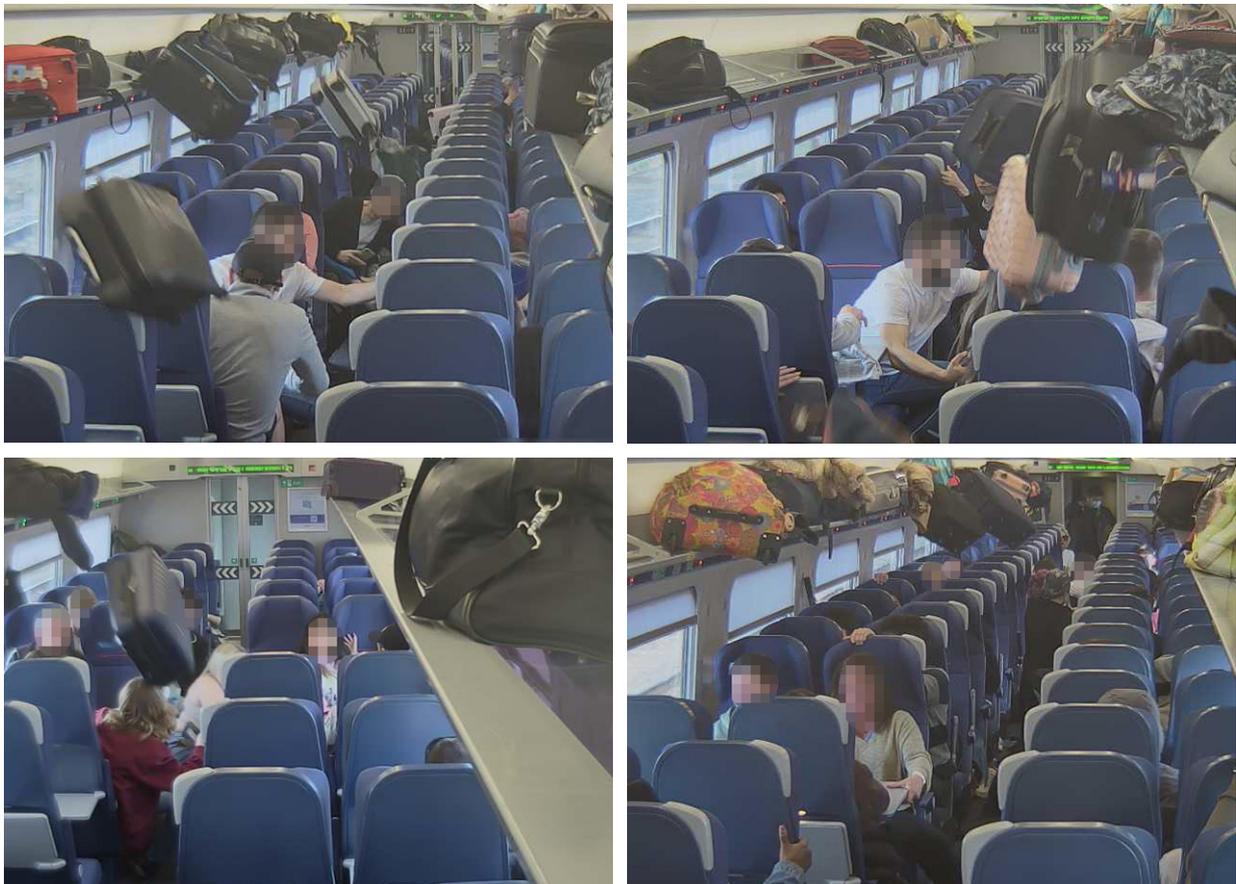
178 RAIB's review of the train's internal CCTV and the descriptions of the injuries sustained by passengers concluded that half of the injuries were caused by luggage falling from the overhead luggage racks as the train went over the junction (figure 20).

Figure 20: Luggage falling from the overhead racks during the incident.

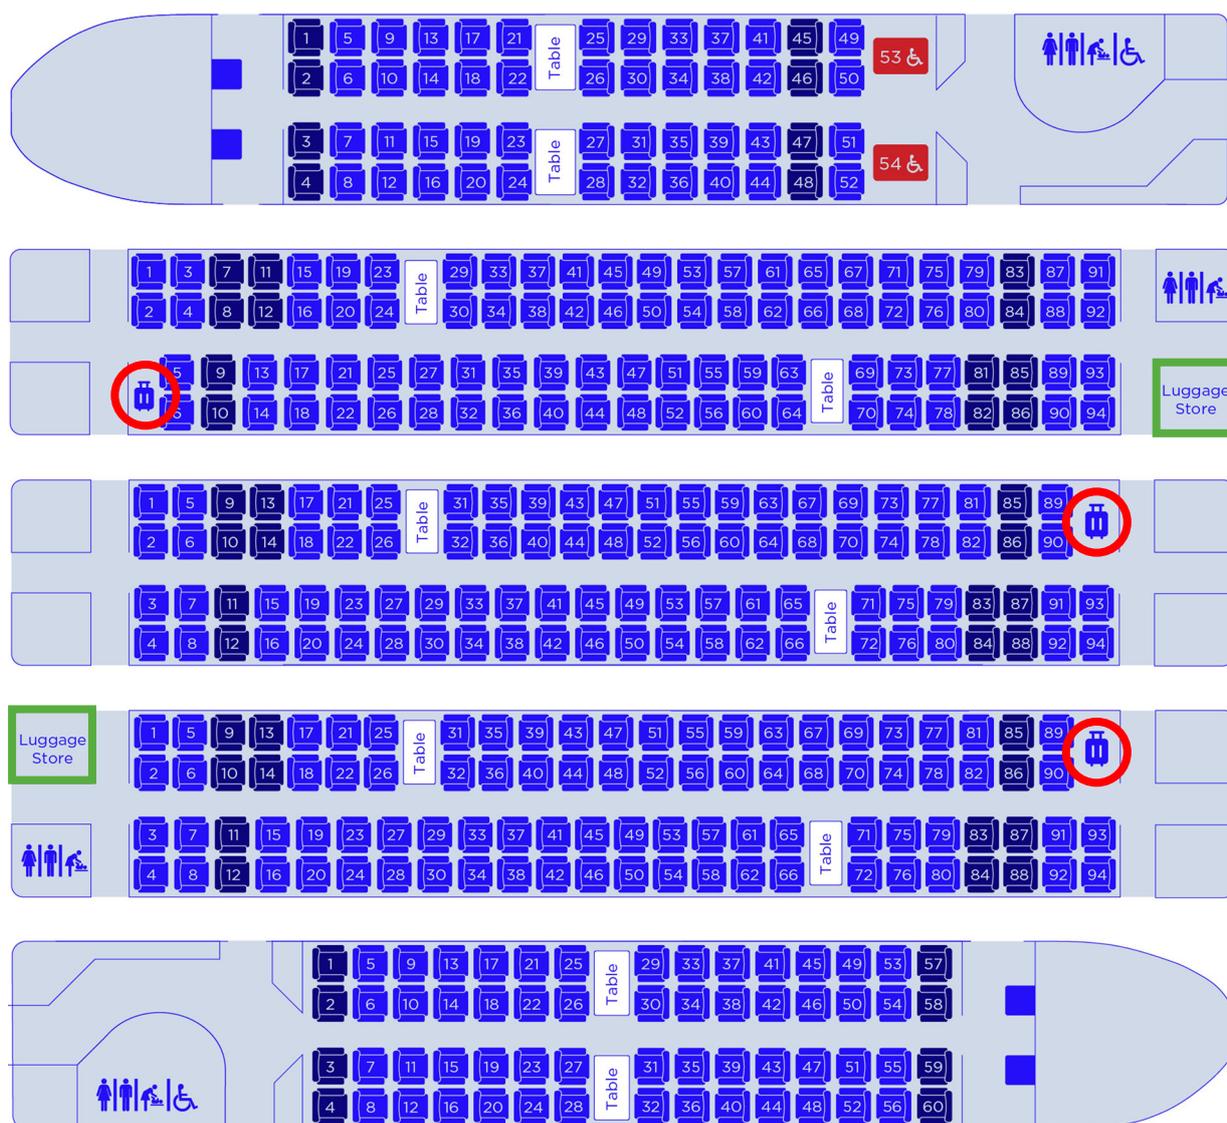
179 Lumo offers less space for passengers to store their luggage in floor-mounted luggage stacks compared to other long-distance operators of the same train type (such as the Great Western Railway (GWR) class 800/0 and LNER classes 800/1 and 800/2 units).

Figure 21: Luggage storage stacks and storage areas on Lumo's trains.

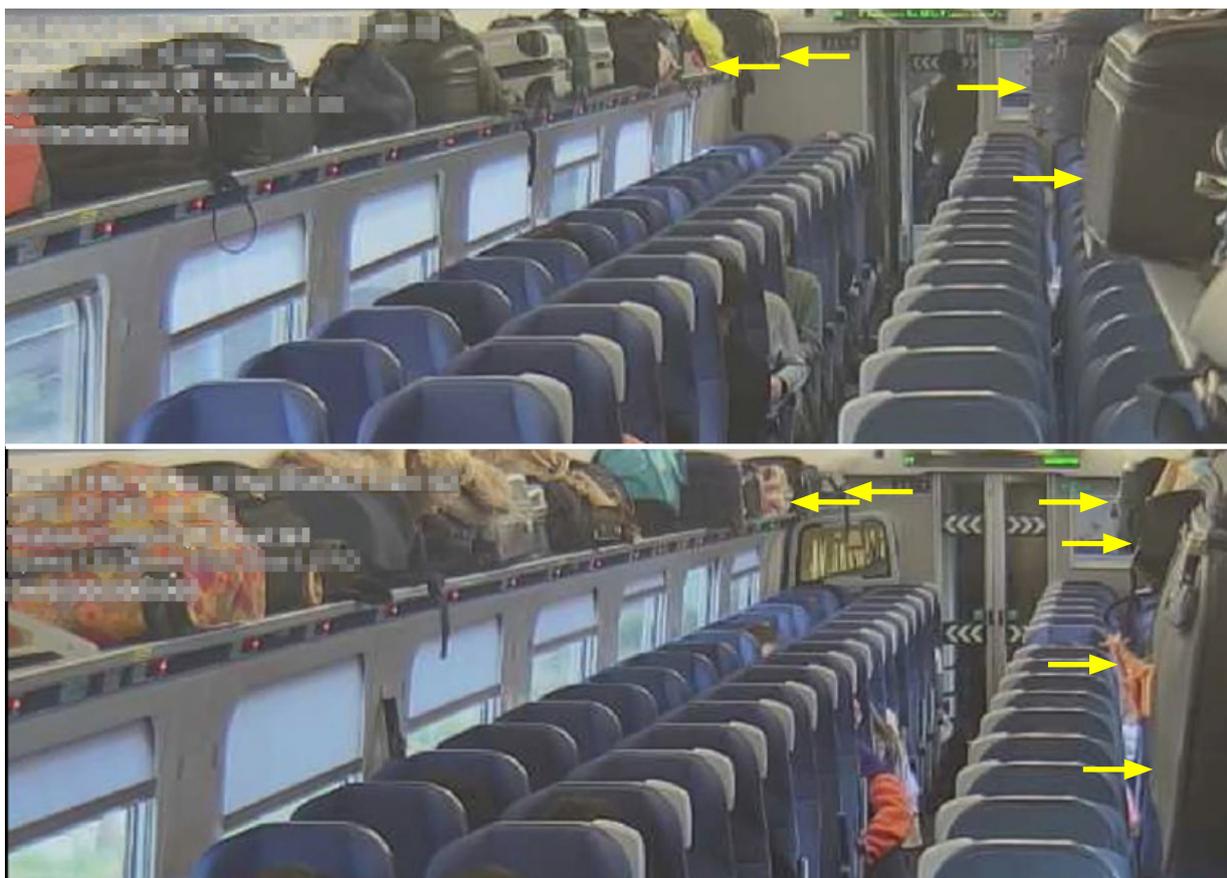
Figure 22: Internal CCTV images showing luggage overhanging edges of overhead racks.

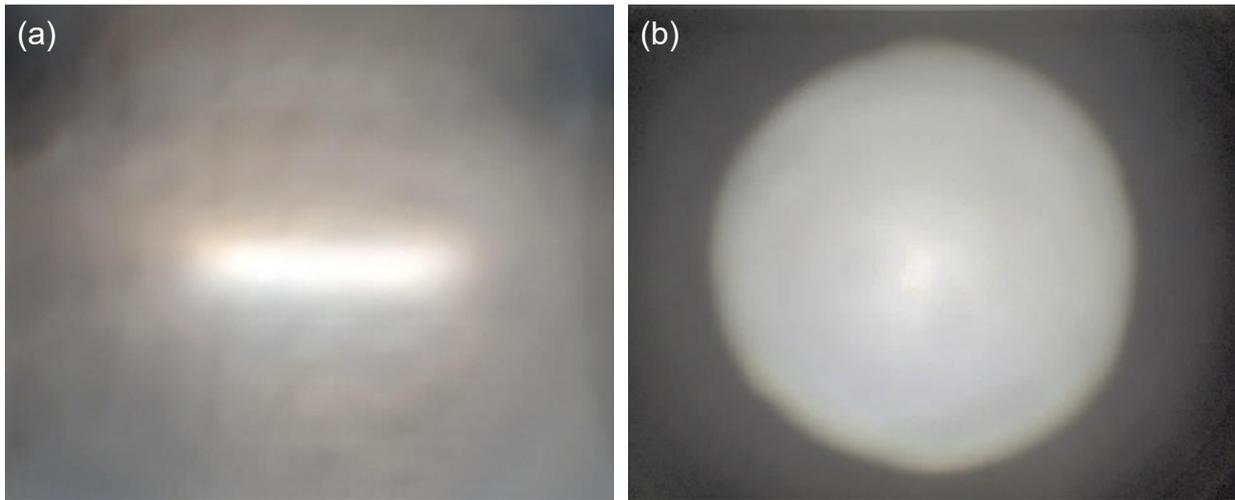
E13. The LED JI light modules were found to be at different alignments within the JI housing, ranging between -0.4 and -2.7 degrees error relative to the designed position within the housing. The pivot light was also found to be installed upside down. These issues are likely to be a consequence of the sample JI having been supplied from one of Network Rail's training centres and is unlikely to be representative of the LED JIs in use. To account for the misalignment, the luminous intensity of all modules was tested 'on-axis' and relative to the light module itself, and not to its position within its housing.

Figure E4: JI projected beam characteristic from filament indicator (a) and LED module (b).

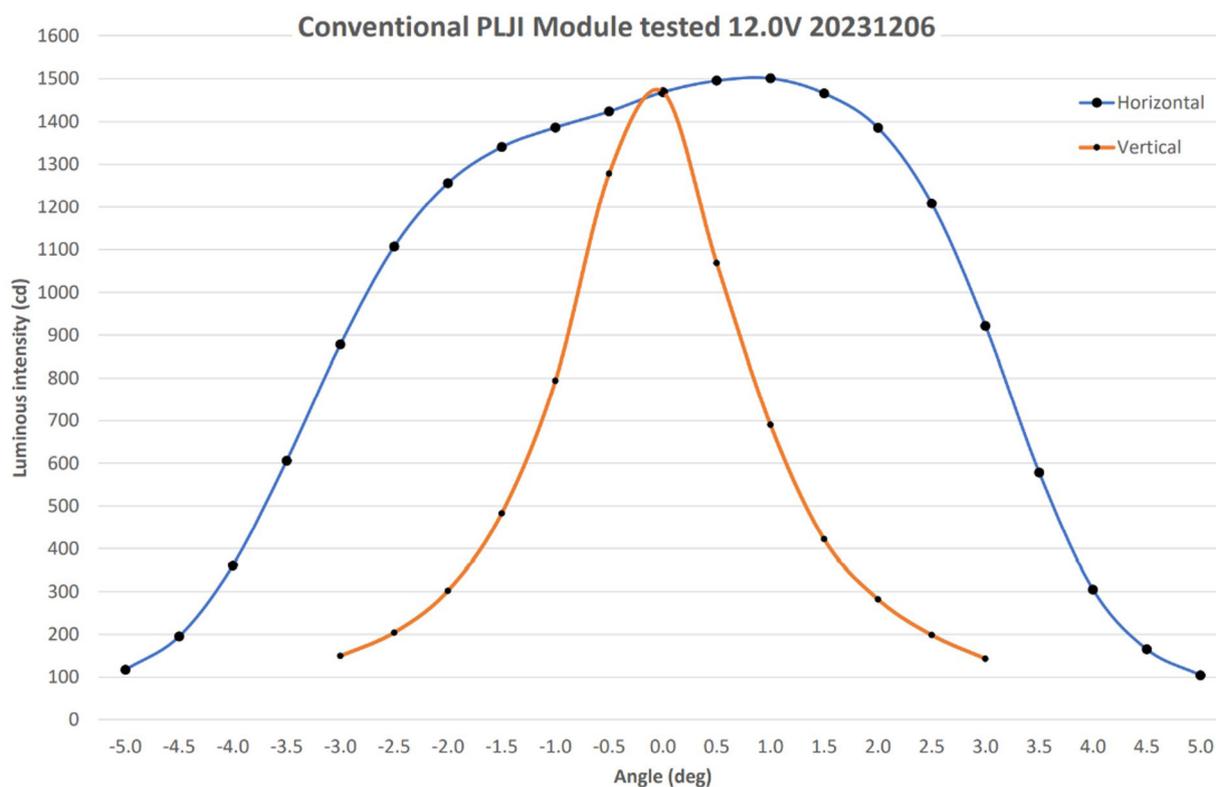
Figure E5: Measured luminous intensity from a filament junction indicator module.

- E18. Testing of the filament and LED JI modules found that the filament module produced a higher peak luminous intensity (paragraphs E14 to E16). This was significantly reduced as the viewing angle increased, especially in the vertical axis. In contrast, LED modules produced a much lower peak luminous intensity output but were less sensitive to viewing angle. This meant they produced an output much closer to the peak luminous intensity as the viewing angle increases away from the projected beam axis.

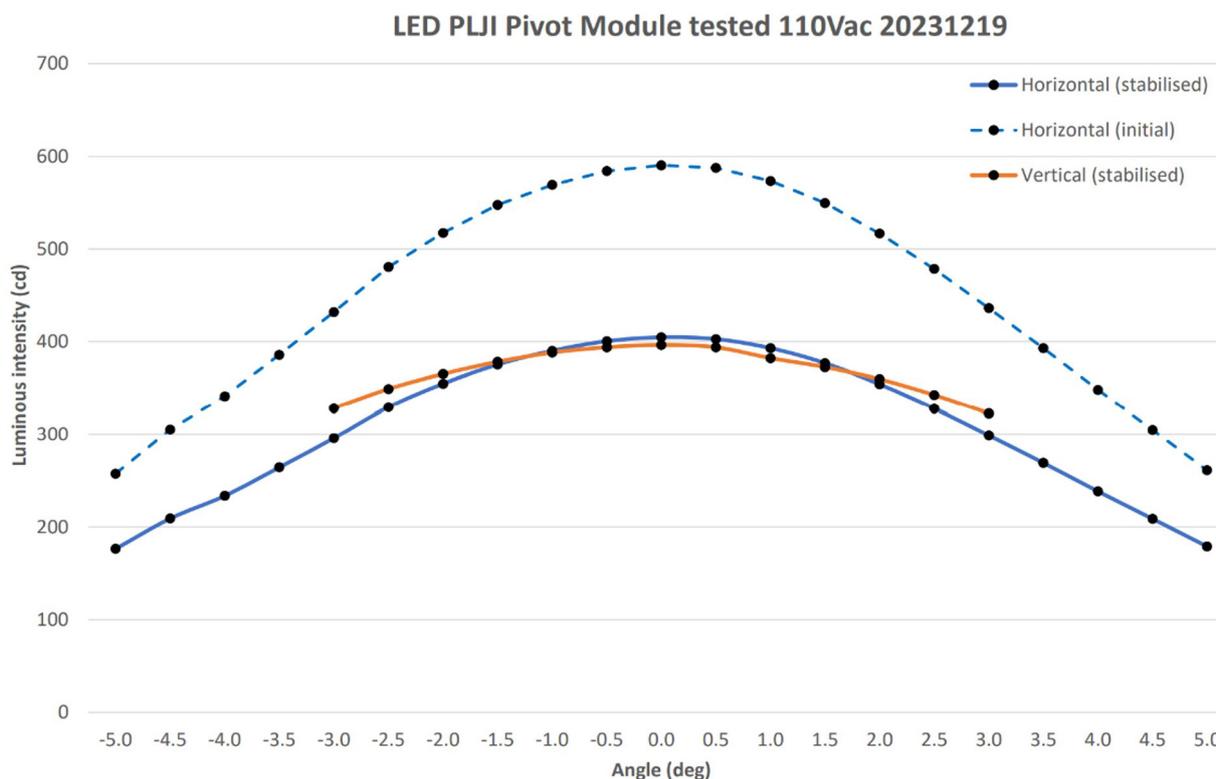
E14. During testing, the LED JI modules were found to emit a greater luminous intensity when initially illuminated. The luminous intensity reduced as the modules became warmer. Although it is unlikely that the LED JI modules fitted to P468 signal would create sufficient heat to affect the light output in the time they were illuminated for an approaching train, it was necessary to allow the modules to stabilise to enable the testing to take place. When tested, the LED JI pivot light module produced the highest output of 591 cd initially, which reduced to 403 cd once it had stabilised after 40 minutes (figure E6). The other LED JI light modules produced a light output of between 255 cd and 314 cd when stabilised.

Figure E6: Measured luminous intensity from an LED junction indicator module.

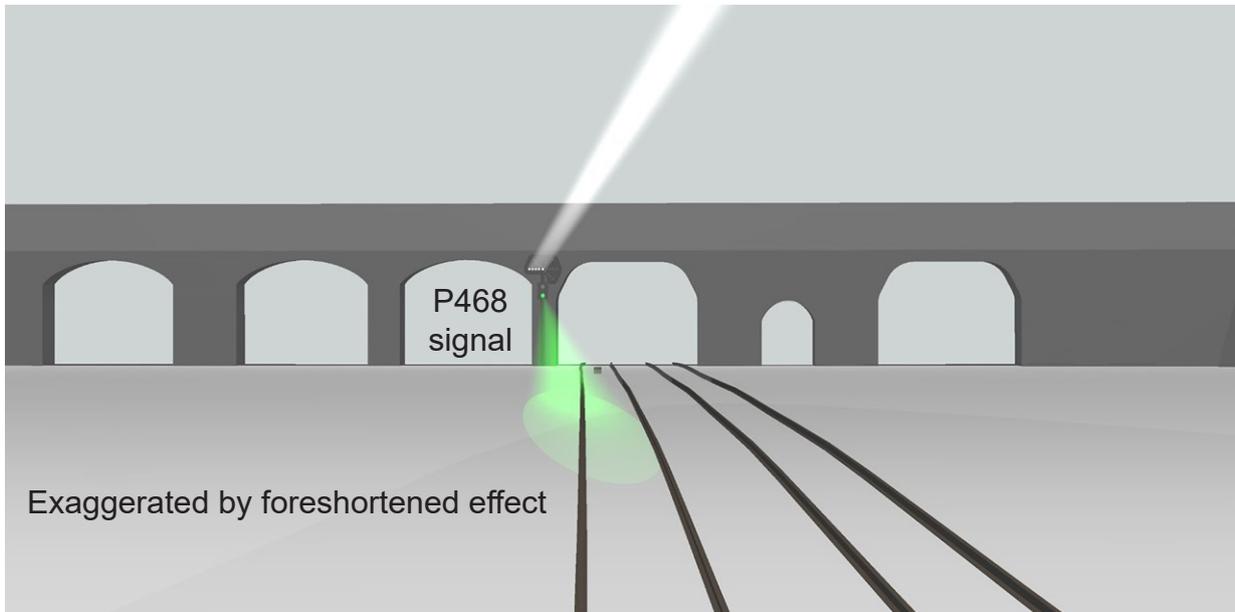
- E19. When a beam drawn from the green aspect and JI of P468 signal is overlaid on the topographical survey of the Up Fast line, the centre line of the green main aspect was found to be pointing down towards the track, and the JI pointing upwards (figure E7). This downwards alignment of the main aspect is in line with the signal sighting guidance to aim the main signal towards driver's eye level at the AWS magnet associated with the signal. Figure E8 places an approaching train at 100 metres (110 yards) from P468 signal. At this distance, the centre of the green aspect beam is to the left and at a height approximating that of a driver's eye line. In contrast, the top of the windscreen of an approaching train is approximately 5 degrees below the centre of the beam projected by the JI.

Figure E7: Alignment of green aspect and JI when viewed at 800 metres from P468 signal.

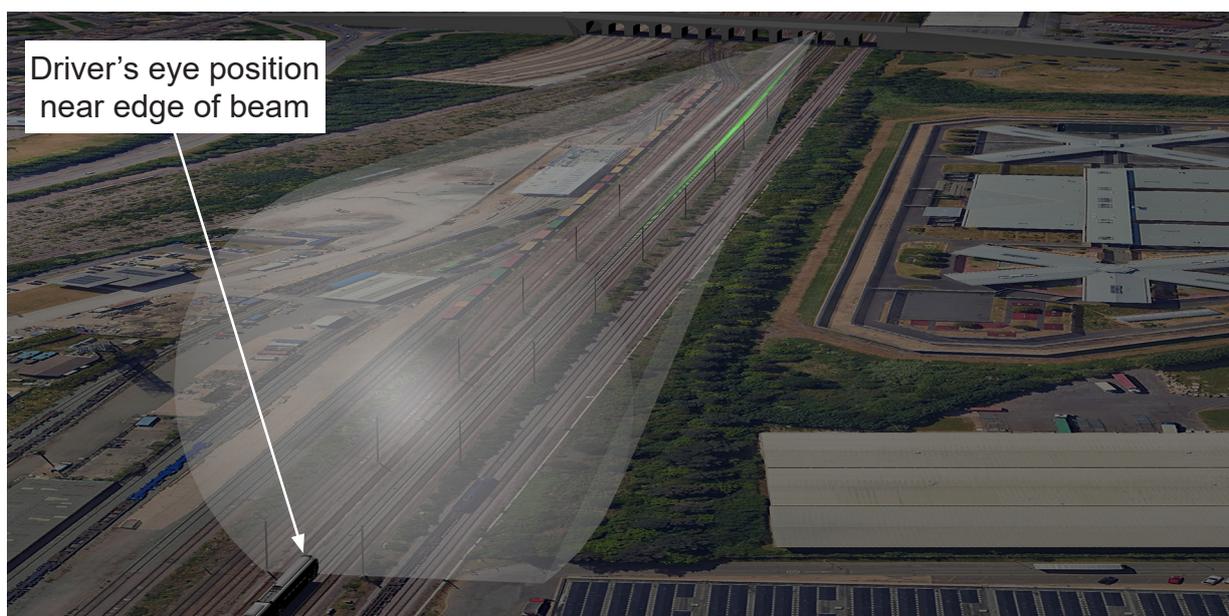
- E20. When these beams are projected to 800 metres (875 yards) from P468 signal, the centre of the green aspect beam remains closer to the driver's eye line, although below the windscreen level of an approaching train. However, the centre of the JI is much further from the driver's eye line (figure E9).

Figure E9: Illustration of the JI beam projected by a 5 degree cone out to a distance of 800 metres.
