Rail Accident Report

**Signal passed at danger on approach to
Wootton Bassett Junction, Wiltshire
7 March 2015**

Signal passed at danger on approach to Wootton Bassett Junction, Wiltshire, 7 March 2015

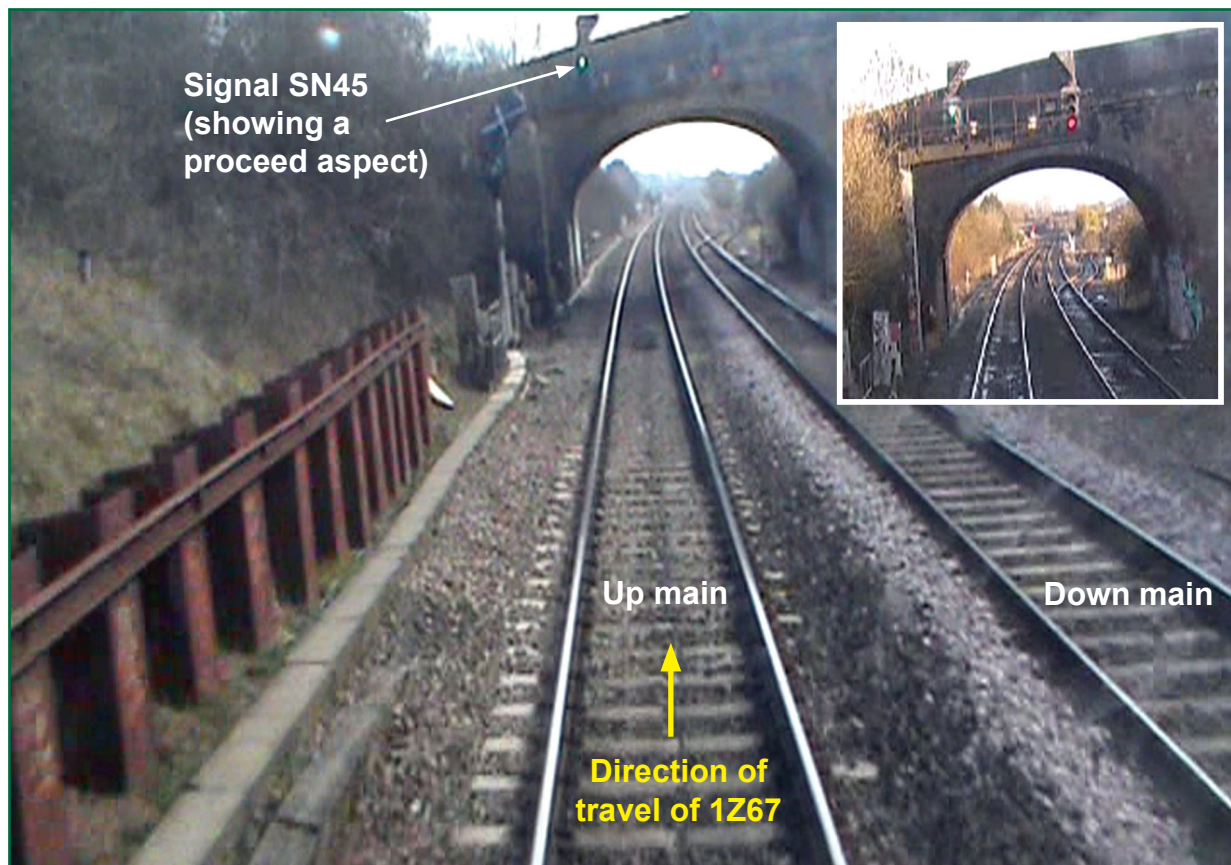
- 6 Wootton Bassett Junction is protected from trains approaching on the up main line from Chippenham by signal SN45, a *three-aspect colour light signal*, fitted with a *junction indicator* (figure 3). SN45 is mounted on a standard cantilever post which places the red aspect around 5 metres above the track and offset towards the cess by around 0.9 metres from the left-hand rail.

Figure 3: A video image of signal SN45 taken shortly after the incident. Inset figure shows an HD video image of the signal head taken in 2012 (images courtesy of Network Rail).

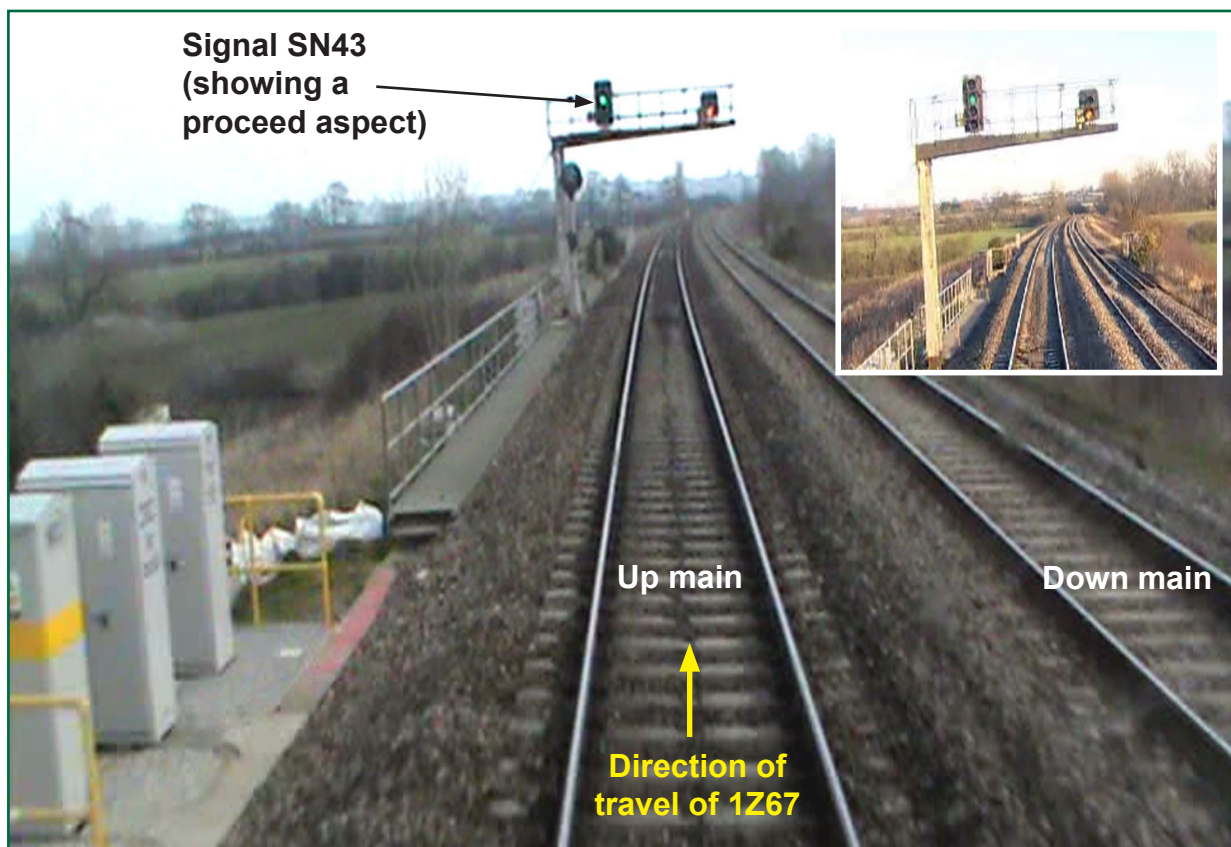
- 8 Signal SN45 is preceded on the up main line by signal SN43, a *four-aspect colour light signal* (figure 4). SN43 is mounted on a standard cantilever post and is also equipped with AWS and TPWS. The normal signalling sequence for a train approaching SN45 at danger is that SN43 signal shows a single yellow *caution* aspect and that the preceding signal, UM85, shows a green *proceed* aspect¹.

Figure 4: A video image of signal SN43 taken shortly after the incident. Inset figure shows an HD video image of the signal head taken in 2012 (images courtesy of Network Rail).

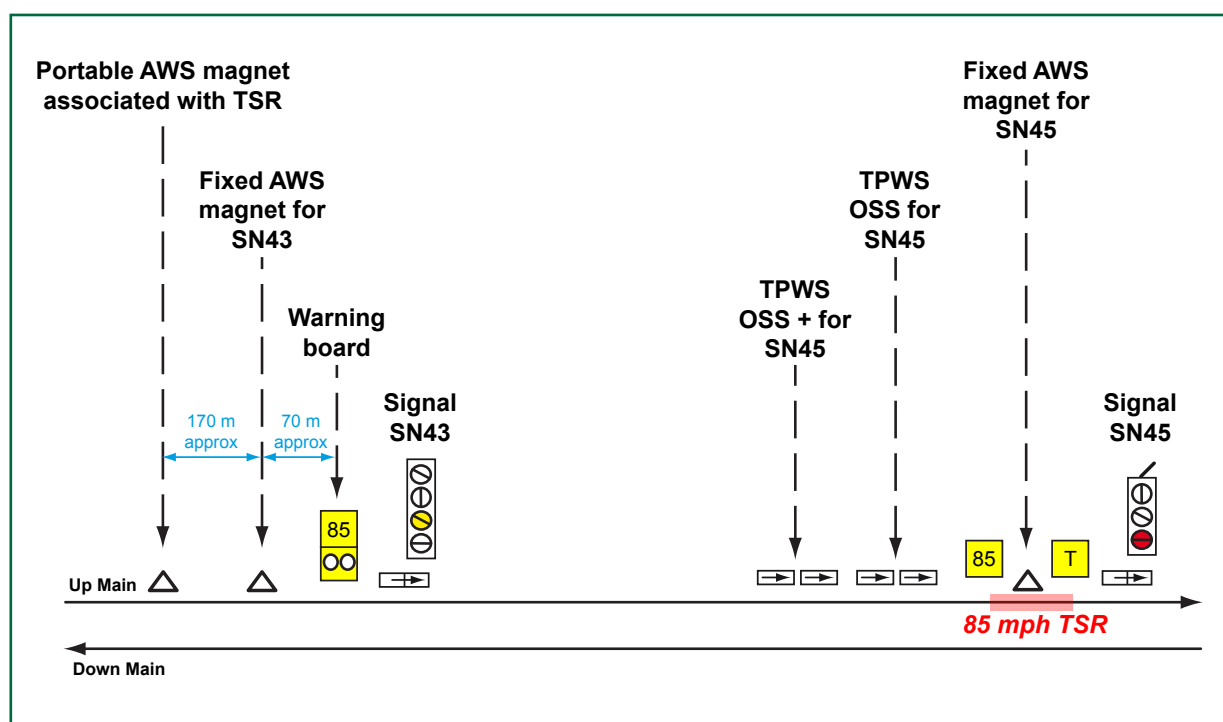
Figure 5: A diagram of the arrangements implemented for the TSR (not to scale)

- 85 The relevant rules and standards relating to TSRs do not allow warning boards to be placed between fixed AWS magnets and the signal to which they apply. Had this rule been correctly observed then it is possible that the driver might have realised that the second AWS warning did not relate to a TSR and that he was approaching a signal showing a restrictive aspect. The rail industry's formal investigation found that the non-compliance with regard to the warning board had not been reported by the drivers of other trains which had passed through the TSR in the preceding months. This may mean that the incorrect placement of the warning board was not found by other drivers to be something which caused them concern or confusion. The design and implementation of the TSR is discussed further as an underlying factor in paragraph 168.

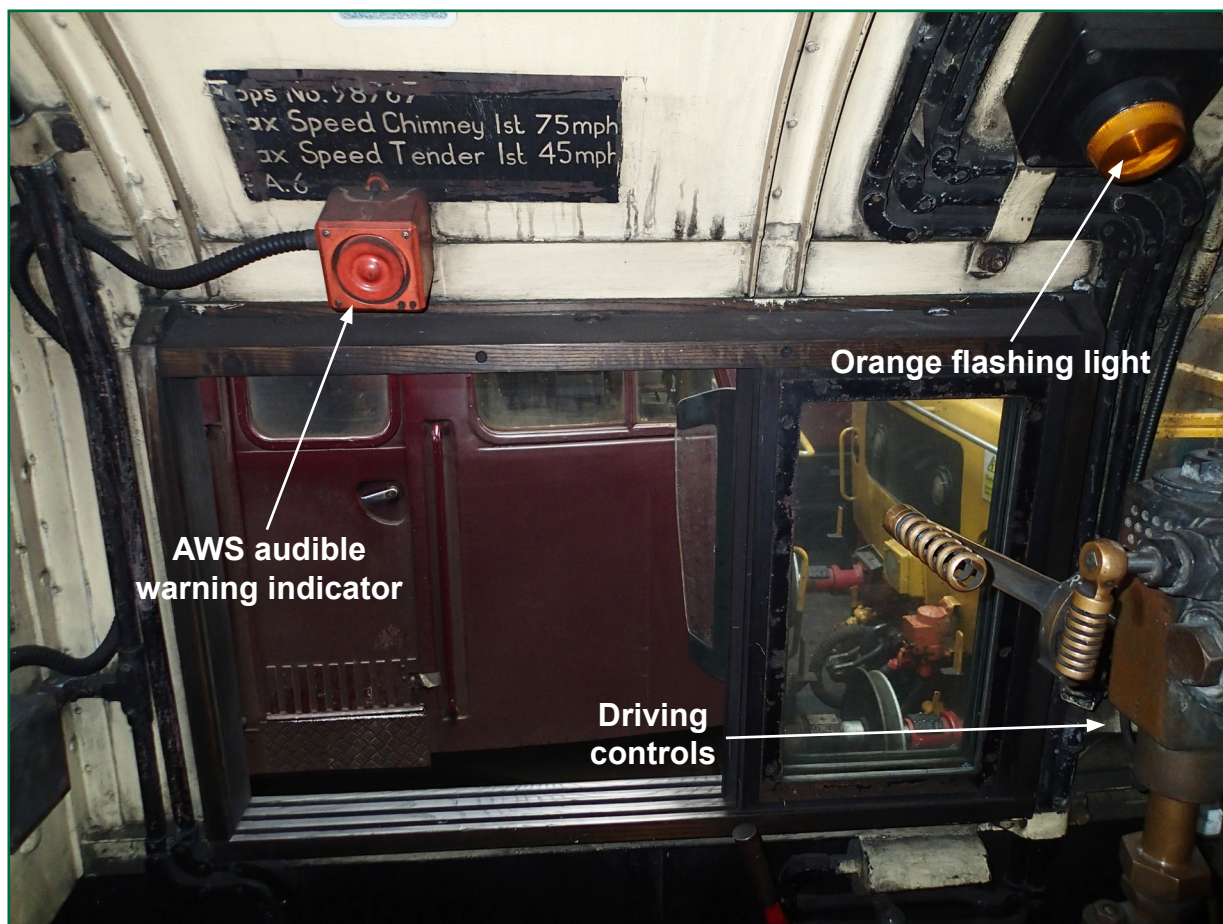
- 15 At the time of the incident, the AWS audible warning indicator on Tangmere was positioned on the inside of the cab roof, just above the *driving position* (which is on the left-hand side of this locomotive) and towards the rear of the driver's side window. The orange flashing light was also positioned on the inside of the cab roof, slightly higher than the audible warning indicator and to the front of the driver's side window (figures 8 and 9). The AWS visual indicator (commonly called the 'sunflower') is mounted in front of the driving position just above the main driving controls, with the TPWS display panel positioned directly above it (figure 9).

Figure 8: The position of the AWS audible warning indicator unit and flashing light on 7 March 2015

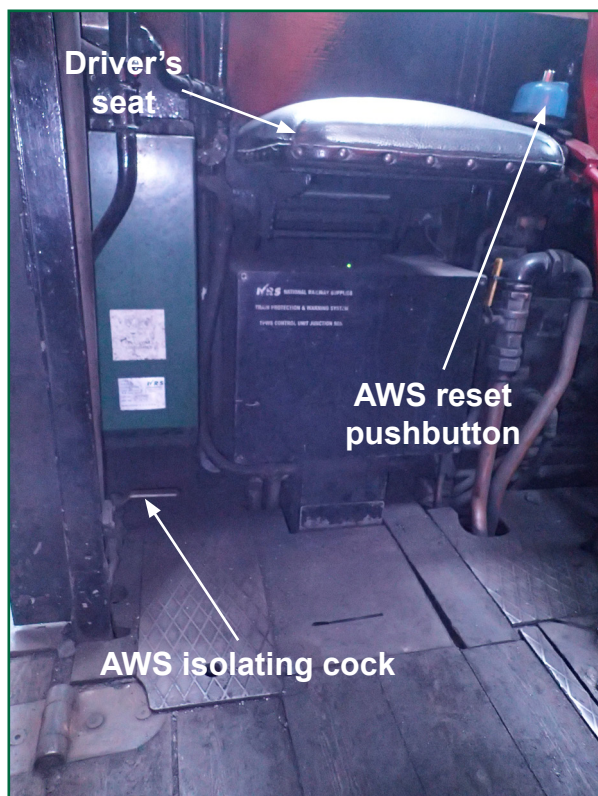
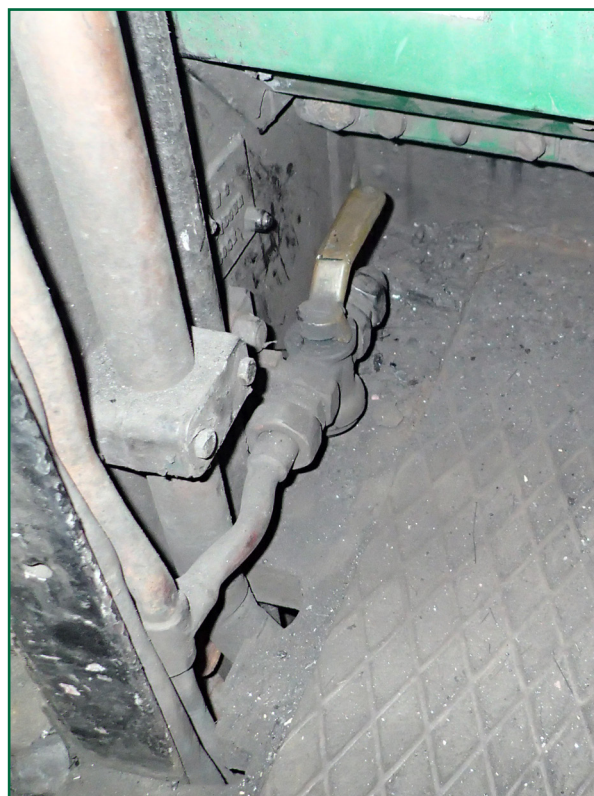
- 19 An AWS isolating cock is also situated to the rear of the driving position, close to the cab floor plates (figures 11 and 12). The AWS isolating cock is normally left closed in service; if opened it will admit air into the electro-pneumatic valve and lock it into the 'ISOLATED' position, regardless of whether it is energised or not. This means that, once the electro-pneumatic valve is locked in this position, de-energising it no longer has any effect on the air braking system and any brake demands generated by the combined AWS/TPWS control unit are rendered ineffective.

Figure 11: The AWS isolating cock shown in the open position

Figure 12: The AWS isolating cock shown in closed position

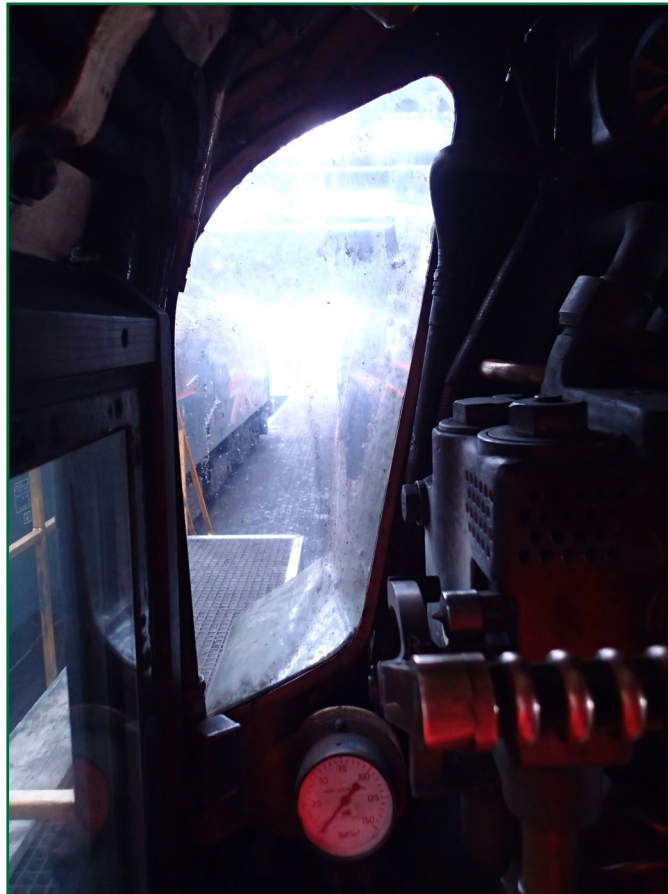
- 46 Train 1Z67 left Bristol Temple Meads at 16:38 hrs, around 3 minutes late. In addition to the driver and the fireman, two members of the locomotive's support crew were also present in the cab. Witness evidence suggested that the journey to Wootton Bassett Junction was uneventful, with the exception that the driver was experiencing poor visibility forwards through his windscreen. This was partly due to condensation on the windscreen from a steam leak (paragraph 40) but also because the locomotive's exhaust was being blown by the wind towards the left-hand side of the boiler, where it was accumulating and blocking his view. In order to improve his sighting, the driver decided to drive the train with his head positioned outside the driver's side window.

Figure 13: The driver's windscreen on Tangmere. Note that this photograph was taken with the train at a stand within a depot and does not show the driver's forward visibility on 7 March 2015

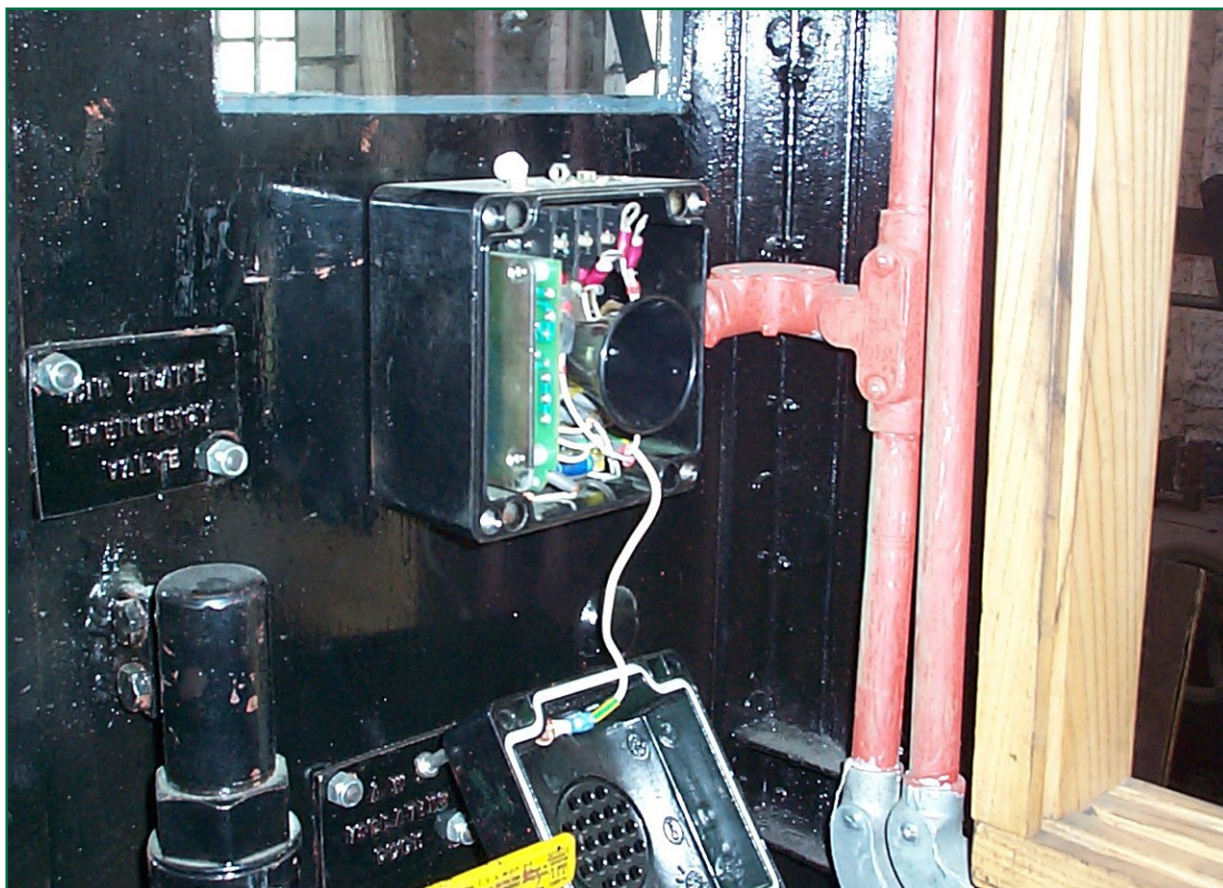
- 61 Despite this rule, there were two members of the support crew present in Tangmere's cab when the SPAD occurred. However, witness evidence was that the presence of the support crew member in the cab did not distract or hinder the train crew and that neither support crew member played any role in the incident.

Identification of the immediate cause

Figure 15: The AWS audible warning indicator unit fitted to Tangmere during its restoration (photograph courtesy of Resco Railways)

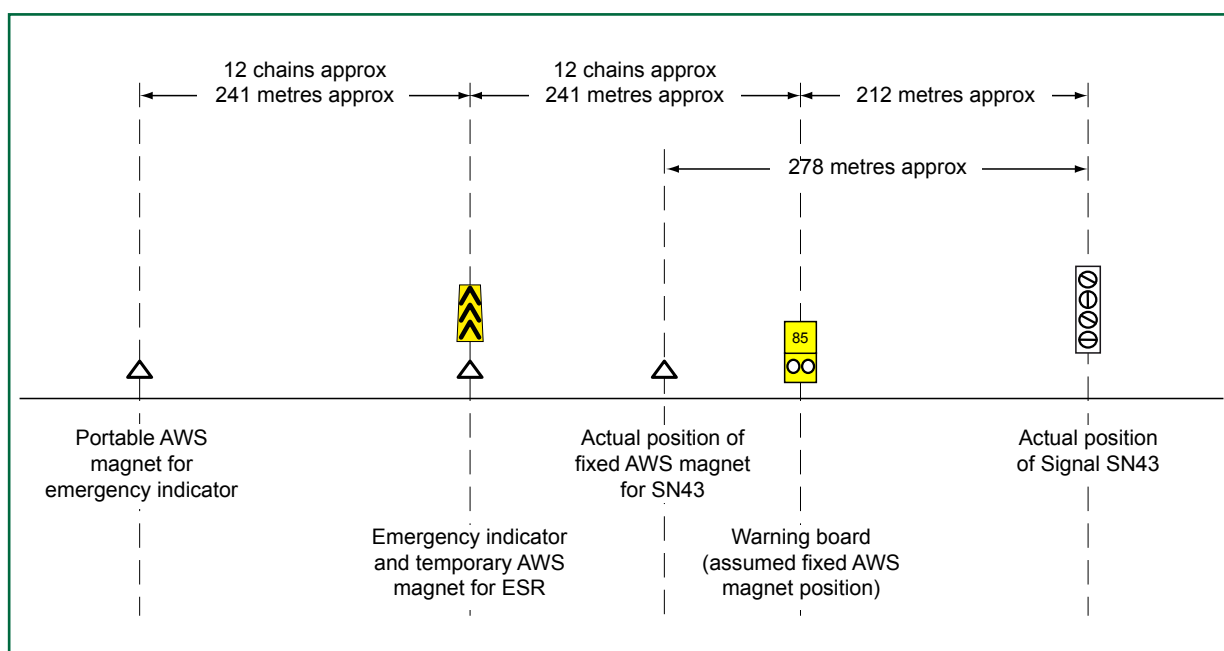
- 76 West Coast Railways managers stated that, in addition to the driver and fireman, traction inspectors may also be present in the cab during some steam movements, although this would normally only be during activities such as the practical assessment of train crew. West Coast Railways stated that it had, in the past, assigned a traction inspector to all steam movements because this had previously been standard practice within British Rail. Witness accounts and correspondence from former British Rail managers indicated that British Rail assigned traction inspectors to all movements involving steam locomotives for a number of reasons. These included providing technical advice, maintaining safety discipline, managing support crew or owner's representatives who are present in the cab and liaising with external parties, such as station staff.

Figure 16: ESR arrangements
