Rail Accident Investigation Branch

Rail Accident Report

Collision between a train and a collapsed signal post at Newbury 17 November 2014

Report 15/2015
September 2015

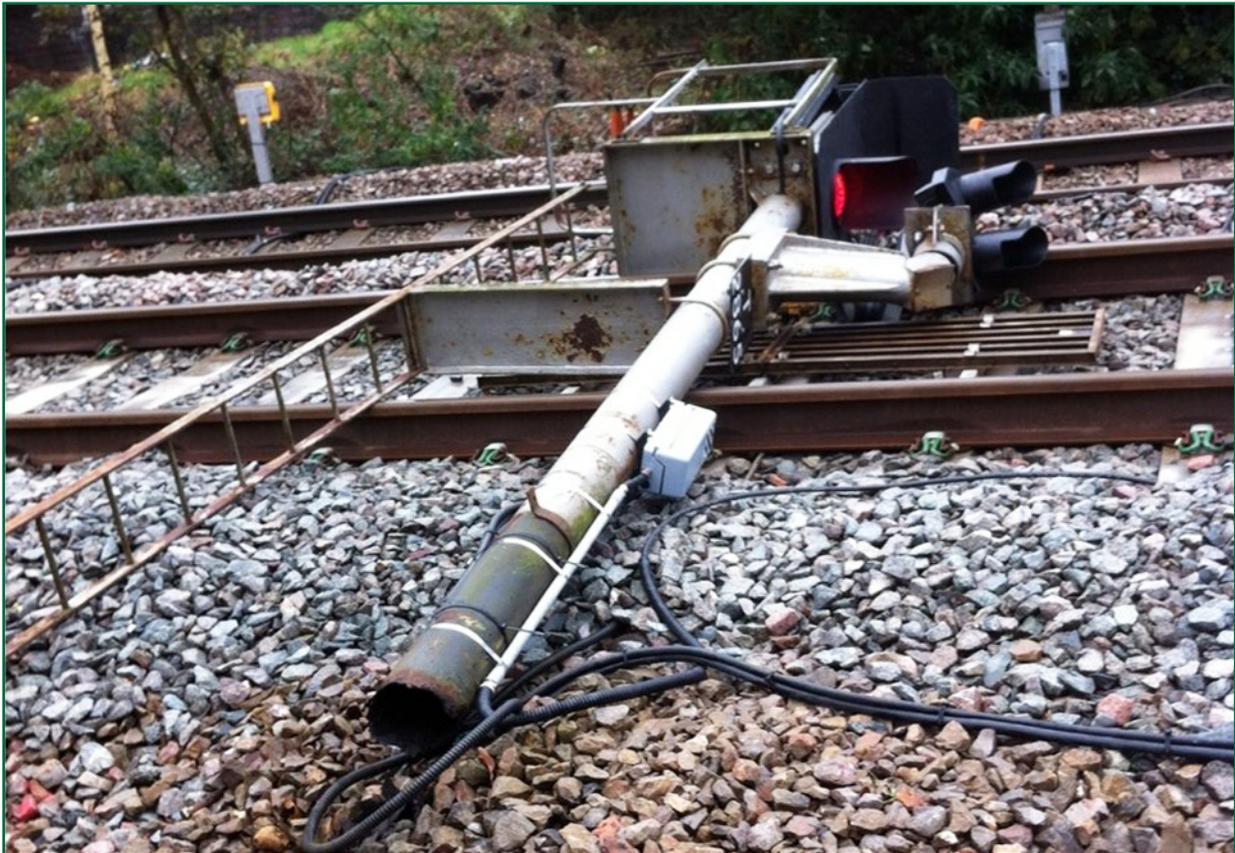
- 3 At about 14:35 hrs on Monday 17 November 2014, a High Speed Train (HST) travelling at 110 mph (177 km/h) struck a set of *junction indicators* attached to the top of a signal which had collapsed and fallen across the railway between Newbury and Newbury Racecourse stations (see Figure 1).
- 4 The signal had fallen across the *Down Westbury* line, but its junction indicators were lying foul of the *Up Westbury* line, on which the train was travelling (see Figure 2).

Figure 2: The fallen signal post after the accident (courtesy of Network Rail). Down Westbury line is closest to the camera, Up Westbury line is furthest away.

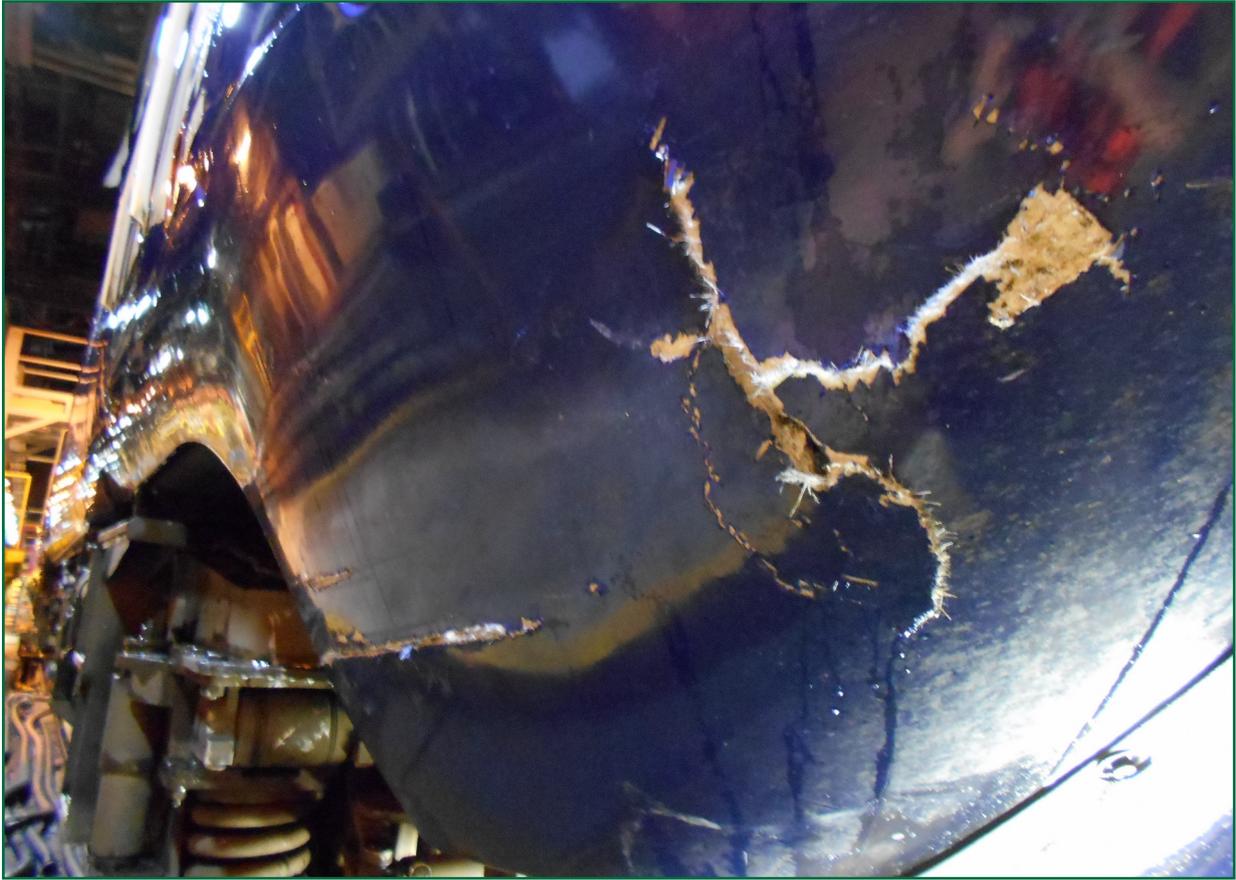
- 12 The train, reporting number 1A83, was the 10:41 hrs First Great Western HST service from Truro to London Paddington.
- 13 The leading power car, vehicle number 43160, sustained exterior body damage (see Figure 4) and a ruptured air pipe.

Figure 4: Damage to power car 43160 (courtesy of First Greater Western)

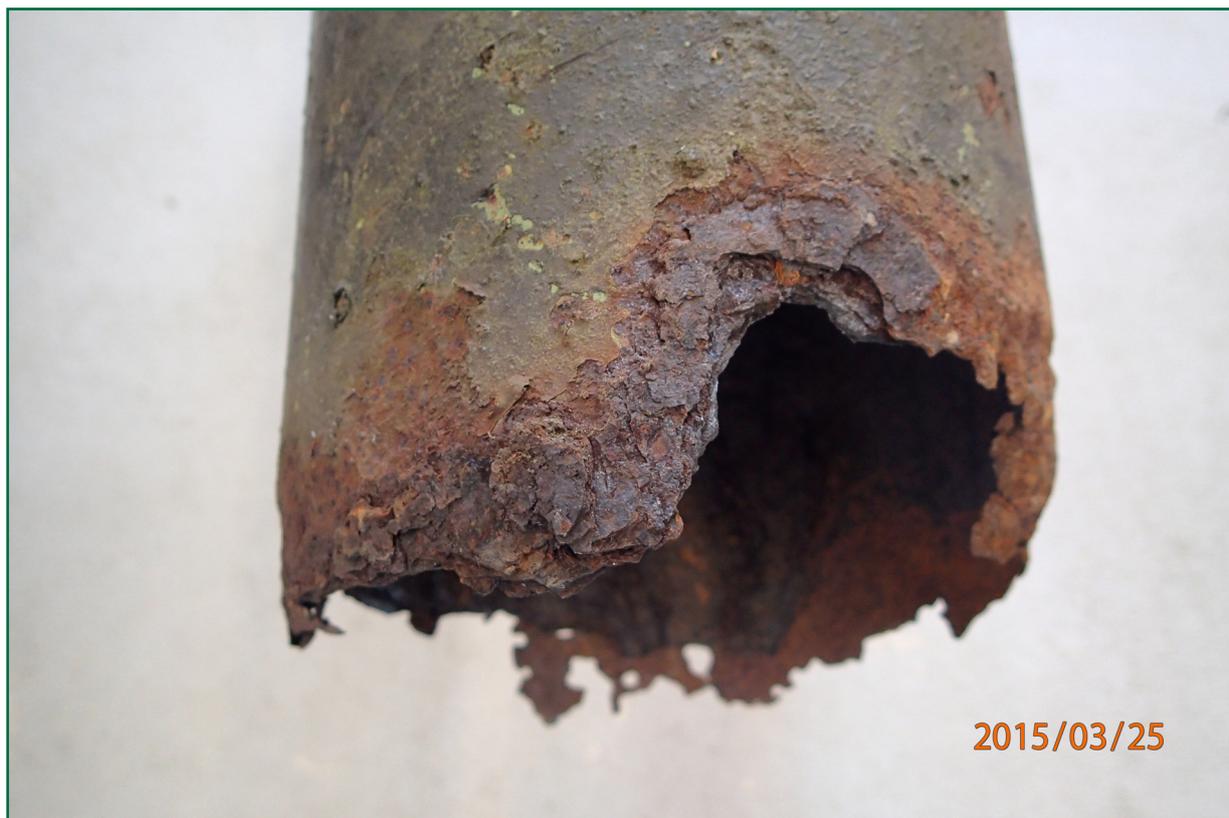
- 43 Corrosion around the base of the post and the ladder had caused severe metal wastage and an almost complete loss of wall thickness at and around the ballast in which the base of the post was buried (see Figures 7 and 8). It is likely that localised sites were perforated (rusted through) before the post collapsed.

- 47 The ballast would have affected the integrity of the external coating (through abrasion) as well as holding water around the base of the post. Once the corrosion activity was established, it would progressively undermine the surrounding coating.

Figure 7: Corrosion at the base of the signal post

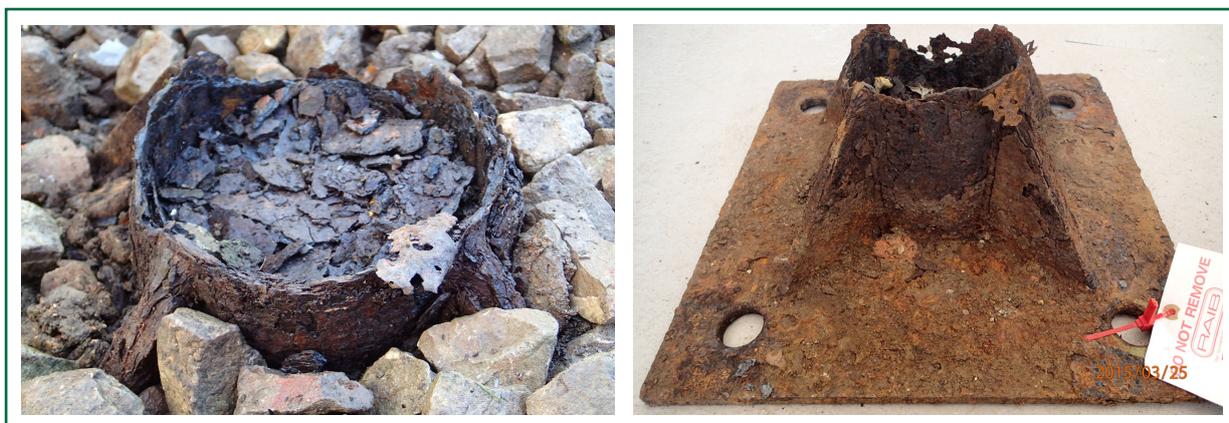
Figure 8: Corrosion at the baseplate (a) in situ after the accident (left image; note level of ballast) and (b) after removal from site

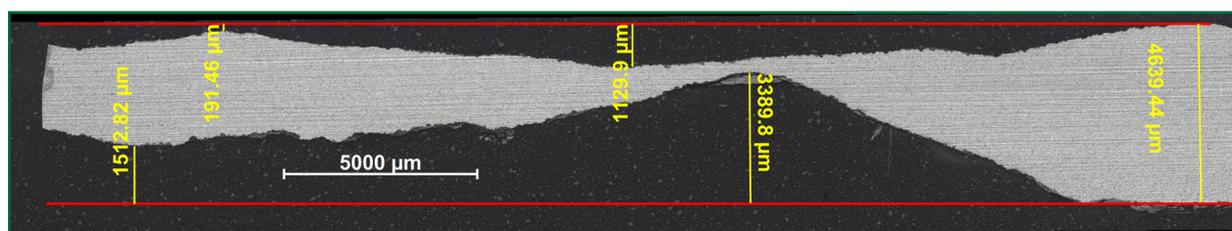
- 44 Corrosion had occurred on both the external and internal surfaces of the post, especially within 250 mm of the rupture site. Remaining wall thickness at the thinnest point measured was around 0.1 mm (see Figure 9), as compared with 6 mm when new (paragraph 16).

Figure 9: Microscopic cross-section through the signal post (seen in grey against black background) at a severely corroded region (internal surface of the post is the top side of the image). Loss of wall thickness indicated at selected sites; original wall thickness represented by red lines.

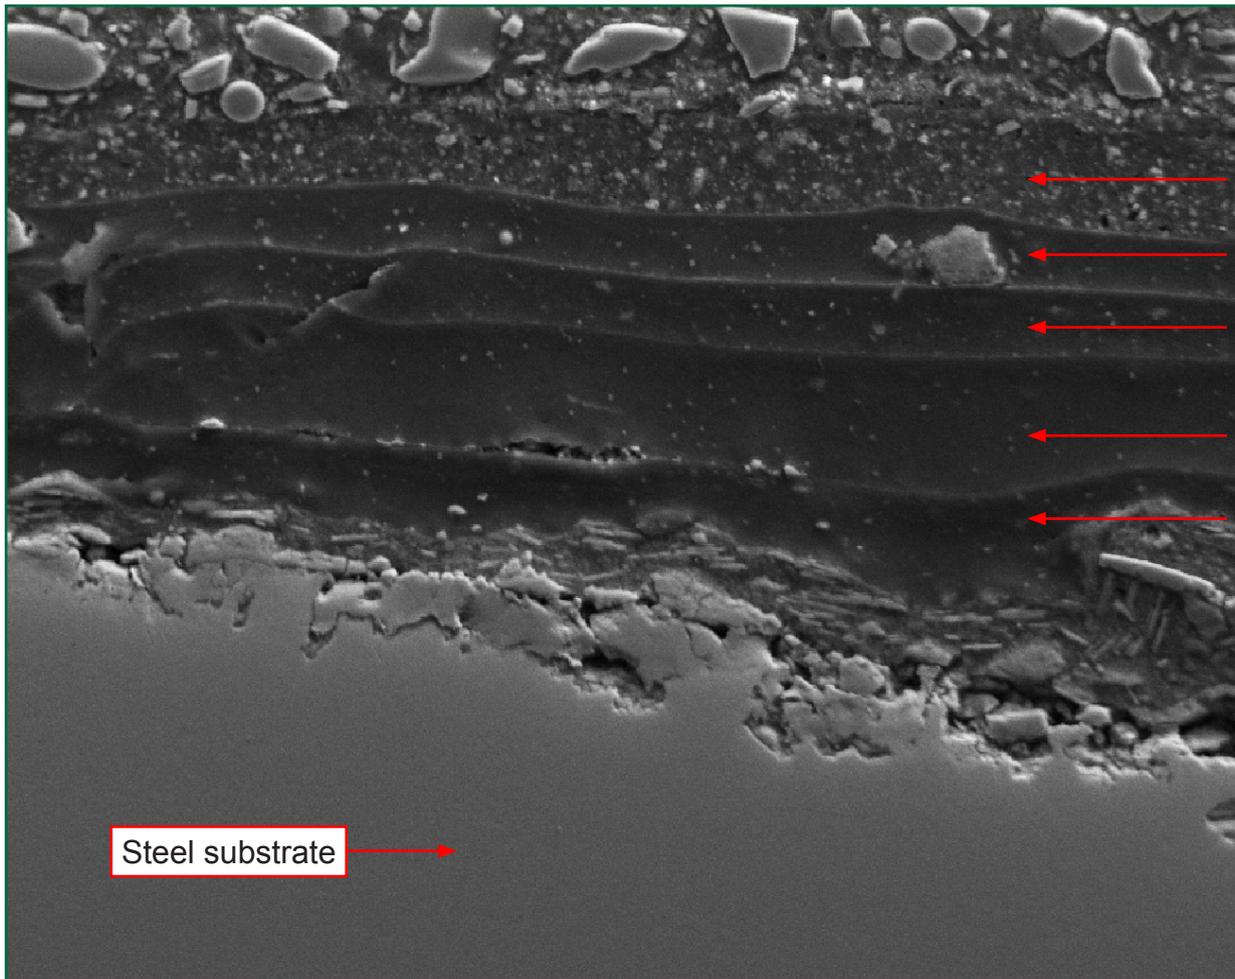
- 45 The external surface had a five-layer organic coating system (see Figure 10), although no zinc galvanised coating was detected. The coating was almost certainly designed to prevent atmospheric corrosion. There was little evidence of any remaining coating on the external surface of the affected region.

Figure 10: SEM micrograph showing cross-section through the signal post illustrating the five layers of the external coating system

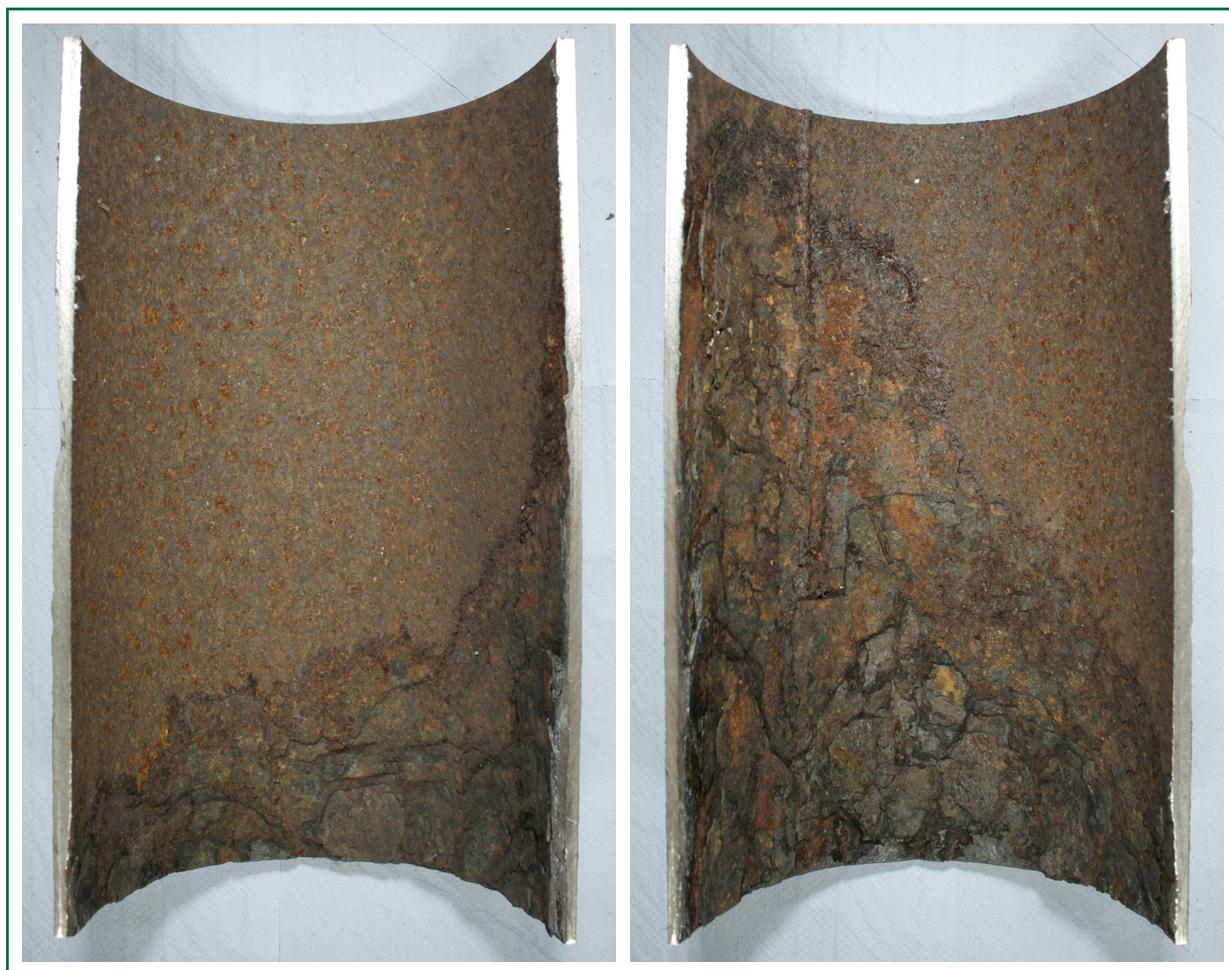
- 48 There was no evidence of any coating on the internal surface, although there was nothing to prevent water getting in (there are several holes in the sides of the post for cable access and there is no cap at the top of the post where the signal head is attached). Corrosion scales (ie rust flakes) were unevenly distributed around the interior of the post, varying from 70 mm to 400 mm above the failure, while metal loss on the internal surface tapered up to around the same point (Figure 11).

- 49 By design, there is no drainage at the bottom of the post where it interfaces with the concrete foundation. It is therefore likely that the internal corrosion occurred due to continual exposure to stagnant rainwater which had entered through the cable holes and the top of the post, and had pooled inside the base. Upon inspection after the accident, the base was full of rust flakes, which would have further impaired the ability of the water to escape.

Figure 11: Internal corrosion of post

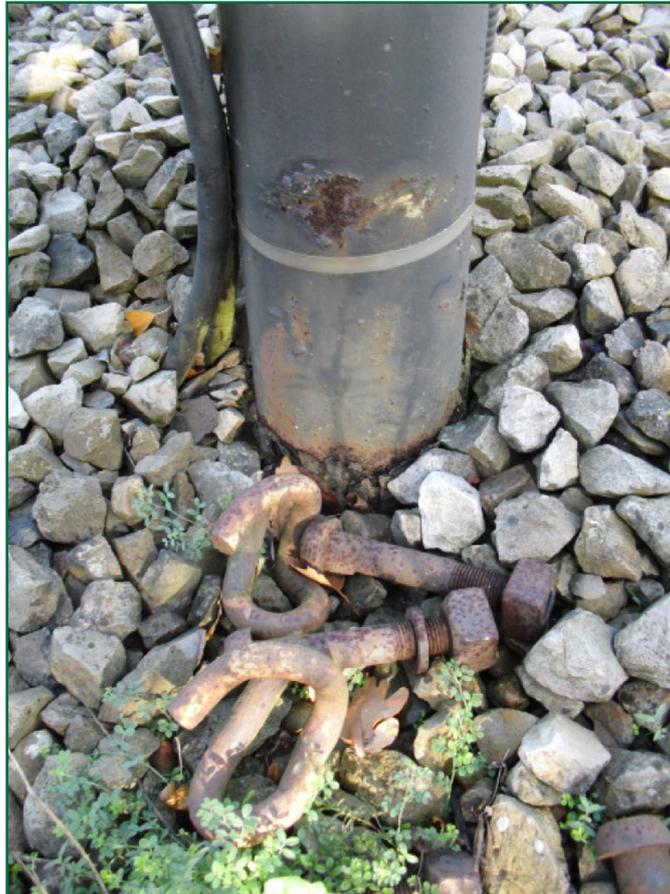
- 62 Arup employed a ‘Link-up’³ approved and competent sub-contractor to conduct its site examinations. Its examiners gave the post of signal TR824 a yellow risk rating (meaning ‘reuse suitable with minor repair works to structure’) for corrosion and for the ladder, and a green risk rating (‘suitable for reuse in existing form’) for paint condition. Upon later review of the report and its associated photographs, Arup decided that the problems appeared more severe, and so changed the ratings for the paint condition and for the ladder to red (‘reuse not recommended on existing structure; recommend renewal’). However, these ratings did not get transferred to a summary table in Arup’s report. Since the summary table was used by Network Rail as the basis for prioritising further actions, it was the less severe ratings that were used to determine whether actions were completed or deferred in the later stages of the project.

- 63 Arup's report noted areas of corrosion to the post and to the ladder, particularly the foot of the ladder which was badly corroded. It also noted that the paint had begun to deteriorate badly at the bottom of the post, but that the base plate and foundations were not inspected because they were buried by ballast (see Figure 13) and were consequently outside of Arup's contractual remit. The report concluded that signal TR824 was serviceable for a further 15 years subject to the paintwork being renewed and the access ladder being replaced.

Figure 13: Photograph from Arup's RORI examinations report showing the base of signal TR824

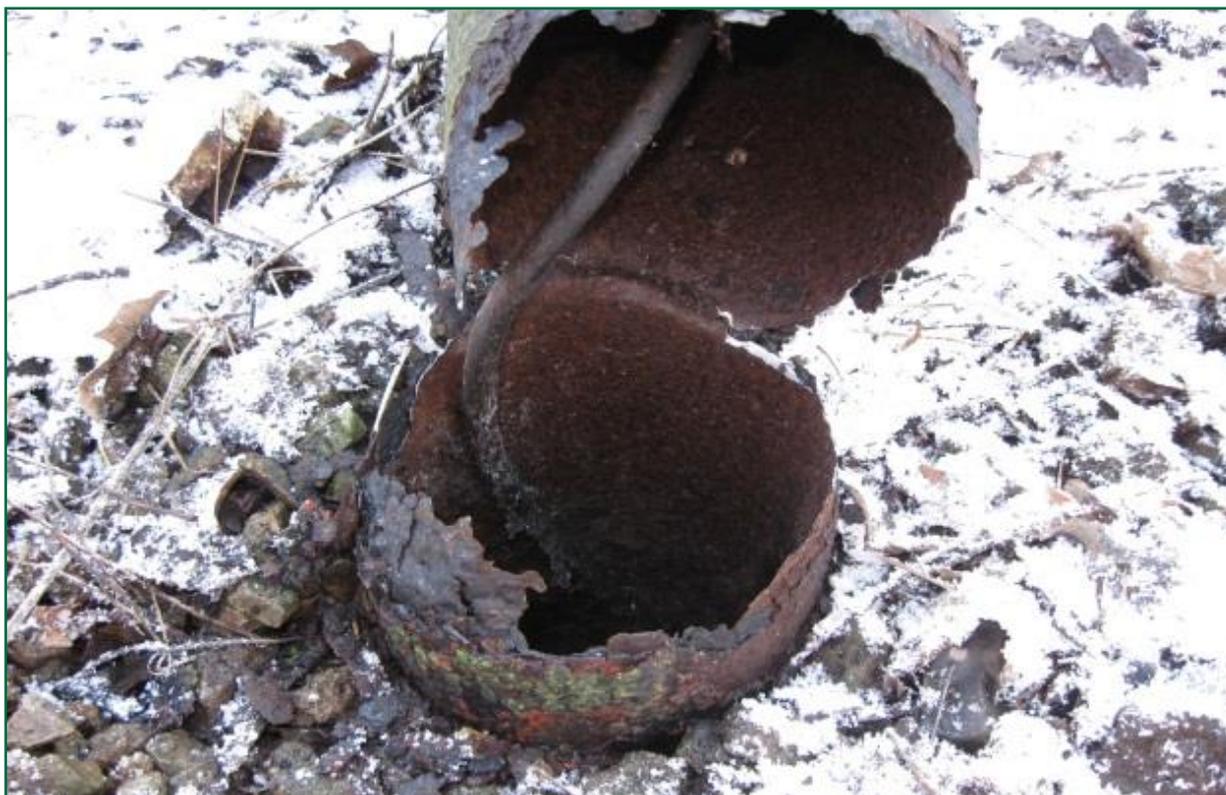
- b. Wymondham (Anglia), 2010: a mechanical signal, approximately 80 years old, was felled on safety grounds due to corrosion at the base of the post (see Figure 14);

Figure 14: Photograph of the failed signal post at Wymondham (courtesy of Network Rail)

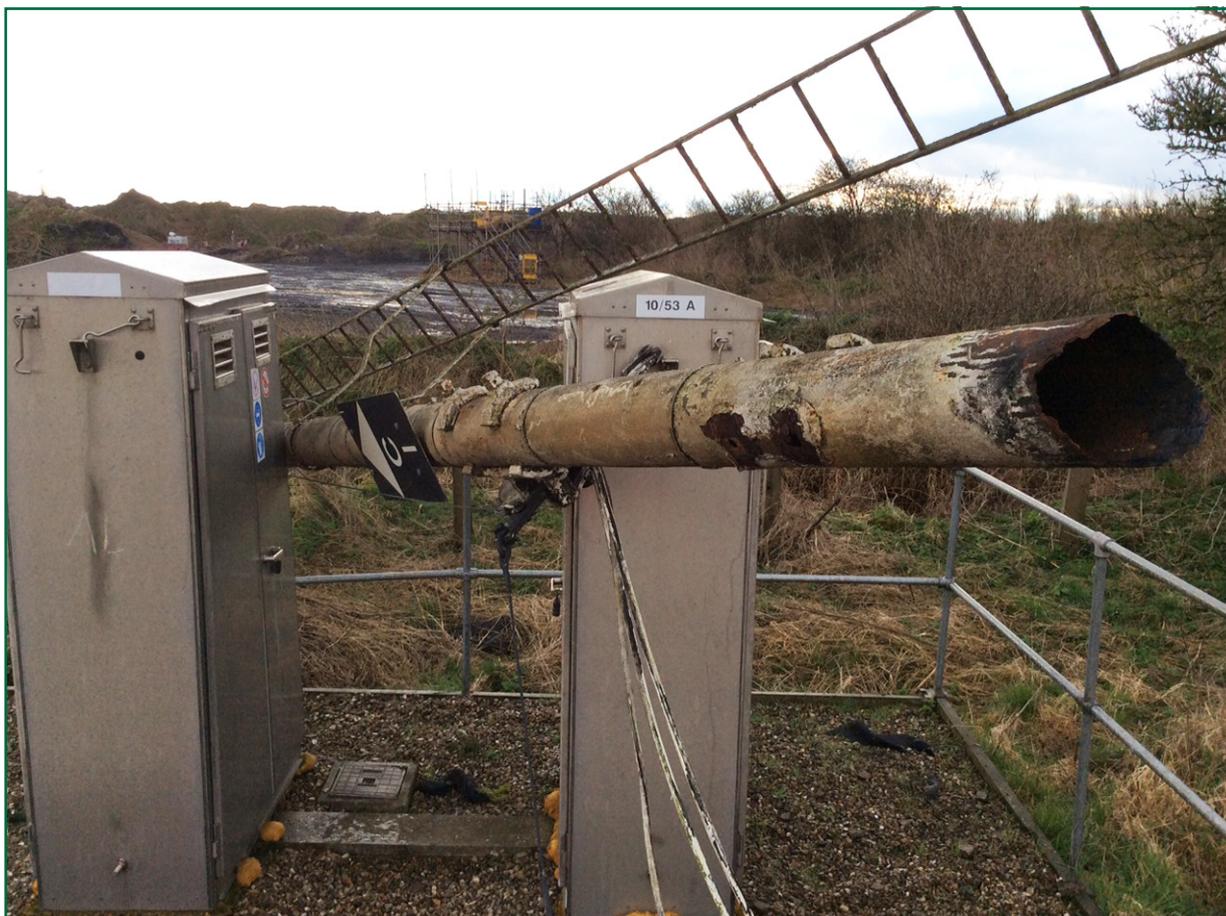
- e. Cantley (Anglia), 29 March 2015: semaphore signal (C1), a *planted post*, collapsed away from the railway due to corrosion at the base just below ballast level (see Figure 15).

Figure 15: Photograph of the failed signal post at Cantley (courtesy of Network Rail)
