Rail Accident Investigation Branch

Rail Accident Report

Derailment at Knaresborough 7 November 2015

Report 16/2016
August 2016

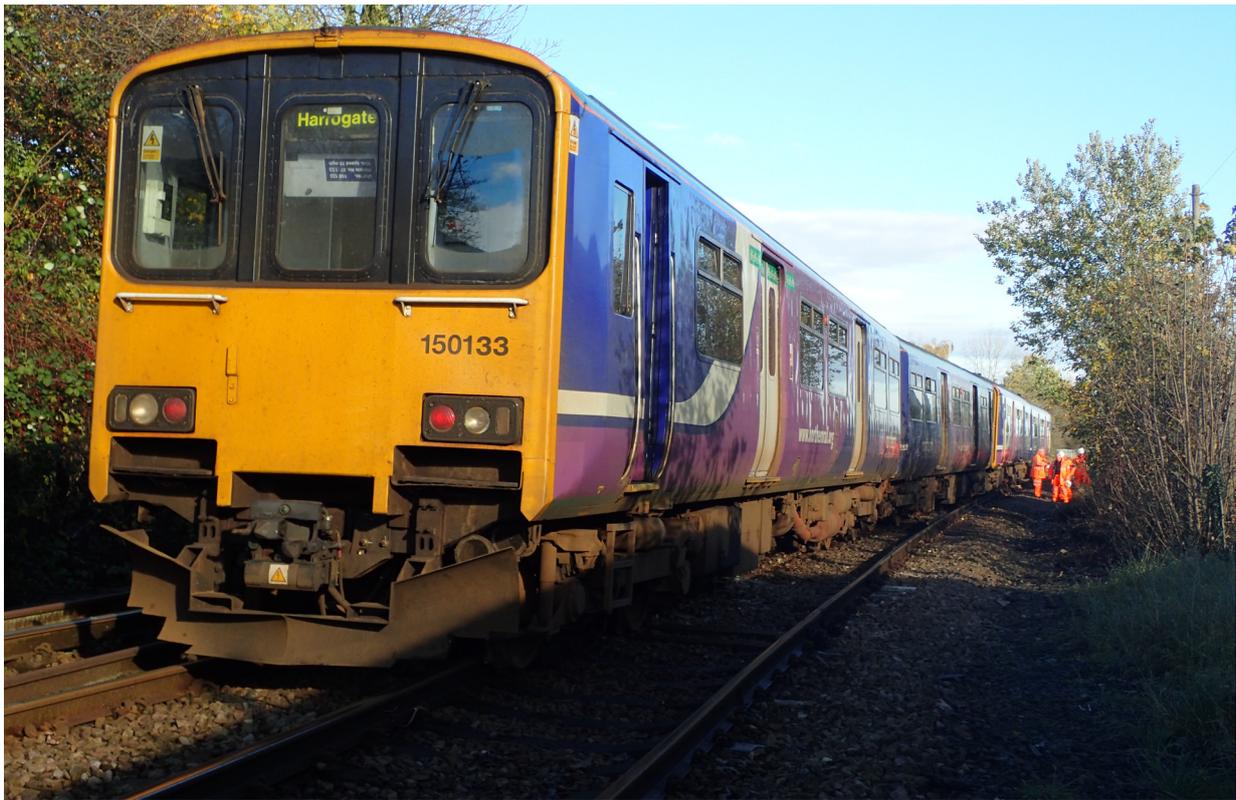
- 4 The first five bogies derailed and damage was sustained by both the train and track. None of the train crew or five passengers on board were injured. The line was re-opened at 12:58 hrs on Sunday 8 November 2015.

Figure 2: Train 2C07 at the site of derailment

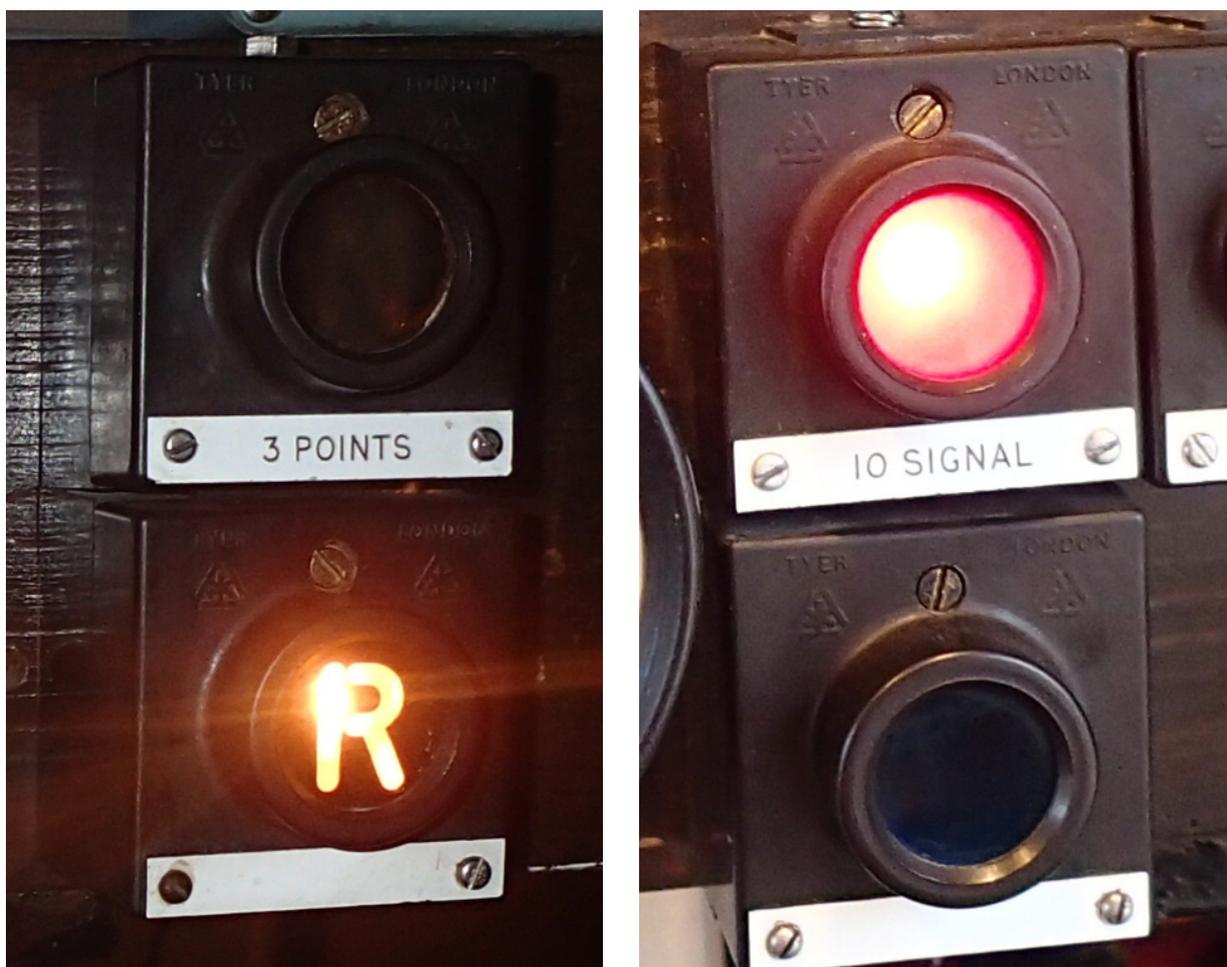
Figure 7: Points position indication³ and signal aspect indication

³ The points position indication for points 3 requires both points 3A and 3B to have obtained detection before it shows 'N' or 'R'.

- 72 The signaller (MOM) did not check the indication on points 3. Had he checked the indication, he would have discovered that neither the normal nor reverse lamp for points 3 was illuminated, indicating that the points were not correctly set. Signal K10 did not clear because of a points failure, and for no other reason.

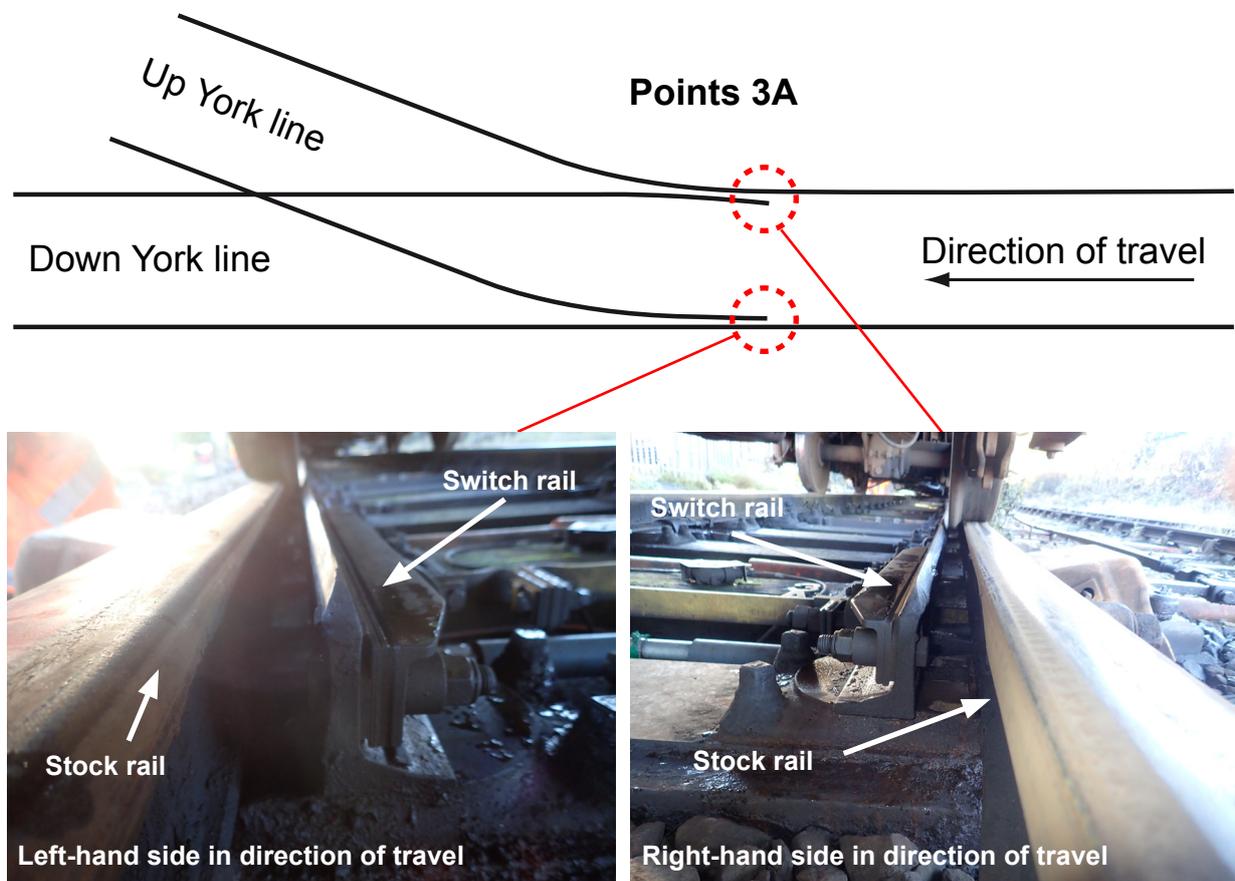
- 49 Train 2C07 derailed on points 3A on the approach to Knaresborough station because the signaller (MOM) authorised the train to proceed towards the points when they were not set in either normal or reverse.
- 50 There was no *data-logger* at the signal box to confirm the state of the points at the time of the derailment. The lack of tell-tale derailing wheel marks on the switch rails after the derailment, indicated that the derailed wheels had passed between the switch and *stock rails* on both the left and right-hand sides (figure 8). This shows that the points were not set in either the normal or reverse position at the time (ie neither switch rail was fully in contact with the adjacent stock rail).

Figure 8: Toes of points 3A after the derailment

- 51 Points 3 are interlocked with signal K10. The fact that points 3A were not set in either normal or reverse would explain why signal K10 remained at danger when the signaller (MOM) tried to clear the signal for a second time⁸ (paragraph 42). When tested after the accident the interlocking and indicator worked correctly.

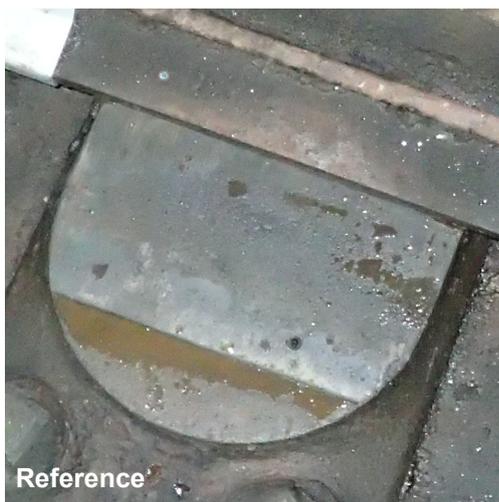
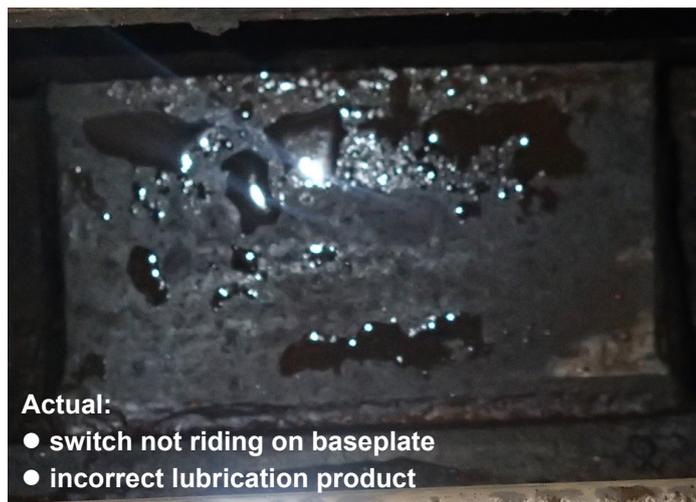
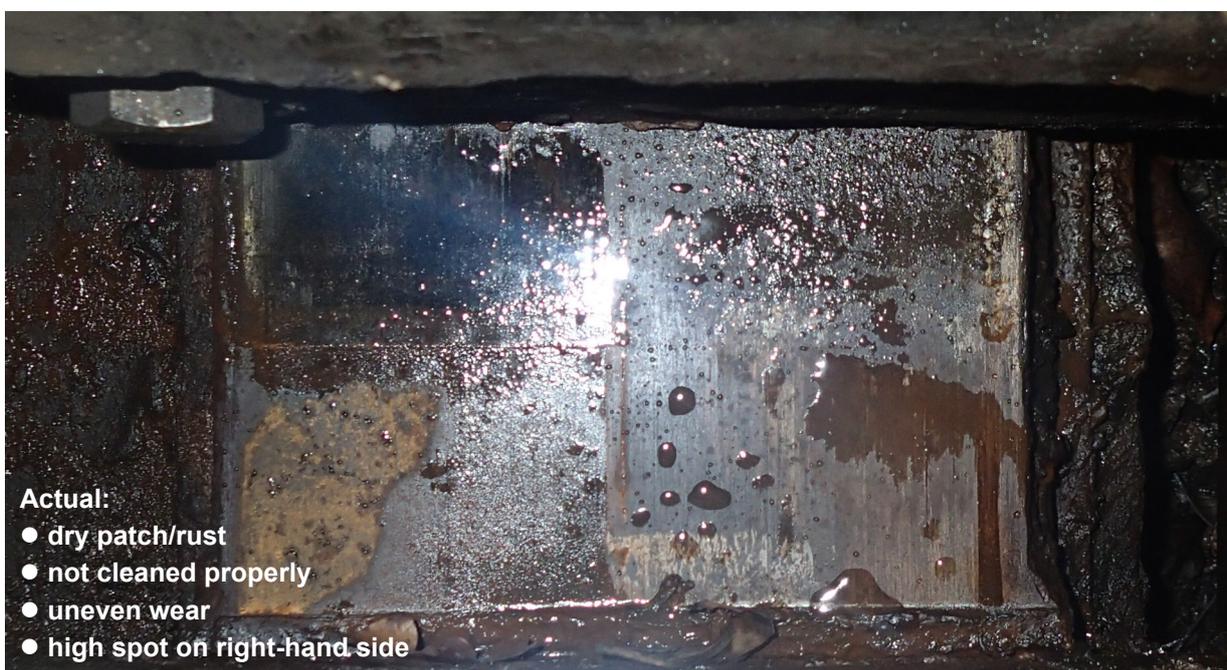
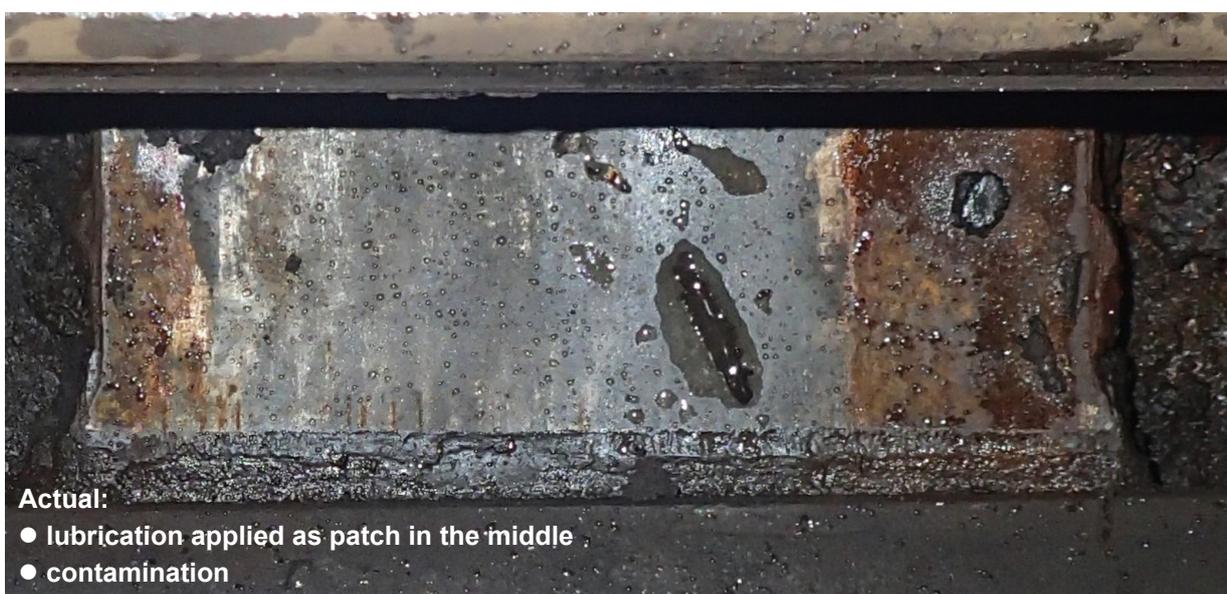
- 62 The lubrication principle relied on two layers of the lubricant: a base layer which was applied only once and a second layer which was renewed during routine maintenance every 4 weeks. The application of the first layer involved cleaning the baseplates back to bare metal, applying a thin, uniform layer of lubricant and letting it dry. The application of the second layer involved, among other steps, wiping clean the baseplates down to the base layer to remove all contamination, and smearing the product across the baseplates if there was evidence that the switch rail might not uniformly contact the baseplate when the points were thrown. Witness evidence indicated that these steps were not always followed by the patrollers during routine maintenance.

Figure 9 – Switch rail to baseplate interfaces (representative examples)

- 63 The photographic evidence captured by the RAIB of the baseplates showed that close to the toe of points 3A, the switch rails were not riding correctly on the baseplates on both sides. This suggested that the bearers (sleepers) had been incorrectly installed at an angle and were causing high spots on the baseplates.
- 64 An examination of the full length of the points showed uneven contact between the baseplates and switch rails on more than 50% of the baseplates. An uneven contact between the baseplates and the switch rail meant that the lubrication product was not uniformly smeared over the baseplates when the points were thrown from one position to the next, possibly leading to high friction.

- 66 According to Network Rail's records, points 3A had previously failed on three separate occasions in 2015: on 9 January 2015, on 27 April 2015 and on 21 August 2015. All three instances had been attributed to high friction and had been addressed by the S&T fault team by re-applying the lubrication product¹⁰. It is also possible that the indication fault reported by the signaller on 31 October 2015 (paragraph 30) which the S&T fault team could not replicate on 5 November was also associated with high friction.

- 106 The maintenance team in charge of the track at Knaresborough is planning to replace the bearers under points 3A in 2017/2018 with a possibility of bringing it forward to 2016/2017.

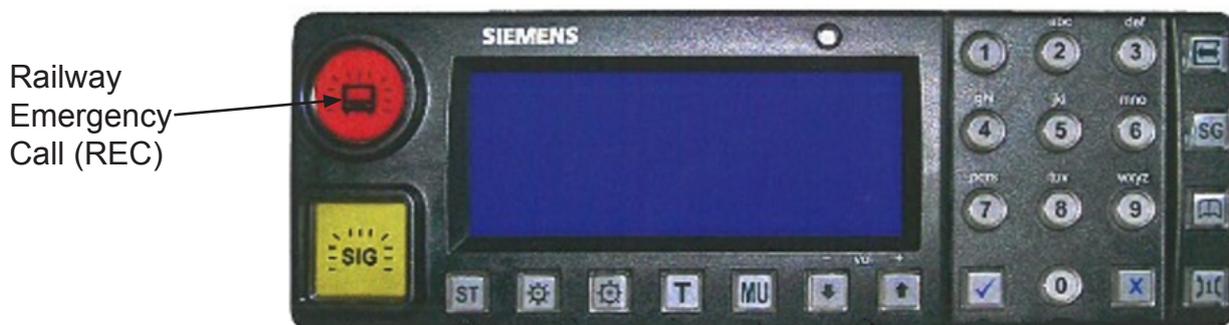
93 The driver used the yellow button on his GSM-R terminal to try to contact the signaller after the derailment (figure 10). This was unsuccessful as the signaller was on the station platform at the time, waiting for the token to be handed back to him. This had no effect on the incident but it would have been more appropriate to immediately use the REC button to raise the alarm. The REC button sends an 'all trains stop' signal to any train in the same operational area to reduce the risk of a secondary collision.

Figure 10: GSM-R terminal
