***Federal Railroad Administration
Office of Safety
Headquarters Assigned
Accident Investigation Report
HQ-2005-79***

***Northeastern Illinois Regional Commuter Rail (NIRC)
Chicago, Illinois
September 17, 2005***

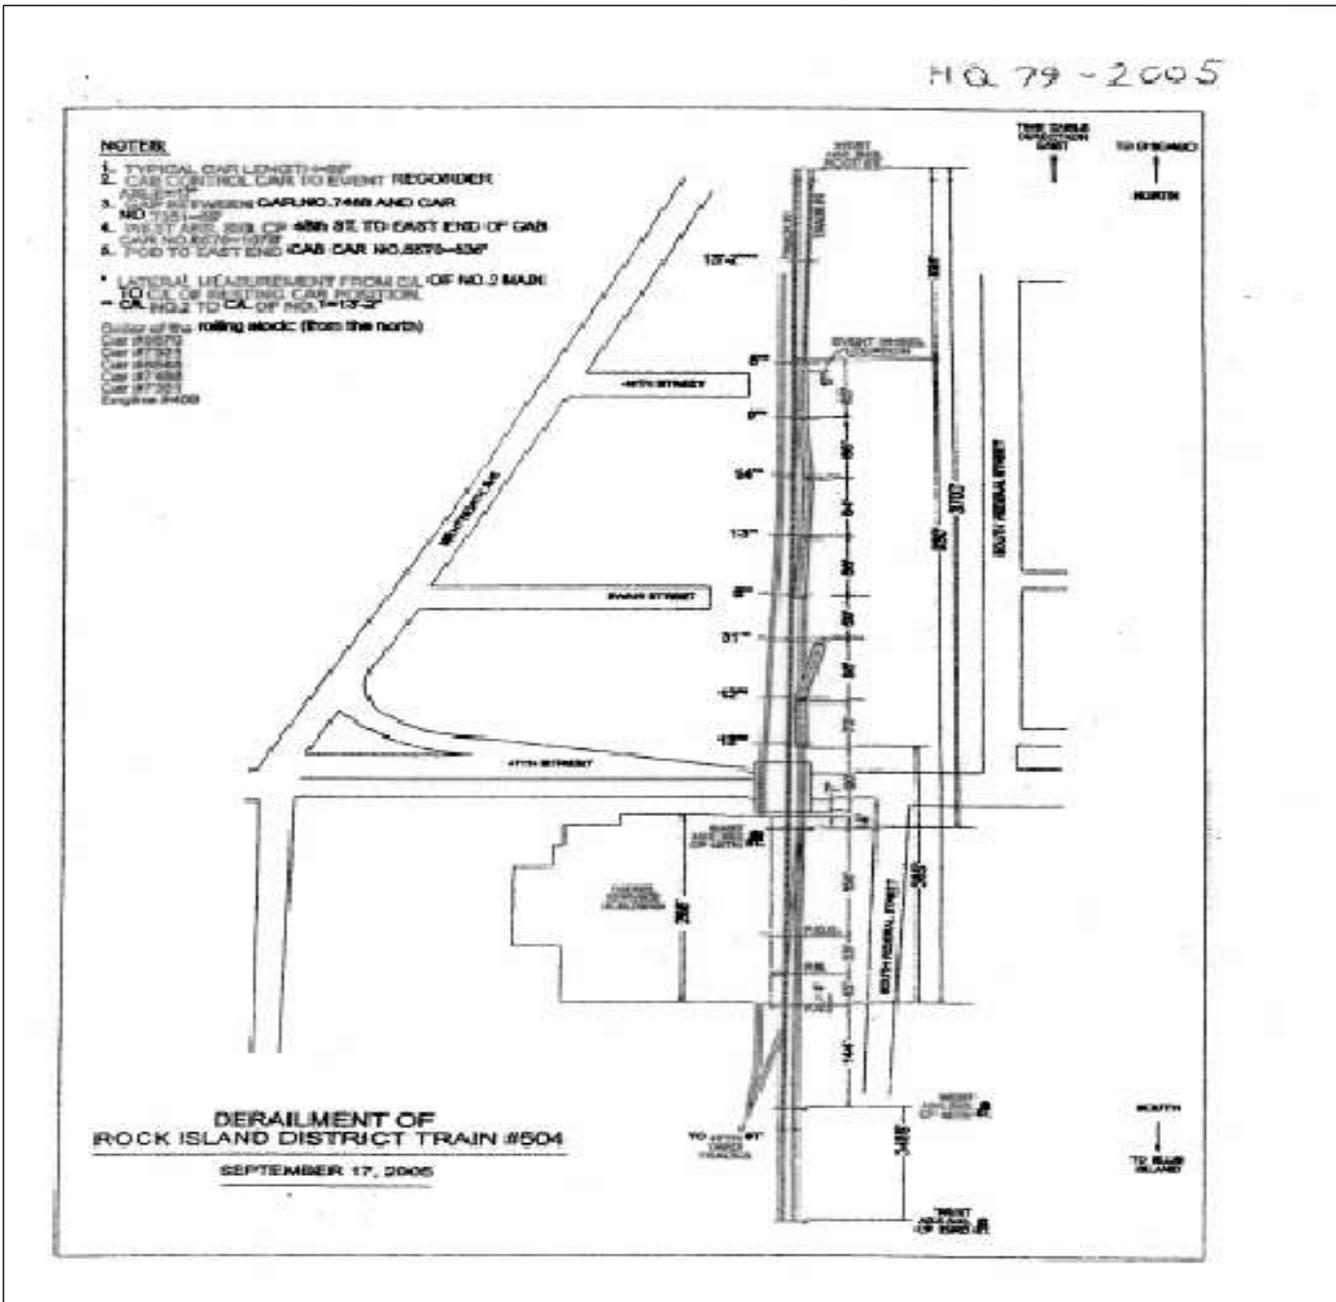
108. DRAW A SKETCH OF ACCIDENT AREA INCLUDING ALL TRACKS, SIGNALS, SWITCHES, STRUCTURES, OBJECTS, ETC., INVOLVED.
79.bmp

An eastbound Northeast Illinois Commuter Corporation (NIRC) a.k.a "Metra" commuter train, No. 504, carrying 185 passengers and a crew of four employees, derailed at a crossover switch on September 17, 2005, at 8:35 a.m. The accident occurred in Chicago, Illinois, at Control Point (CP) 48th Street, Milepost (MP) 4.7, on Metra's Rock Island District.

Before the engineer had time to react, Train 504 entered the facing-point crossover switch at CP 48th Street at a recorded speed of 69.3 mph, derailing the entire train. The derailed cars continued moving forward, through the crossover onto No. 1 Main Track and through the 47th Street bridge. At this point, some of the derailed cars struck the south end of the east side of the 70-foot long, through plate girder bridge which extends about three feet above the ballast on each side of the track.

FRA and NTSB Track inspectors determined by consensus that the point of derailment was 52.74 feet north (railroad east) of the end of the switch point on the curved closure rail on No. 2 Main Track. They also noted extensive damage to track and bridge structure caused by the derailment, however they concluded that neither the track nor the bridge was a primary or contributing cause of the derailment.
