***Federal Railroad Administration
Office of Safety
Headquarters Assigned
Accident Investigation Report
HQ-2008-61***

***Norfolk Southern (NS)
Salem, OH
July 3, 2008***

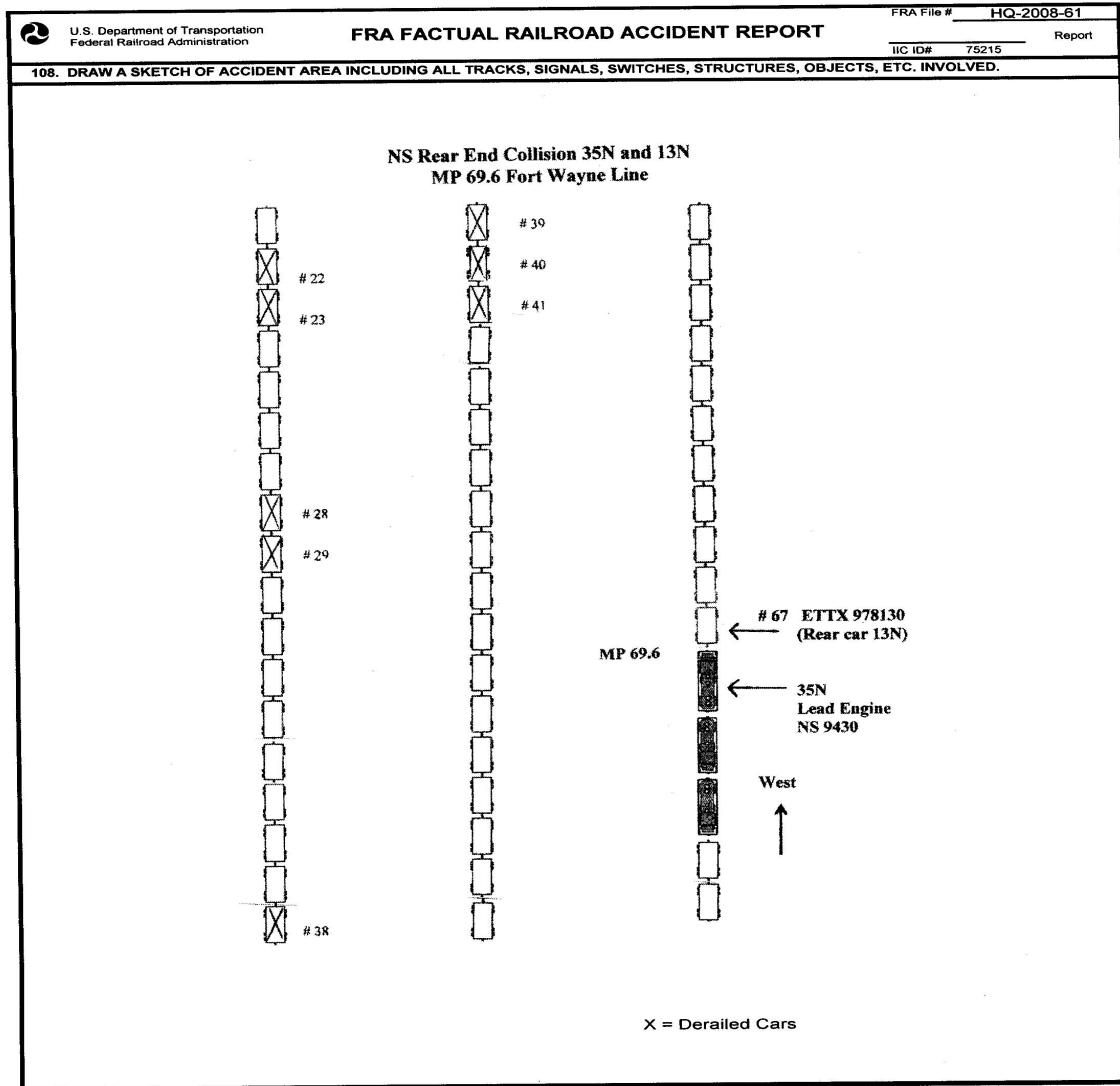
136. DRAW A SKETCH OF ACCIDENT AREA INCLUDING ALL TRACKS, SIGNALS, SWITCHES, STRUCTURES, OBJECTS, ETC., INVOLVED.

Westward Norfolk Southern (NS) freight train 35NC3-02 struck the rear of a stopped NS train 13N3-01 derailing 8 empty cars of the stopped train. The derailment occurred at 9:15 p.m. July 2, 2008 at Salem, Ohio on # 2 Main Track at Mile Post (MP) PC 69.6 on the Fort Wayne Line of the NS Pittsburgh Division.

Eight empty multi-level cars derailed on NS Train 13N. The rail canted and rolled at several locations under the train. The derailed wheels were lying on the web of the rail. The derailed cars were in the following positions: 22, 23, 28, 29, 38, 39, 40, and 41. The last car of the sixty-seven car train was damaged but did not derail. Car damage to NS Train 13N, including the rear EOTD, was \$9,513. No locomotives or cars of NS Train 35N were derailed; however, damages to lead locomotive NS 9430 was set at \$1,736. The south

(left) rail over-turned for about two car lengths at four separate locations under NS Train 13N. The total length of the canted/rolled rail was approximately 400 feet. NS set total material and labor cost at \$ 1,000.
