***Federal Railroad Administration
Office of Safety
Headquarters Assigned
Accident Investigation Report
HQ-2008-94***

***Canadian Pacific (CP)
River JCT, MN
December 17, 2008***

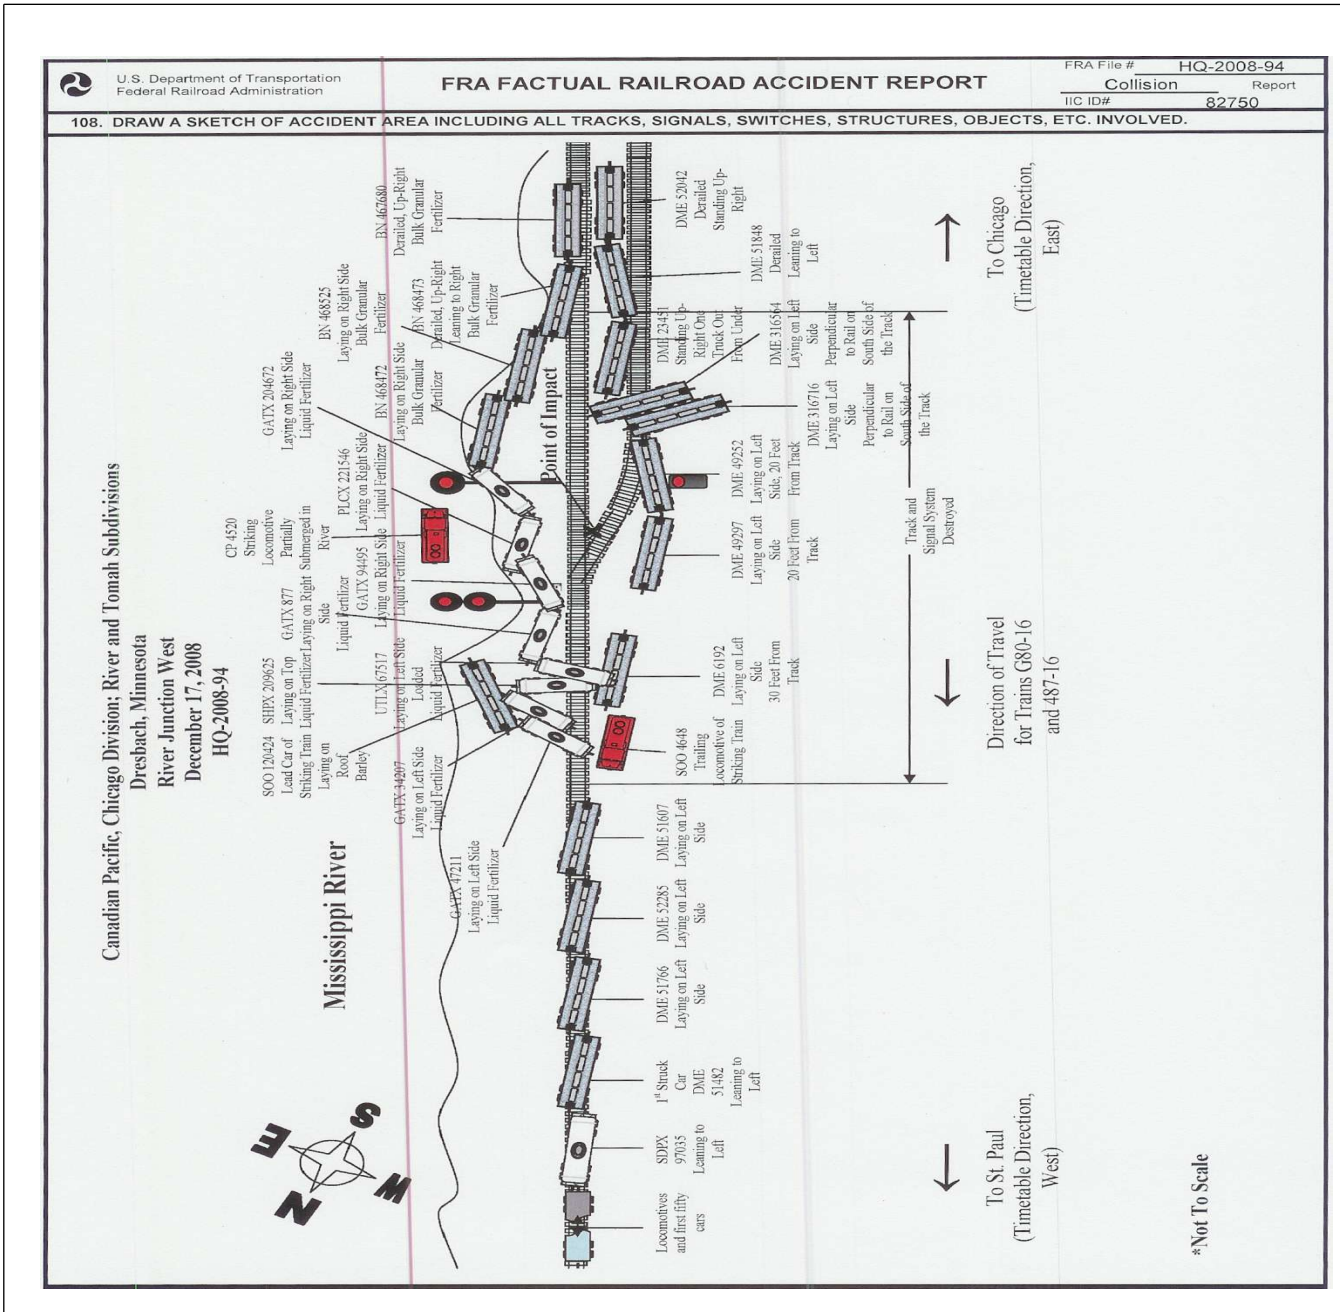
136. DRAW A SKETCH OF ACCIDENT AREA INCLUDING ALL TRACKS, SIGNALS, SWITCHES, STRUCTURES, OBJECTS, ETC., INVOLVED.

On December 17, 2008, at 4:48 a.m., CST westbound Canadian Pacific SOO Line Railroad Company (CP) local freight train, G80-16 collided with westbound CP Manifest Train, 487-16 resulting in the derailment of 26 cars and two locomotives. The incident occurred near Dresbach, Minnesota, on the CP River Subdivision at Control Point (CP) River Junction West at milepost (MP) 288.0.

CP 4520, the leading locomotive of CP Train G80-16 struck DME 51482, the 51st car of CP Train 487. As a result of the collision locomotive CP 4520 came to rest upright and partially submerged in the Mississippi River. The trailing locomotive of Train CP G80-16 was destroyed and the lead 13 cars of Train CP G80-16 were derailed. Thirteen cars of Train CP 487-16 were also derailed, the 50th through the 62nd car. There was no fire and no release of hazardous materials from either train. The collision pushed a ground mounted liquefied petroleum gas (LPG) tank, that was used for the switch heater for the power switch at River Junction West, from its mounting causing it to vent LPG to the atmosphere. This release of LPG required an evacuation of 28 people from a nearby retirement home. Two crew members of Train CP G80-16 were transported by ambulance to a local hospital; one crew member received medical treatment.
