## INTERSTATE COMMERCE COMMISSION

REPORT OF THE DIRECTOR OF THE BUREAU OF SAFETY IN RE INVESTIGATION OF AN ACCIDENT WHICH OCCURRED ON THE WABASH RAILWAY AT BEMENT, ILL., ON JANUARY 1, 1931.

January 22, 1931.

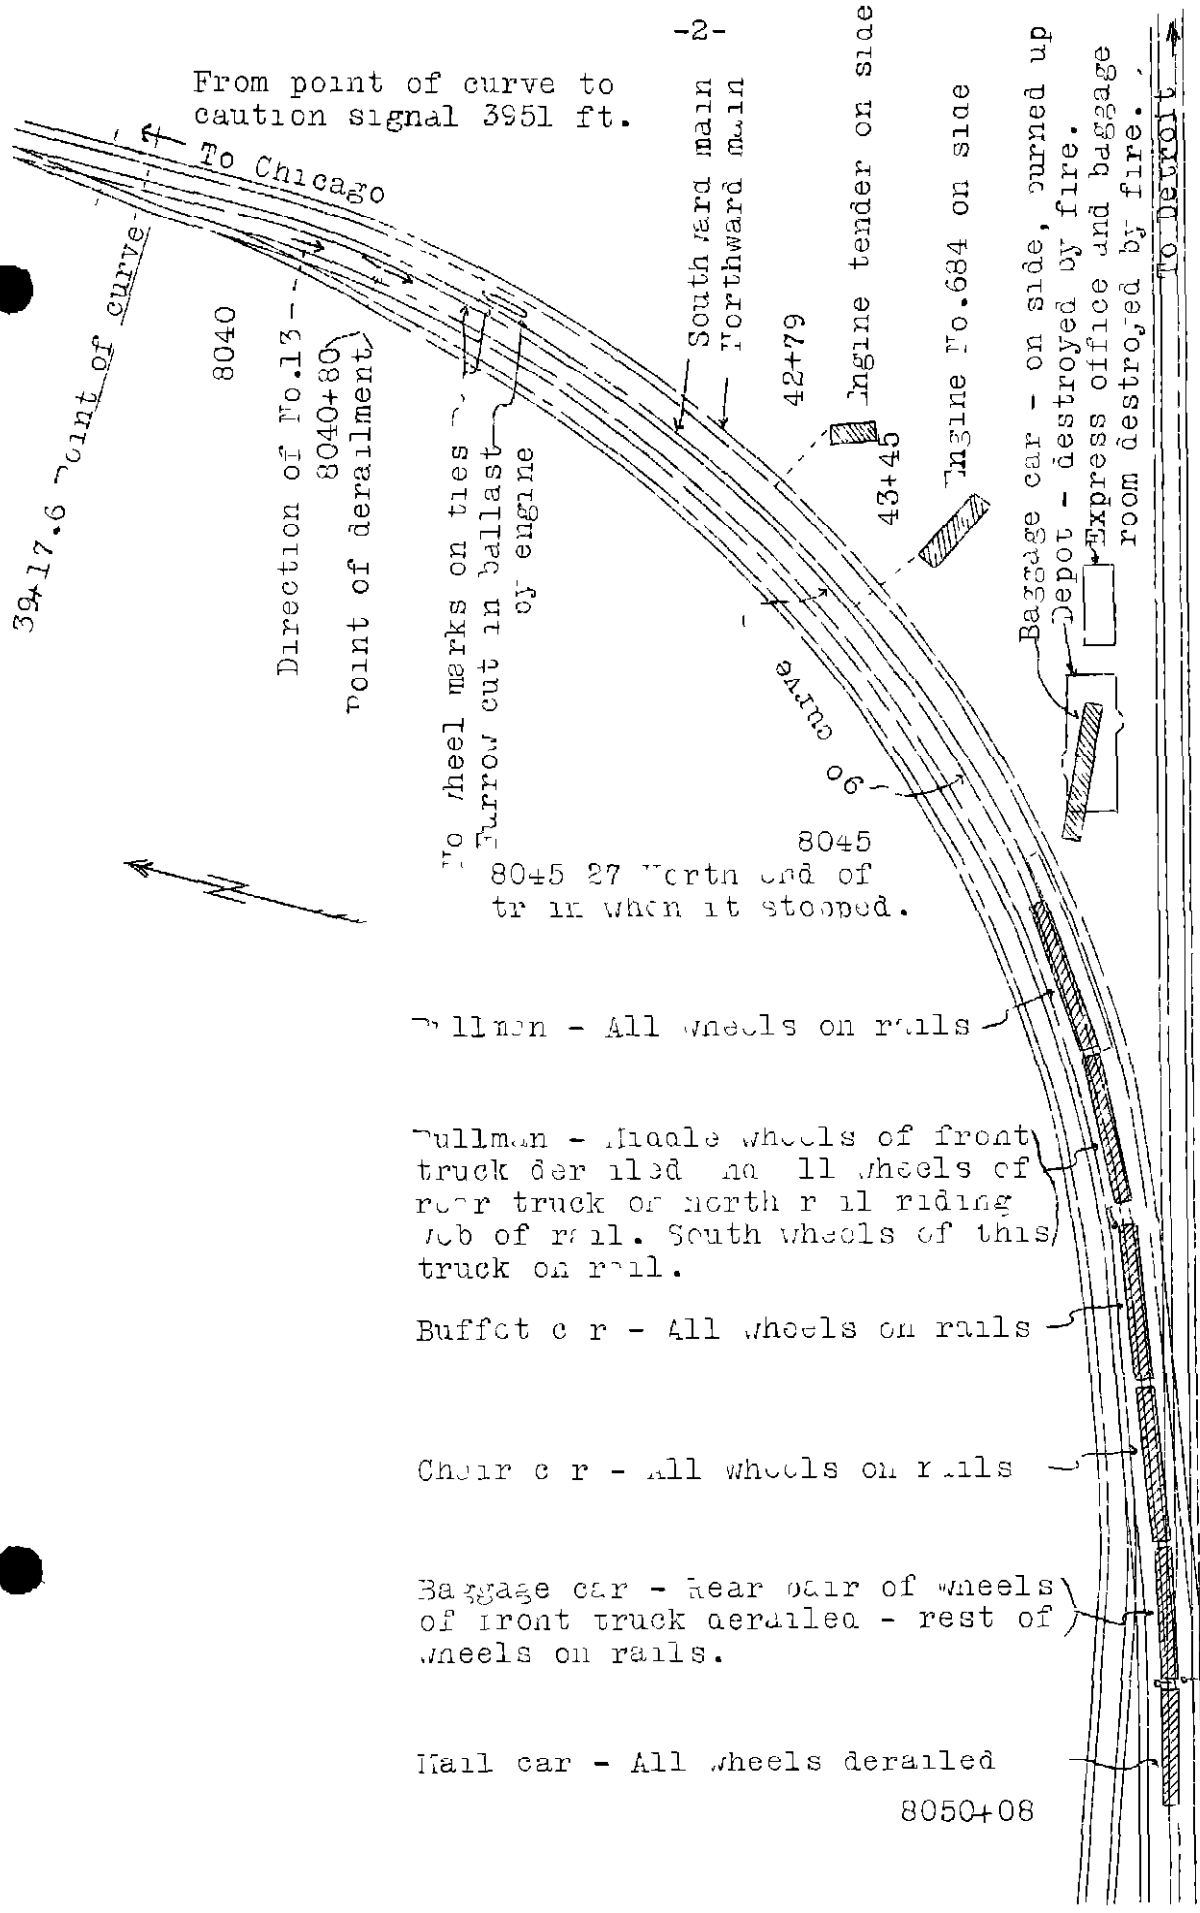
No. 1682  
Wabash Ry.  
Bement, Ill.  
Jan. 1, 1931.

Direction of No. 13 -  
8040+80  
point of derailment

No wheel marks on ties  
Narrow cut in ballast  
of engine

Engine tender on side

Engine No. 684 on side

80+5 27 North end of  
train when it stopped.

Baggage car - on side, burned up  
Depot - destroyed by fire.  
Express office and baggage  
room destroyed by fire.

Millman - All wheels on rails

Pullman - Middle wheels of front  
truck derailed and all wheels of  
rear truck on north rail riding  
web of rail. South wheels of this  
truck on rail.

Baggage car - Rear pair of wheels  
of front truck derailed - rest of  
wheels on rails.

Mail car - All wheels derailed

The engine and tender were derailed and overturned, the engine coming to rest in a badly-damaged condition 264 feet south of the point of derailment and 28 feet east of the northbound main track, the tender also came to rest on the east side of the main tracks, 63 feet to the rear of the engine. The first car landed against the station, 420 feet from the point of derailment, while the remaining cars in the train were not derailed at the initial point of derailment, but continued southward and stopped in upright position, partly derailed as a result of encountering debris, with the rear end of the last car 446 feet beyond the point where the engine was derailed. The stove in the station building was overturned, causing a fire which destroyed the station and a nearby express office and baggage room. All of the other cars in the train were more or less damaged. The employee killed was the engineman, and the employees injured were the fireman and brakeman.

disturbed and the only indication of derailment consisted of slight marks on the ends of the ties on the left or east side of the track for a distance of 11 feet. From this point southward, the ballast was badly disturbed between the two main tracks, apparently caused by the pilot beam or cylinder while the engine was turning over. Engineman Hitchcock was quoted by one of the officials as having made an antemortem statement, on the morning of January 2, that he did not know how the accident happened, but that he "was going down there mighty fast."

This accident was caused by excessive speed on a sharp curve.
