INTERSTATE COMMERCE COMMISSION

REPORT OF THE DIRECTOR OF THE BUREAU OF SAFETY IN RE INVESTIGATION OF AN ACCIDENT WHICH OCCURRED ON THE NEW YORK, NEW HAVEN & HARTFORD RAILROAD AT READVILLE, MASS., ON JANUARY 19, 1931.

February 20, 1931.

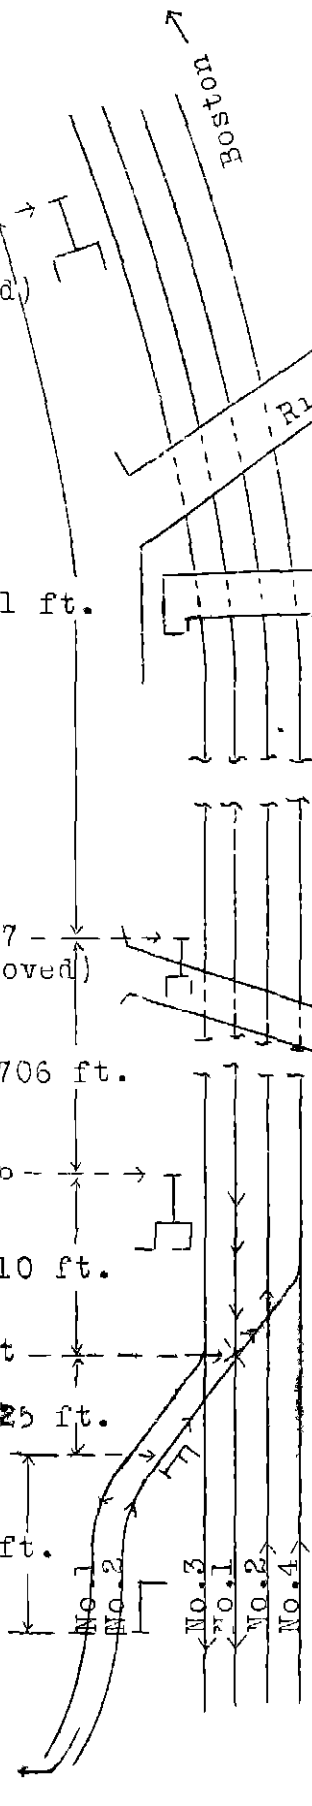
INR. No. 1684,
New York, New Haven & Hartford R.R.
Readville, Mass.
January 19, 1931

New Distant Signal
(No blade on mast
for movement involved)

Old Distant Signal 97 -
(Blades had been removed)

Point of accident -

This accident was caused by the failure of Engineman Gladding, of train No. 175, properly to control the speed of his train, particularly in view of the existing weather conditions, with the result that he was unable to bring it to a stop before passing home signal 96, and the lack of a distant signal indication, for which Signal Foreman Mills and Forbes were responsible.

So far as the signal department is concerned, there was an inexcusable lack of cooperation. The procedure was very simple so far as it affected the two distant signals, all the signal department employees had to do was to place in operation the new distant signal and then cut out the old distant signal. Signal Supervisor Dobson was absent on account of illness, and this left it up to Signal Foreman Mills, an electrical foreman, and Signal Foreman Forbes, a mechanical foreman. The former was the only one in possession of a copy of the plans, and had been given to understand that he was in charge of the work in the absence of Signal Supervisor Dobson. He said he did not understand it that way, however, his idea being that he and Signal Foreman Forbes were jointly responsible, each for his own part of the work. While there is no question but that some one should have been in charge of the work, even this misunderstanding on the part of Signal Foreman Mills is not a sufficient excuse for what occurred. These two foremen were experienced men, were fully aware of the nature of the work to be done, and each realized that the old distant signal should not be cut out until the new distant signal had been placed in service. There was no cooperation between them, however, and no definite arrangement made to guard against the possibility of cutting out the old signal before the new one had been placed in service. The result was that Signal Foreman Forbes proceeded to the old distant signal location, waited 15 or 20 minutes, within which period he supposed the new signal would be placed in service, and then proceeded to cut out the old signal. The new signal had not been placed in service, however, and train No 175 therefore was enabled to approach at a high rate of speed without receiving any warning on either of the distant signals to indicate that the home signal was in the stop position. The actions of these two foremen made very probable the occurrence of just such an accident as did occur, and they can not be too strongly condemned for their total lack of cooperation and for their failure to realize the responsibilities of their respective positions.
