INTERSTATE COMMERCE COMMISSION

REPORT OF THE DIRECTOR OF THE BUREAU OF SAFETY IN RE INVESTIGATION OF AN ACCIDENT WHICH OCCURRED AT THE IN- TERSECTION OF THE TRACKS OF THE CHICAGO, MILWAUKEE, ST. PAUL & PACIFIC RAILROAD AND THE CHICAGO, ST PAUL, MINNE- APOLIS & OMAHA RAILWAY AT CAMP DOUGLAS, WIS, ON FEBRUARY 28, 1931

APRIL 3, 1931

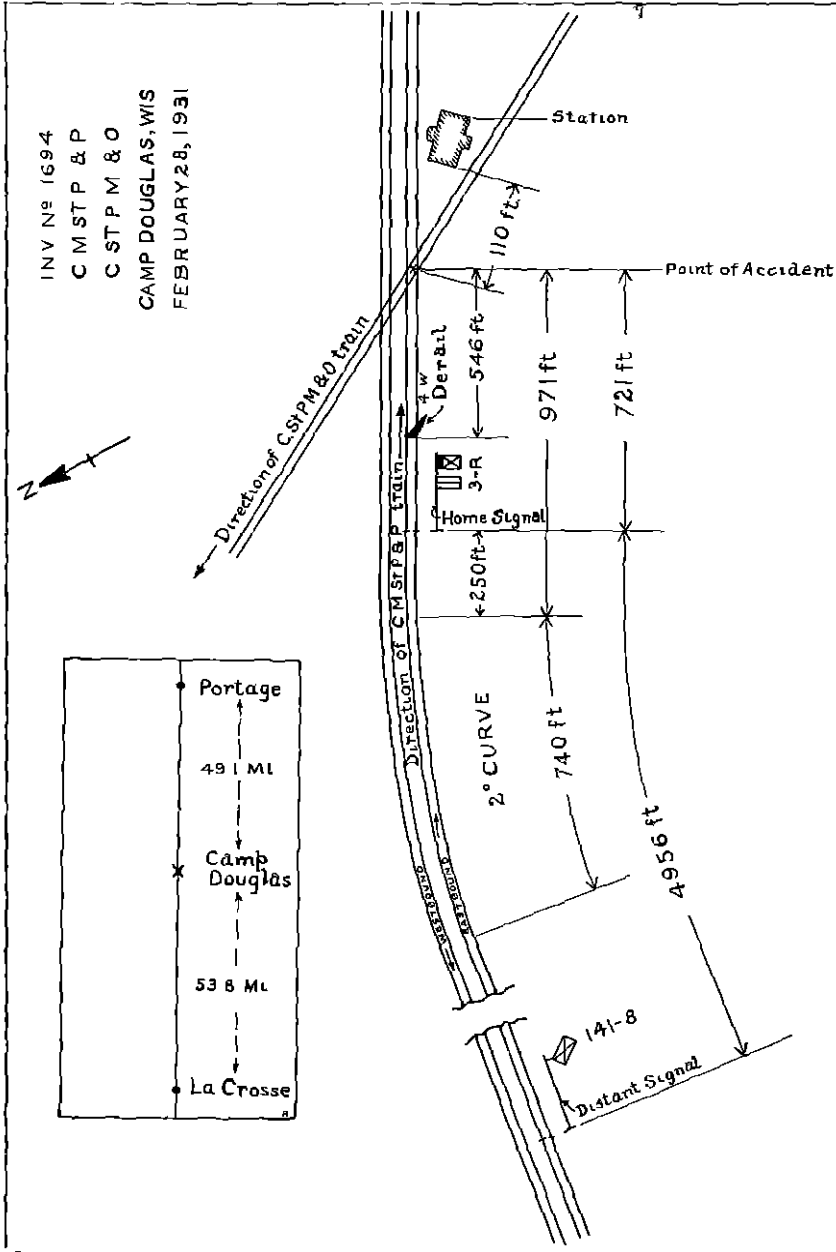
Trains approaching the crossing on the Chicago, Milwaukee, St. Paul & Pacific eastbound main track are governed by interlocking distant signal 141-8, a 1-arm signal which is also used as an automatic block signal and is located 4,956 feet west of home signal 3-R, which is a 2-arm signal and is located 721 feet west of the crossing. Except for the bottom arm of signal 3-R, which is fixed, these signals are of the 3-position, upper-quadrant type, displaying white, green, and red indications, for proceed, caution, and stop, respectively. The view of distant signal 141-8 is unobstructed for a distance of more than 1 mile, while a view of home signal 3-R, from the engineer's side of an approaching train, can not be obtained until a point 900 feet west of the signal is reached, due to the intervening curve and also a pole line located on the south side of the tracks.

A split-point derail operated in conjunction with the signals is located in the south rail of the Chicago, Milwaukee, St. Paul & Pacific eastbound track between the home signal and the crossing, the point of the derail being 546 feet west of the crossing.

FIGURE 1—Track layout at Camp Douglas, with signals involved in accident

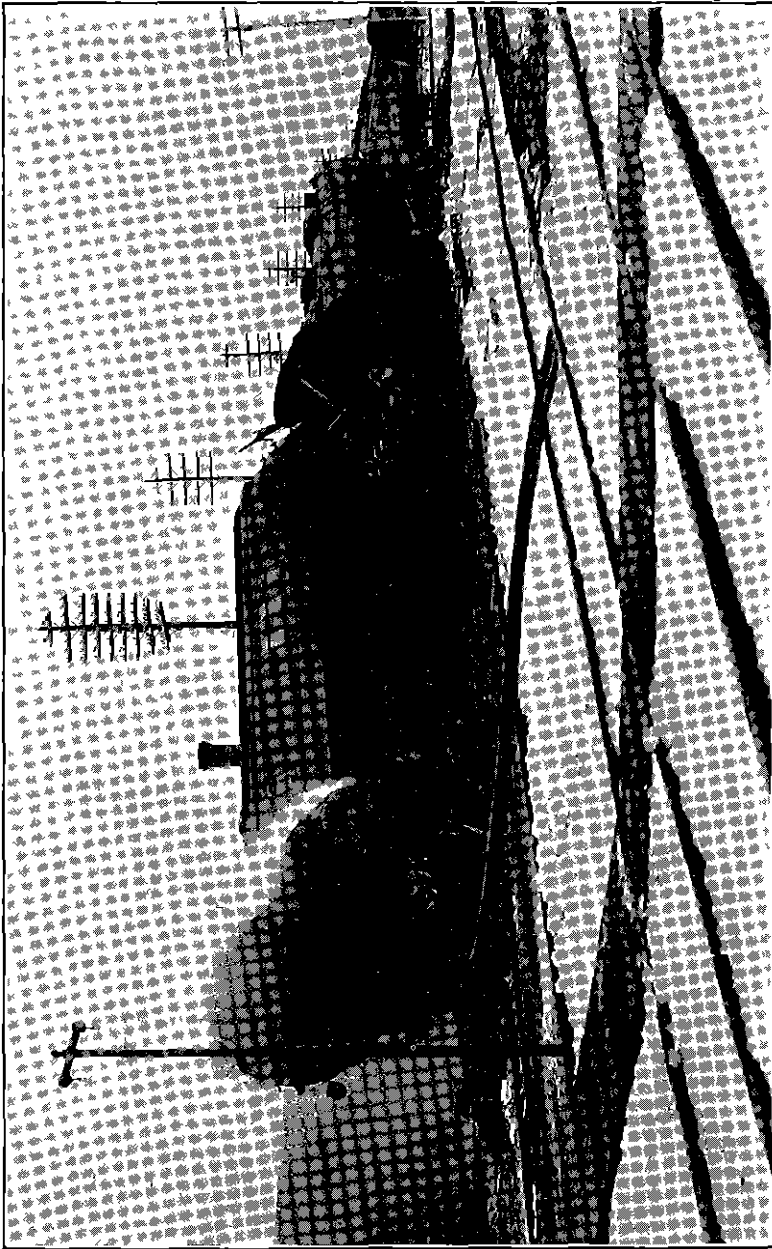
Chicago, Milwaukee, St Paul & Pacific engine 6409 collided with the left sides of the tender and the first car of Chicago, St Paul, Minneapolis & Omaha train No 515, passed over the crossing, and came to rest derailed and leaning to the right at an angle of 45°, near the west end of the station, in a badly damaged condition, the tender was also derailed but remained upright behind the engine. The first car of train No 16 stopped in an upright position in line with the Chicago, St Paul, Minneapolis & Omaha track and on top of the first car of train No 515. The second car of the Chicago, Milwaukee, St Paul & Pacific train stopped on the crossing, derailed and badly damaged, the front truck of the third car and one pair of wheels of the rear truck of the fifth car were also derailed, while the remaining equipment in this train was not derailed or damaged. Chicago, St Paul, Minneapolis & Omaha engine 601 was partly derailed and considerably damaged, and the tender and the first car of that train were derailed and badly damaged. The employee killed was the fireman of Chicago, Milwaukee, St Paul & Pacific train No 16, and the employees injured were the conductor and engineman of that train, the injured mail clerks, the Pullman employee and the passengers injured were also on Chicago, Milwaukee, St Paul & Pacific train No 16.

FIGURE 2—General view of wreckage, north side Milwaukee engine on left, Omaha engine on right

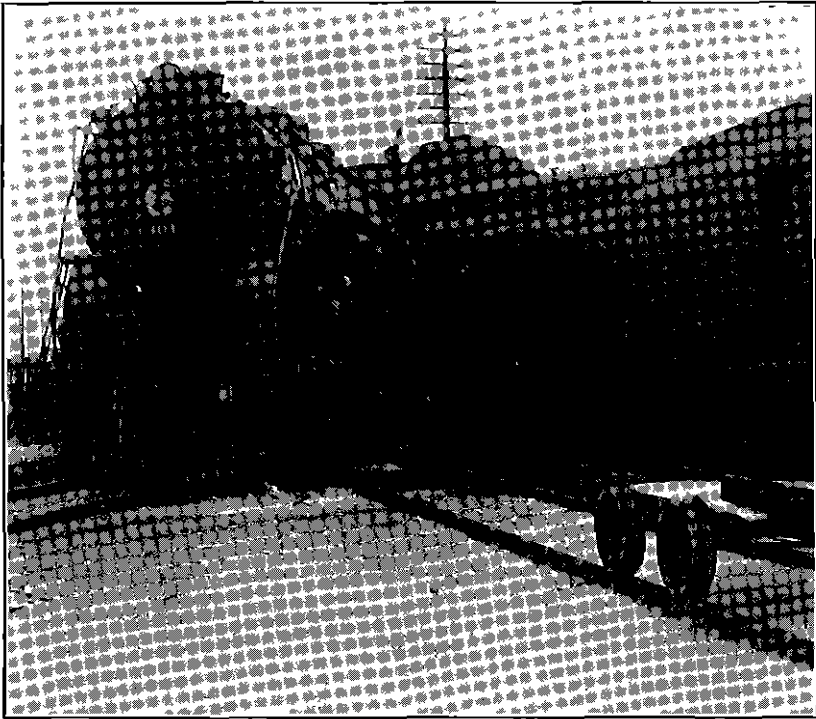
FIGURE 4—Omaha engine with Milwaukee train on right
