## INTERSTATE COMMERCE COMMISSION

REPORT OF THE DIRECTOR OF THE BUREAU OF SAFETY IN RE  
INVESTIGATION OF AN ACCIDENT WHICH OCCURRED ON THE  
CLEVELAND, CINCINNATI, CHICAGO & ST. LOUIS RAILWAY,  
NEW YORK CENTRAL LINES, AT KANKAKEE, ILL., ON  
SEPTEMBER 30, 1931

November 4, 1931.

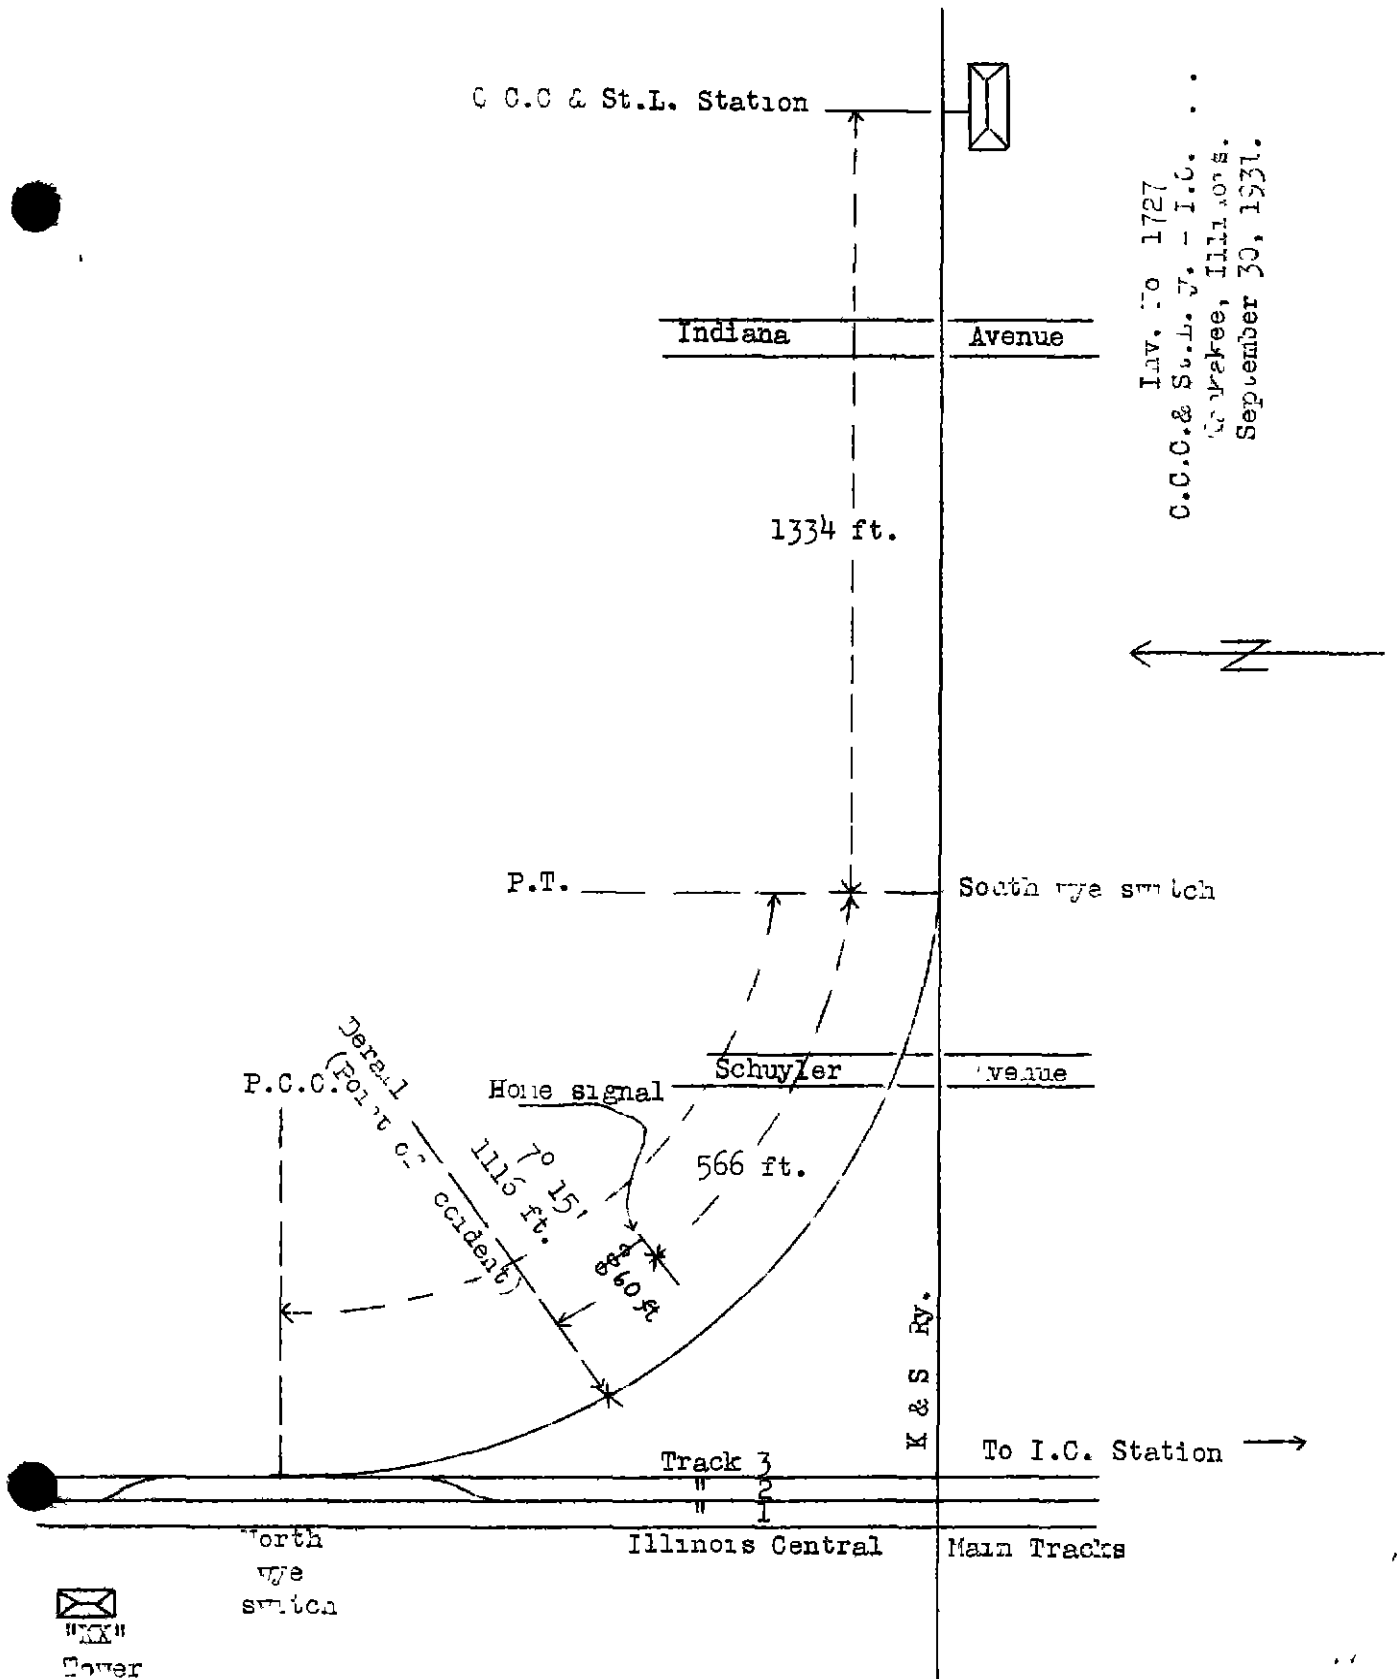
This accident occurred at a derail located 1,960 feet north of the Big Four passenger station, on the Big Four wye; approaching this derail from the south, beginning at the passenger station, there are 1,334 feet of tangent track followed by a compound curve to the right 1,116 feet in length, with a maximum curvature of  $8^{\circ}$ . The derail is located on this curve approximately 626 feet from the south switch, the curvature at that point being  $7^{\circ} 15'$ .
