## INTERSTATE COMMERCE COMMISSION

REPORT OF THE DIRECTOR OF THE BUREAU OF SAFETY CONCERNING AN ACCIDENT WHICH OCCURRED ON THE BALTIMORE & OHIO RAILROAD NEAR WARSAW, N. Y., ON MARCH 7, 1932

Inv. No. 1757  
 Baltimore & Ohio R.R.  
 Warsaw, N.Y.  
 March 7, 1932.

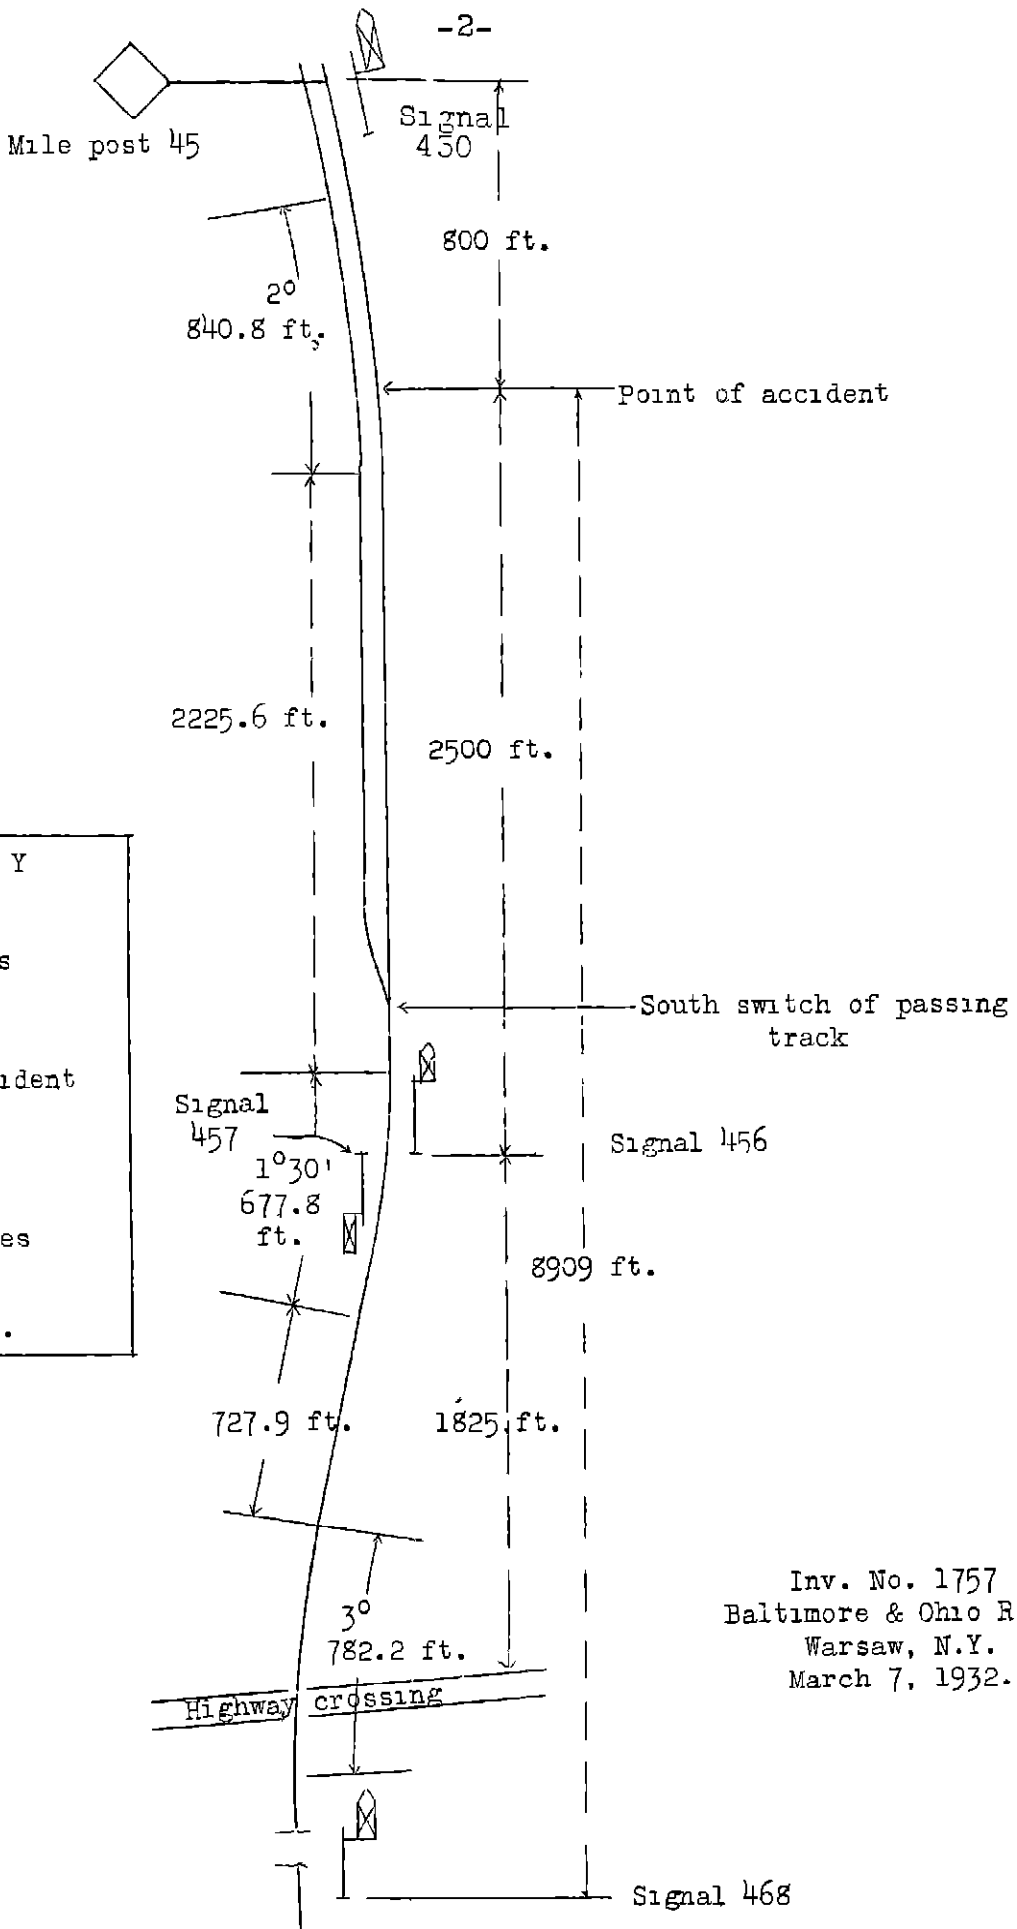
The signals involved in this accident are permissive signals 468 and 456, located 8,909 and 2,500 feet, respectively, south of the point of accident. These signals are of the three-position, upper-quadrant, semaphore type. A passing track, 6,900 feet in length, parallels the main track on the west and in the center of this passing track are two crossovers for entering the passing track from either direction. The south switch of the passing track is located about 200 feet north of signal 456.
