## INTERSTATE COMMERCE COMMISSION

REPORT OF THE DIRECTOR OF THE BUREAU OF SAFETY CONCERN-  
ING AN ACCIDENT WHICH OCCURRED ON THE ERIE RAILROAD  
AT NORTH TONAWANDA, N. Y., ON MARCH 26, 1932.

May 16, 1932.

Inv. No. 1760  
 Erie Railroad  
 North Tonawanda, N.Y.  
 March 26, 1932

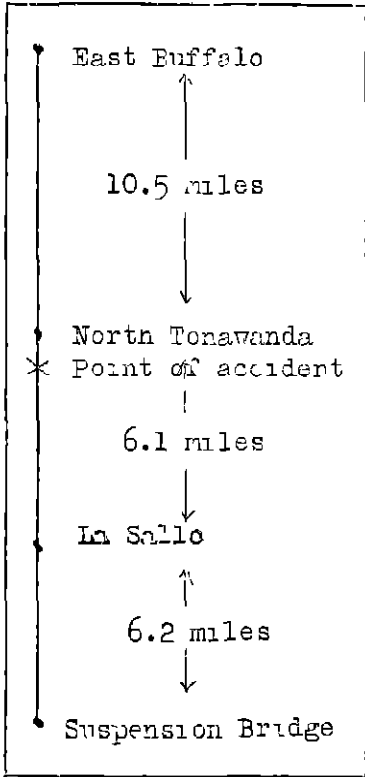
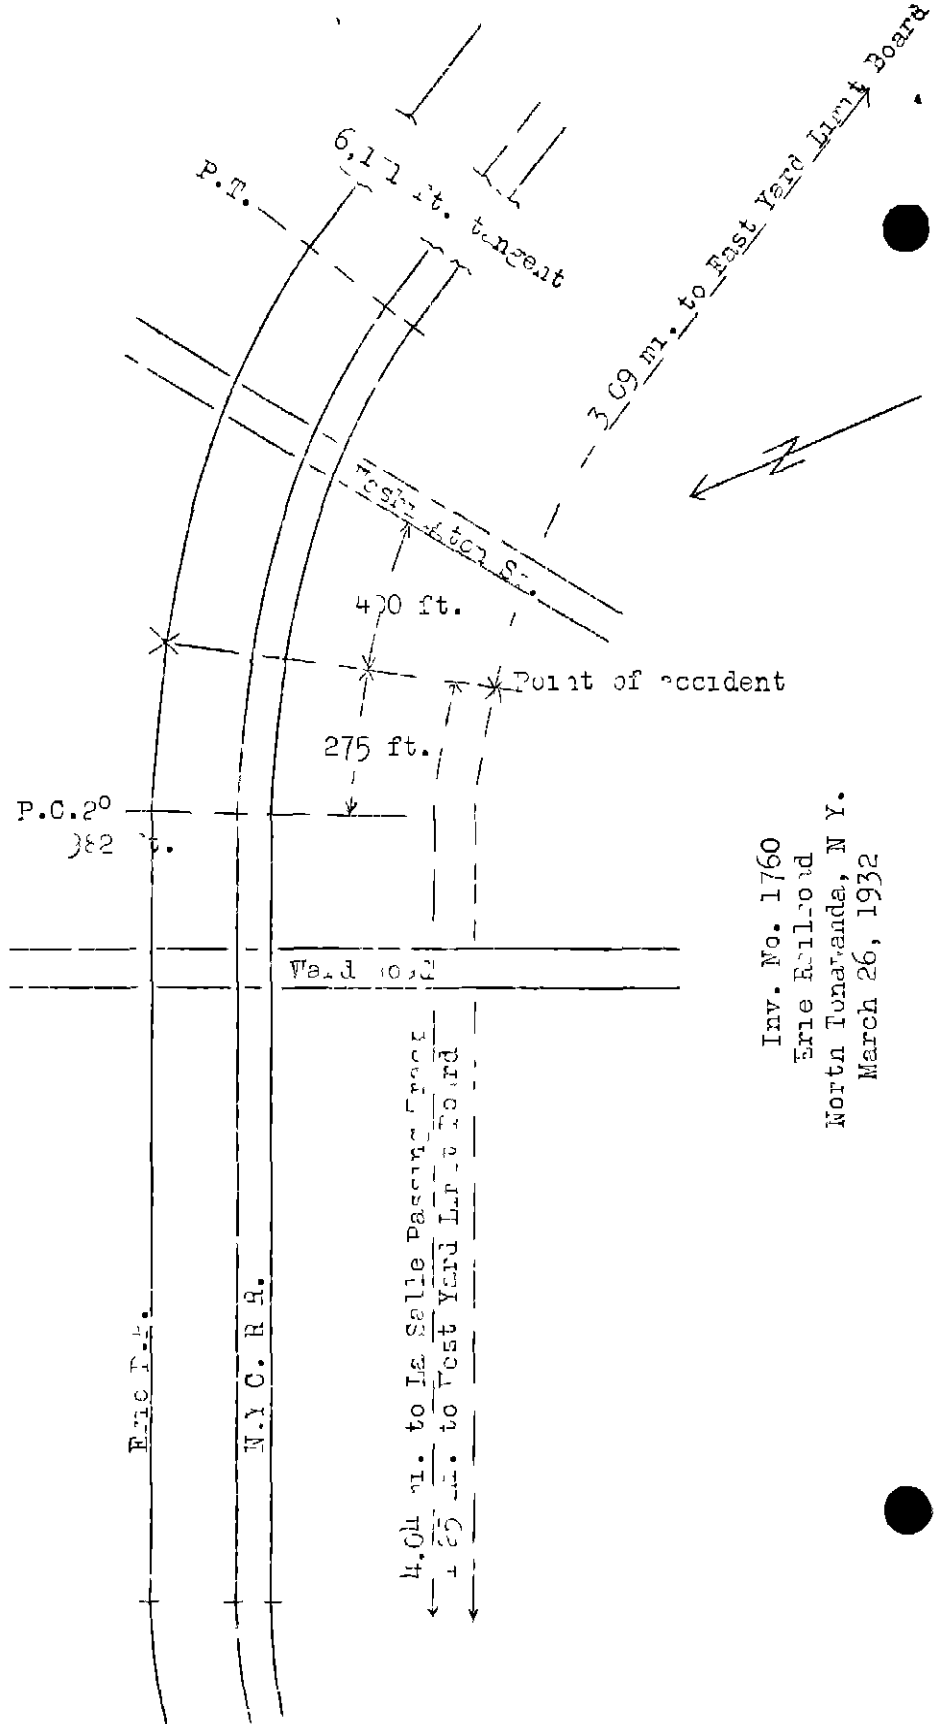
This accident occurred on the Niagara Falls Branch of the Buffalo Division, extending between Suspension Bridge and East Buffalo, N. Y., a distance of 23.9 miles, in the vicinity of the point of accident this is a single-track line over which trains are operated by time-table, train orders, and a casual block-signal system. The accident occurred within yard limits, at a point 1.25 miles east of the west yard-limit board, approaching this point from the west, the track is tangent for a distance of 1,241 feet, followed by a 2° curve to the right 983 feet in length, the accident occurring on this curve at a point about 275 feet from its western end. Approaching from the east the track is tangent for a distance of 5,151 feet, followed by the curve on which the accident occurred. The grade is level.

The tracks of the New York Central Railroad parallel the track of the Erie Railroad on the south in this vicinity, and on account of a line of telegraph poles located between the tracks of these two roads the view across the inside of the curve is considerably obstructed.
