INTERSTATE COMMERCE COMMISSION

REPORT OF THE DIRECTOR OF THE BUREAU OF SAFETY CONCERNING AN
ACCIDENT ON THE CHICAGO, BURLINGTON & QUINCY RAILROAD
NEAR POTTSTOWN, ILL., ON AUGUST 3, 1932.

September 17, 1932.

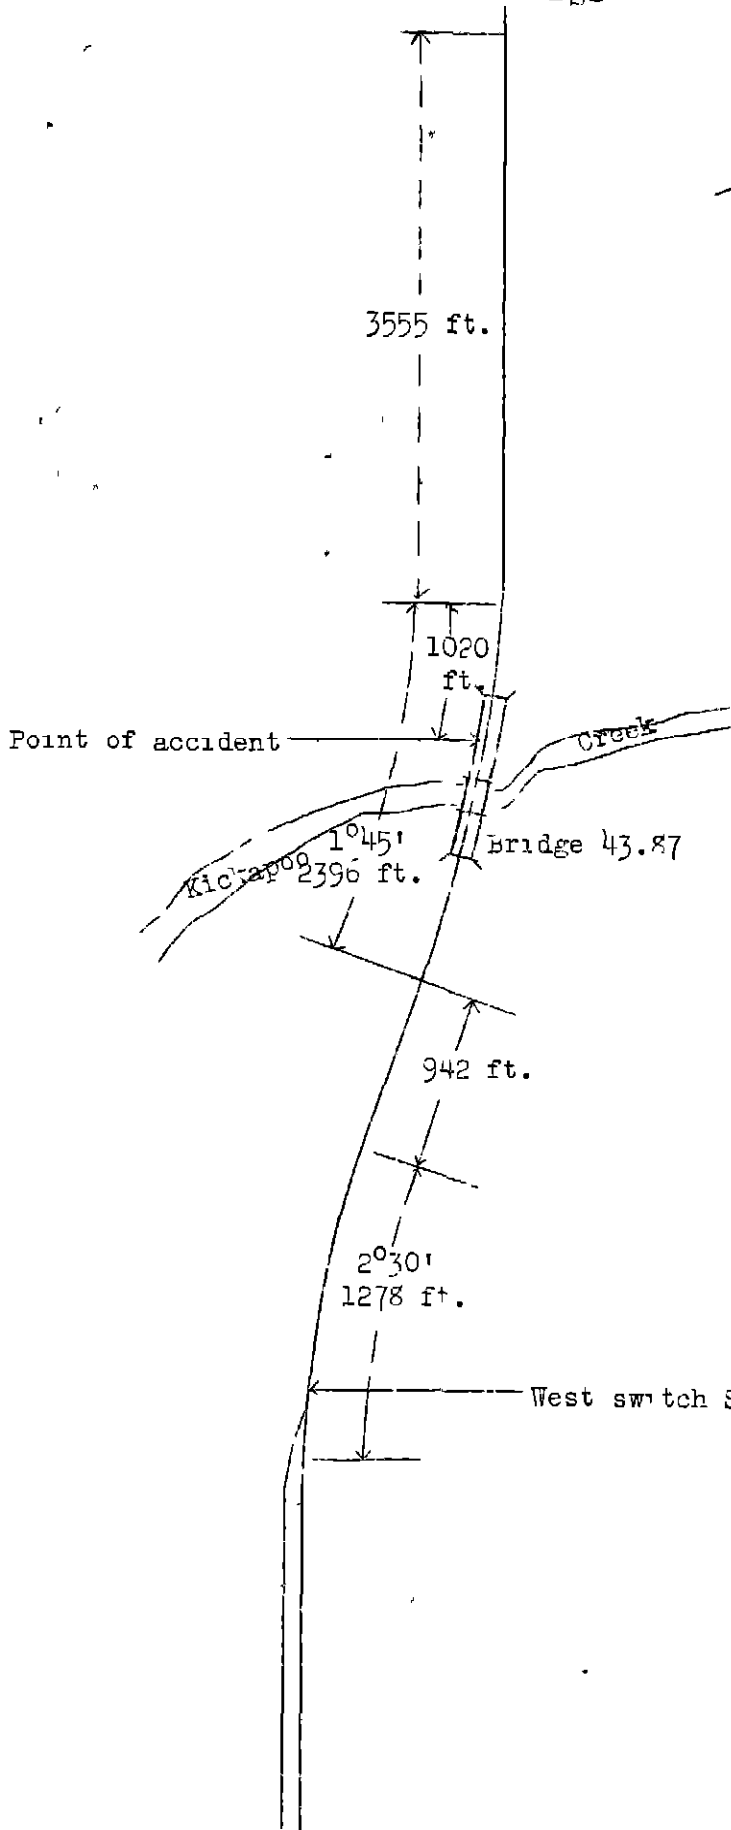
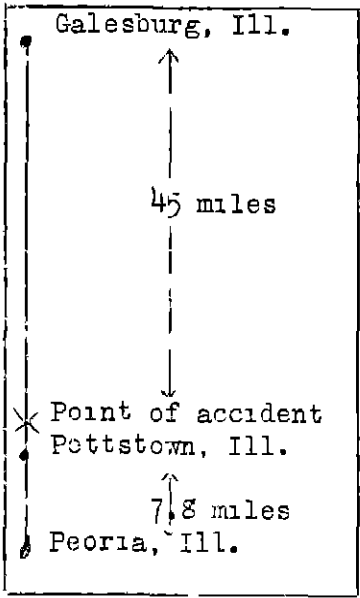
Inv. No. 1777
 Chicago, Burlington & Quincy RR
 Pottstown, Ill.
 August 3, 1932.

The caboose of extra 5329 was derailed and the superstructure was practically demolished. Motor 9666 stopped on its side with its front end on the ground 13 feet below the level of the bridge; the rear end was supported by the floor of the bridge approach and was still coupled to and held up the front end of the express car about 6 feet above the rail which leaned to the right at an angle of about 45°; the rear trucks remained on the rails. The last car in train No. 56 was not derailed or damaged. The employee killed was the flagman of extra 5329 and those injured were the engineman, conductor, express messenger and roadmaster of train No. 56.
