REPORT OF THE DIRECTOR OF THE BUREAU OF SAFETY CONCERNING AN ACCIDENT ON THE CHICAGO & ERIE RAILROAD NEAR LIMA, OHIO ON DECEMBER 21, 1932.

February 10, 1933.

Inv. No. 1800
 Chicago & Erie Railroad
 Lima, Ohio
 Dec. 21, 1932.

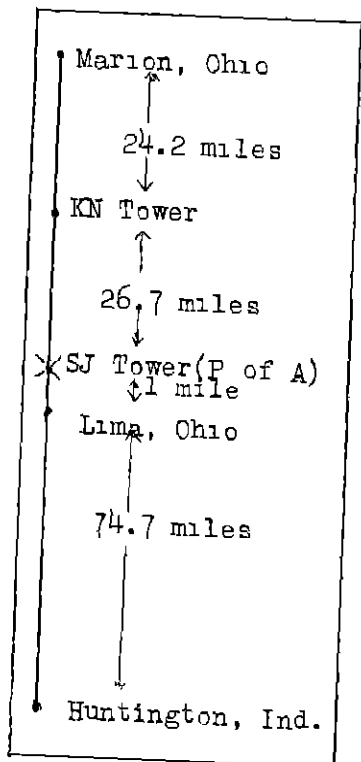
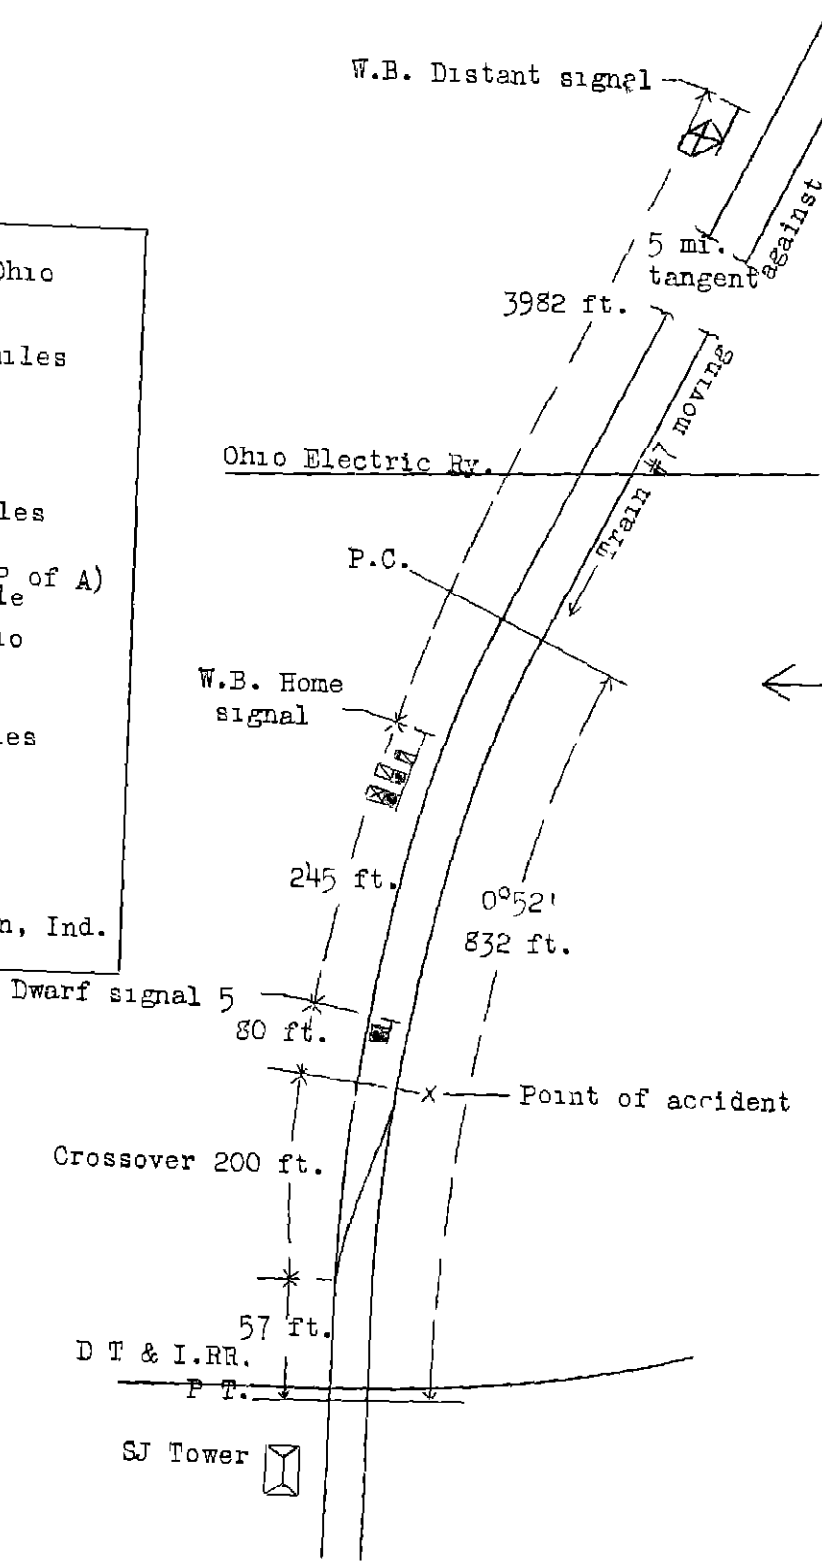
The track of the DT&IRR extends north and south and crosses the Erie tracks at right angles. SJ tower is located in the northwest angle of this crossing, and in it is located the interlocking machine controlling the switches and signals located in the vicinity. Dwarf signal 5, the only signal directly involved, is a two-position, upper-quadrant signal, located between the two main tracks at a point 80 feet east of the crossover, and governs westbound movements against the current of traffic, night indications are purple for stop and yellow for proceed at restricted speed. The westbound home signal at SJ tower is located about 325 feet east of the crossover, while the westbound distant signal is located 3,982 feet east of the home signal, at the time of the accident westbound freight train extra 3144, consisting of 91 cars and a caboose, stood on the westbound main track with its engine just east of the distant signal.
