INTERSTATE COMMERCE COMMISSION

REPORT OF THE DIRECTOR OF THE BUREAU OF SAFETY CONCERNING
AN ACCIDENT ON THE CLEVELAND, CINCINNATI, CHICAGO & ST.
LOUIS RAILWAY AT DANVILLE, IND., ON APRIL 7, 1933.

June 12, 1933.

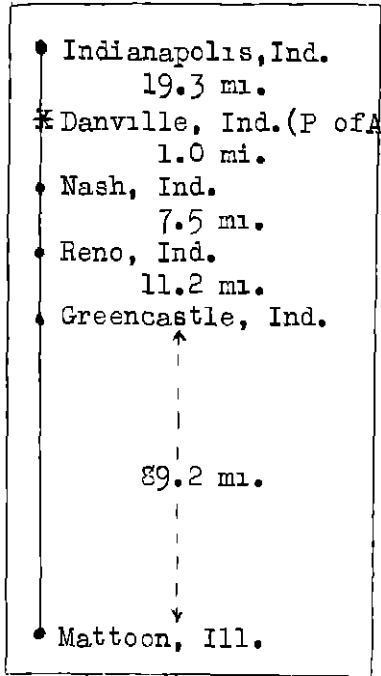
INV. NO. 1816
CLEV., CIN., CHI., & ST. LOUIS R
DANVILLE, IND.
April 7, 1933.

Point of Accident

The view of signal 212 and also of the home signal at Nash tower is unobstructed, but the view of the rear end of an eastbound train at the passenger depot at Danville is obstructed by the south bank of a cut, approximately 25 feet in height, and by overhead bridges and a pole line, and at the time of this accident by freight cars which were standing on the passing track. The first view the engineer of an east-bound engine could get of signal 182 would be on reaching a point near the eastern end of the curve.
