Railroad accident investigation report  
E.V. 387 NO. 1851-1900

REPORT OF THE DIRECTOR OF THE BUREAU OF SAFETY CONCERNING AN ACCIDENT ON THE ERIE RAILROAD NEAR WESTCOLANG, PA., ON SEPTEMBER 1, 1933.

Inv. No. 1851  
Erie Railroad  
Westcolang, Pa  
Sept. 1, 1933

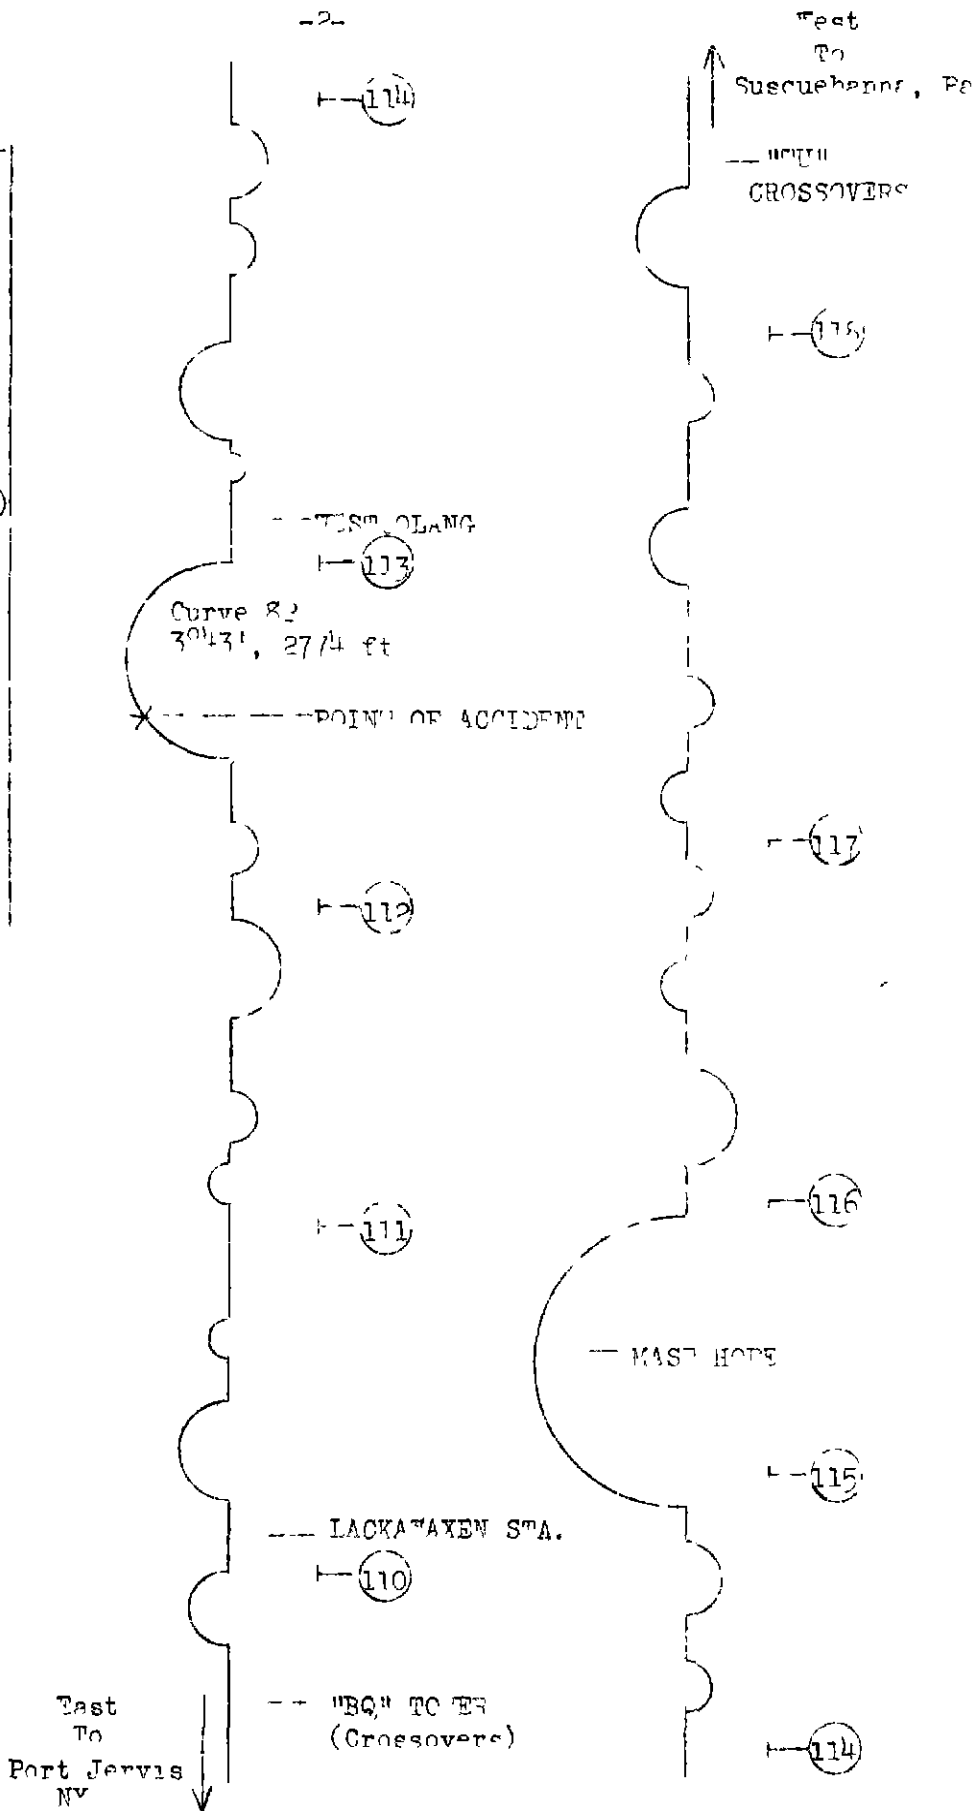
o	Port Jervis, N.Y.	2.6 mi
o	Sparrowbush, N.Y.	19.3 mi
o	BQ Tower	1.0 mi.
o	Lackawaxen, Pa.	3.0 mi.
x	Westcolang, (P of A)	2.3 mi
o	Mast Hope, Pa.	2.18 mi
o	Tusten, N.Y.	0.72 mi.
o	"TU" Crossovers	73.3 mi.
o	Susquehanna, Pa.

The accident occurred within the loop on the west-bound track, at a point about 0.45 mile east of Westcolang, which station is located 5.5 miles east of Tusten. Approaching the point of accident from either direction, there is a series of curves and tangents; the curves on this division are numbered from east to west and the accident occurred on curve 82, at a point 800 feet from its eastern end, this being a 3° 43' curve to the right for west-bound trains 2,774 feet in length. The grade at the point of accident is 0.21 percent ascending for west-bound trains.
