INTERSTATE COMMERCE COMMISSION

REPORT OF THE CHIEF, DIVISION OF SAFETY, COVERING THE INVESTIGATION OF THE ACCIDENTS WHICH OCCURRED ON THE WABASH RAILROAD AT ATTICA, IND., ON APRIL 5, 1914.

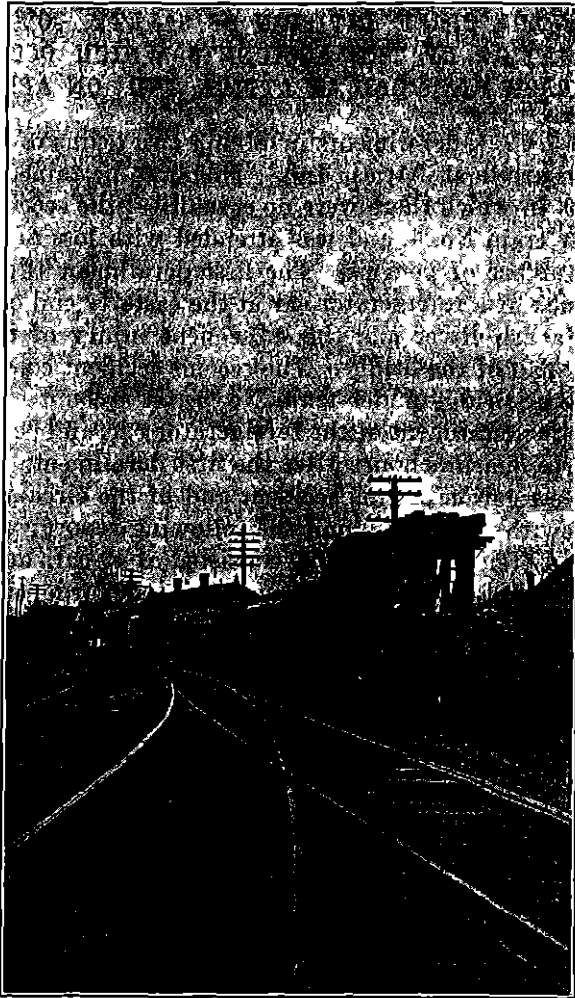
The train was brought to a stop with the disabled car about 200 feet west of the eastern end of the bridge, none of the other cars in the train being derailed. Examination of the derailed truck showed all of the wheels to be in good condition and no defects were discovered on any other part of the truck. The frog at which the car was derailed is located on a curve of 5°, and the empty refrigerator car was derailed as the train rounded this curve at a speed estimated to have been between 15 and 20 miles per hour. Illustration No 1 is a view of the frog at which the derailment occurred, looking in the direction opposite to that in which the train was traveling at the time.

NO 1—VIEW OF FROG AT COVINGTON BRANCH LOOKING EAST

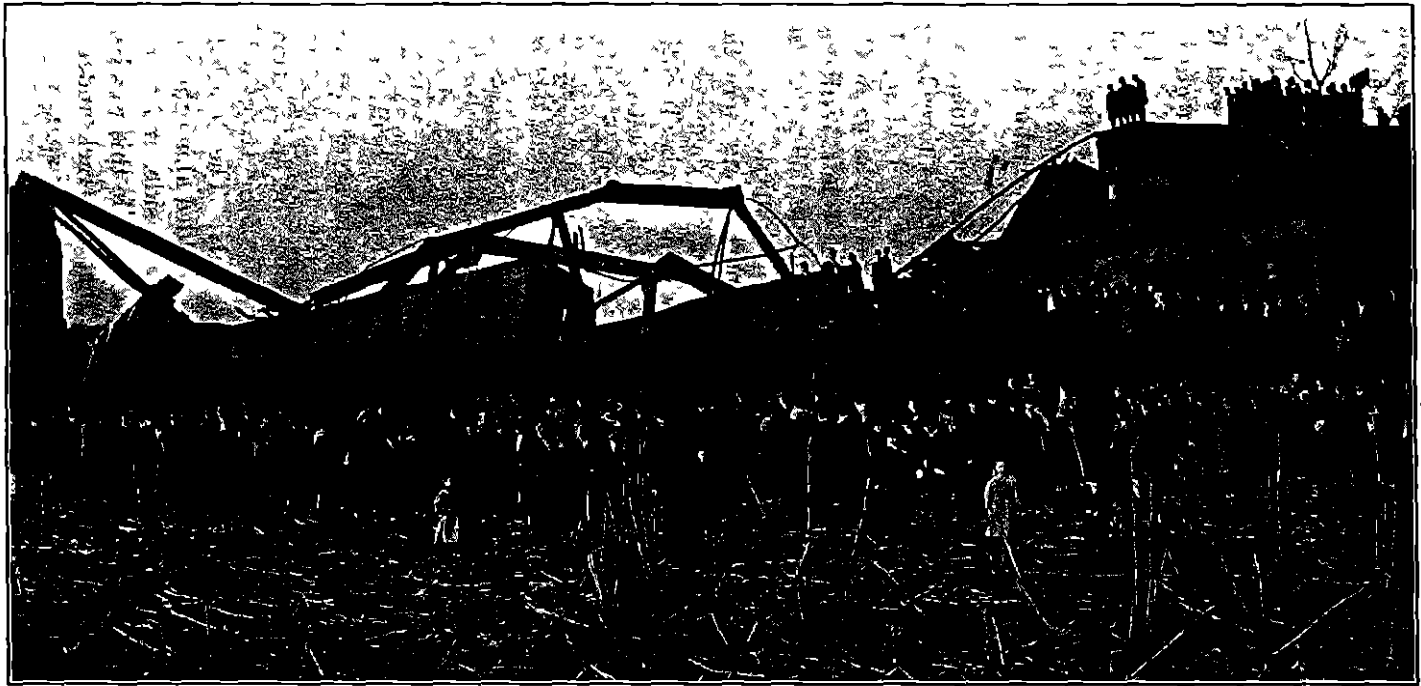
The locomotive and mail and combination cars were thrown to the ground beneath the bridge and considerably damaged Illustrations Nos 2a and 2b are general views of the wreck It will be noted that the most easterly span of the bridge collapsed entirely, and that the eastern end of the span adjacent to it also dropped to the ground the western end resting against the top of the second pier The third car in the train, the coach, remained on this span, inclined at an angle of about 30°

NO 2a—GENERAL VIEW OF WRECK, FIRST SPAN OF BRIDGE

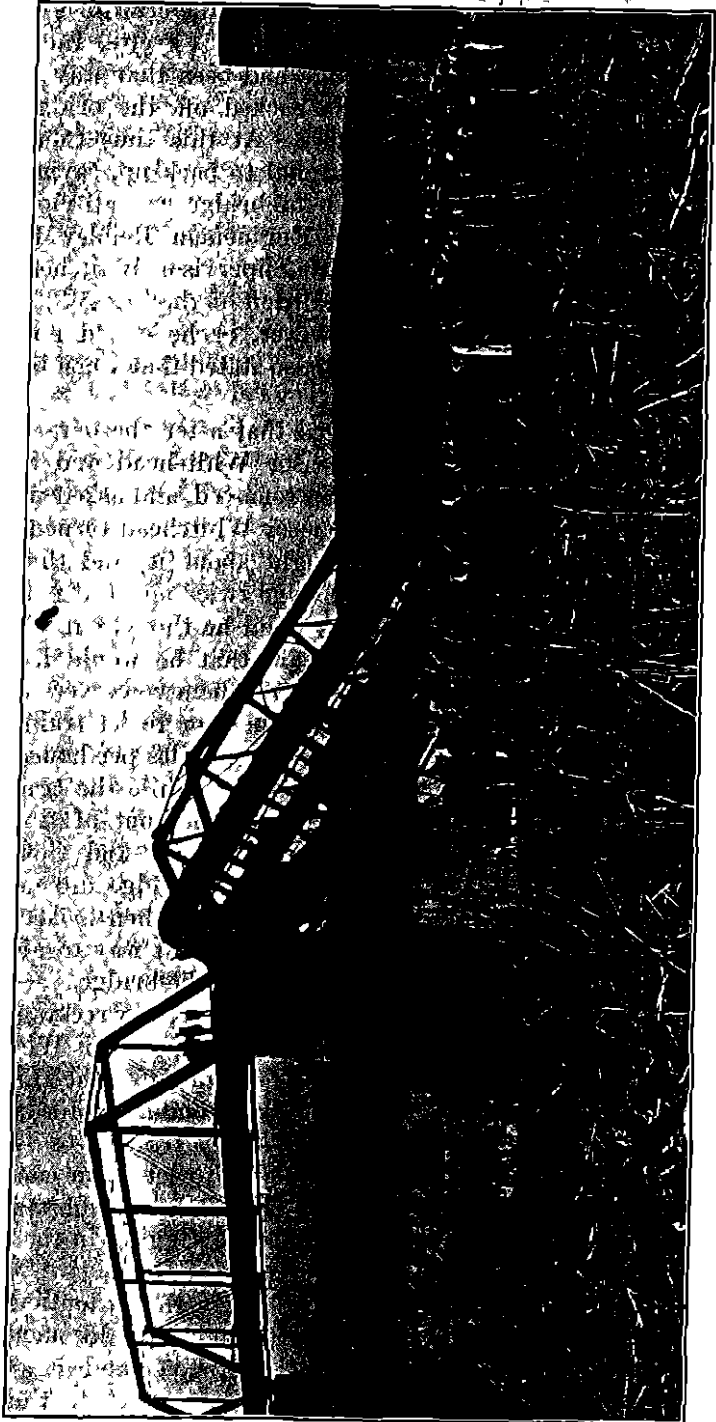
NO 2b —GENERAL VIEW OF WRECK SECOND SPAN OF BRIDGE

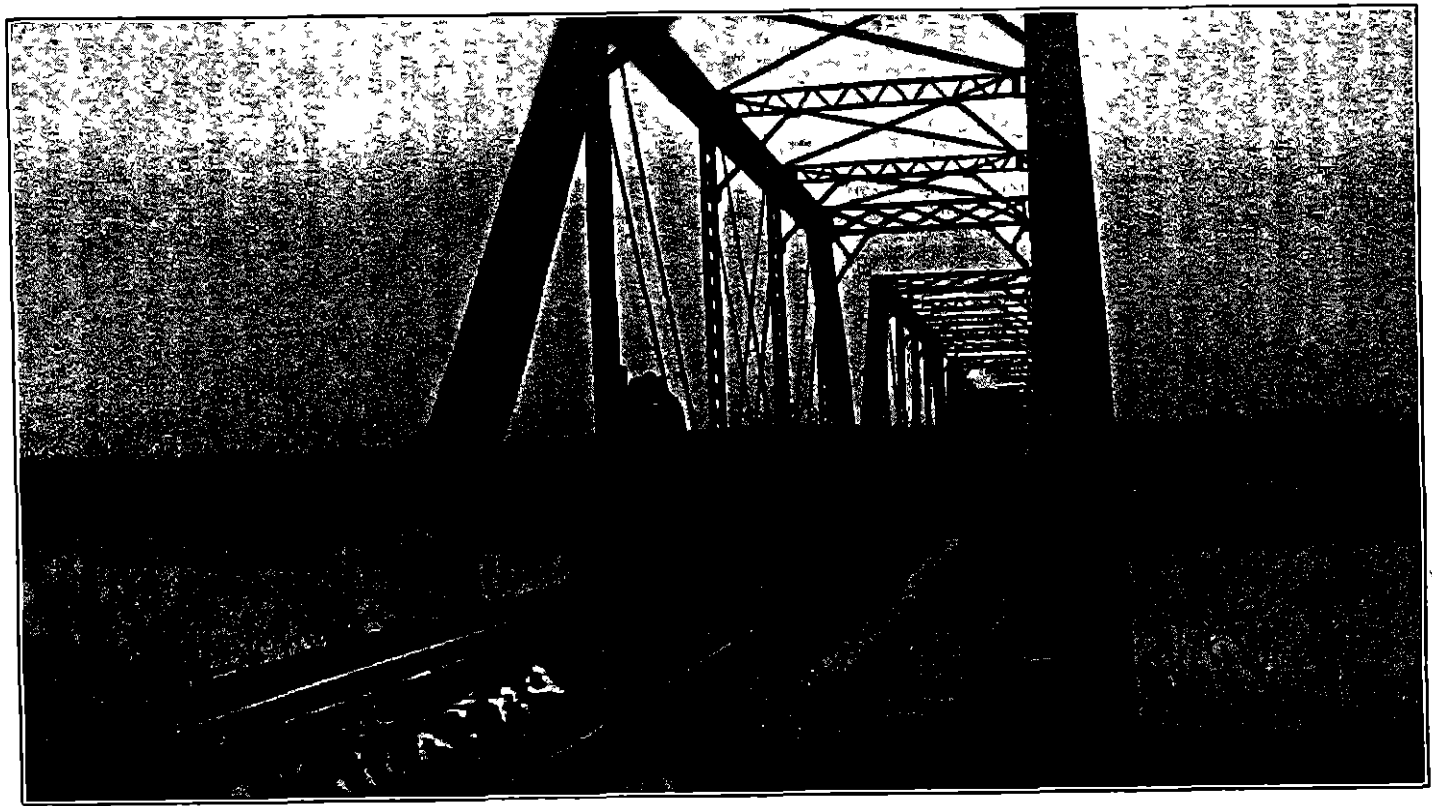
NO 3—VIEW OF DAMAGED_END POST.

Photographic evidence was secured showing the appearance of the end post after it had received the blow from the truck of the refrigerator car. Illustration No 3 is reproduced from the photograph which was then taken. Two of the principal parts of the post, namely, the cover plate and one web plate were practically destroyed, while the other web plate was considerably bent. In consequence of these injuries the post was incapable of offering normal compressive resistance in any of its parts. No visual evidence was lacking at this time to indicate the seriously weakened condition of this important member.

An examination of the photographic print showed that the cover plate was split along its south edge for a distance of 30 rivet pitches or 11 feet 3 inches. Along its north edge it was split a distance of 8 feet 3 inches. Across its width it was torn apart, all but a narrow strip on its south edge. On the north edge the plate and outstanding leg of one of the 3 by 3 by $\frac{3}{4}$ inch angles was completely carried away for a short distance.

On the north side the web was split and distorted. It was evident from its appearance that the south web and angles were also considerably buckled. The injury to the post could hardly have been greater.

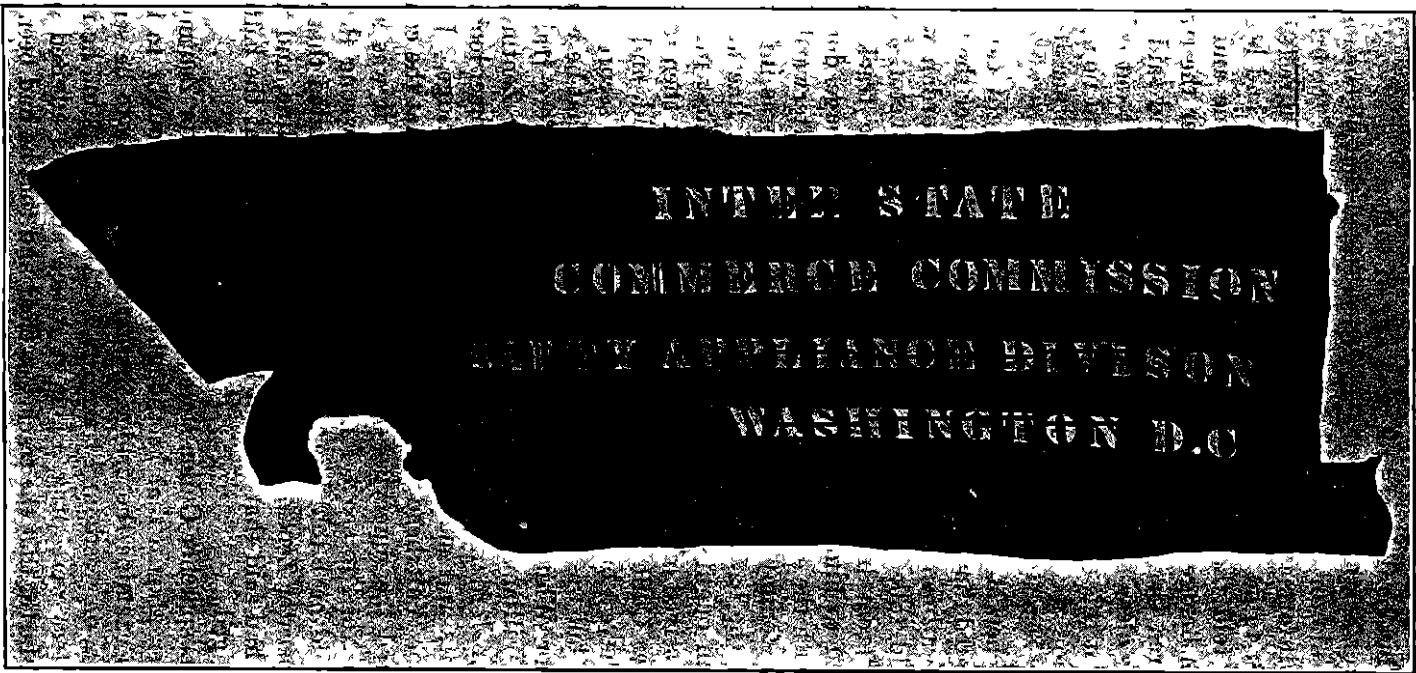
NO 4—PHOTOGRAPH OF FRAGMENT OF COVER PLATE FROM WHENCE TENSILE TEST PIECES WERE TAKEN

In explanation of the extensive destructiveness caused in this member by the derailed truck, attention will be called to the fact that it was made of wrought iron, in which there was practically no toughness in the metal in the direction taken crosswise the grain.

The following table shows the results of tensile tests on the metal of the cover plate. The fragment from whence these specimens were taken is shown by figure No 4 and is believed to have been a part of the end post in question.

In a crosswise direction the iron displayed low strength and was further characterized by fracturing without the development of appreciable extension. The tensile strength in this direction did not reach the normal elastic limit of the material. Lengthwise the iron displayed tensile strength usual to wrought-iron plate.

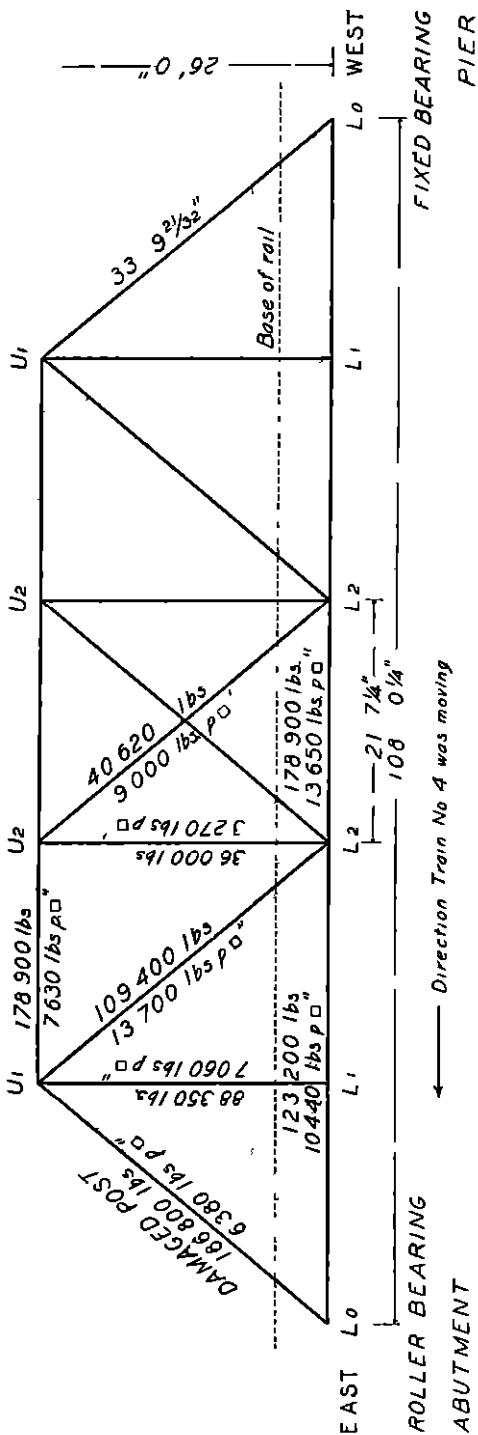
NO 6

Stresses for Locomotive No 672 and forward truck Postal Car No 164

Diagram figure No 6 shows the stresses which would come upon the different members of the east span under the combined weight of the locomotive of train No 4 and the forward truck of the postal car, which was in the train next behind the tender. The computed stress on the post caused by this load was 6,380 pounds per square inch. This must be regarded as a very moderate stress for the intact member to sustain. The stresses entered on this diagram, and others which accompany herewith, are from data furnished by the Wabash Railroad Co.

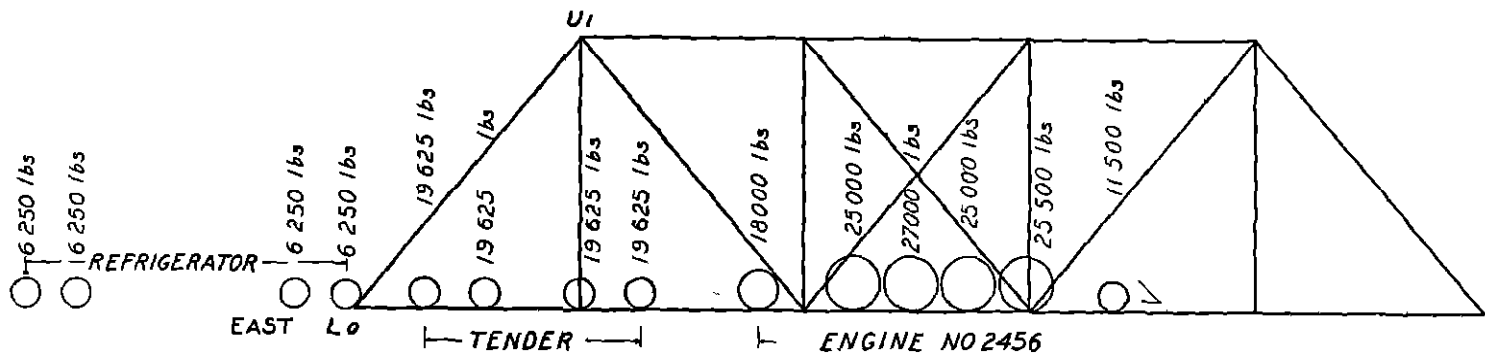
NO 7

EAST SPAN, ATTICA BRIDGE
 POSITION OF LOCOMOTIVE NO 2456 CAUSING MAXIMUM STRESS IN END POST

DEAD LOAD	47 000 LBS
LIVE LOAD	<u>100,800 LBS</u>
TOTAL	147,800 LBS

On diagram No 7 it will be seen that locomotive No. 2456, of train No 69, had at this time just pushed the refrigerator car off the east end of the bridge. The locomotive alone stood on the bridge at the time. With this locomotive on the bridge the sum of the live and dead loads on the post was 147,800 pounds. This load represents the highest which the bridge was called upon to sustain, during the interval succeeding the injury to the batter post and preceding its loading by passenger train No 4, which latter train applied a heavier load.

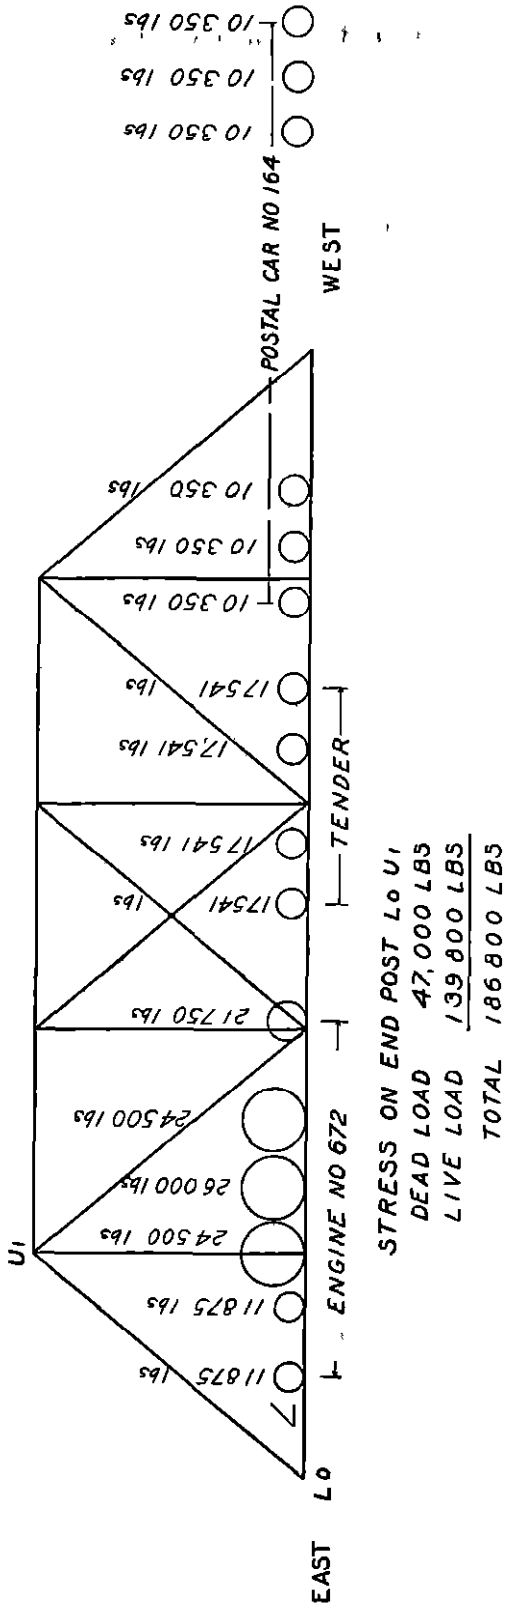
NO 8

EAST SPAN ATTICA BRIDGE
 POSITION OF LOCOMOTIVE NO 672 CAUSING MAXIMUM STRESS IN END POST

Diagram No 8 shows the position of locomotive No 672, of train No 4, giving the maximum load on the end post. The forward truck of postal car No 164 was upon the east span of the bridge at this time. The rear truck of the car was upon the second span. In this position the load upon the end post would have been 186,800 pounds, or 39,000 pounds more than the load caused by the freight locomotive. Train No 4 was proceeding slowly at the time of the collapse and, as it appears from the testimony, the locomotive had nearly or quite reached the position indicated on the diagram when the structure gave way.
