BUREAU OF SAFETY

REPORT NO. 1952

REPORT OF THE DIRECTOR OF THE BUREAU OF SAFETY CONCERNING AN
ACCIDENT ON THE CHICAGO, BURLINGTON & QUINCY RAILROAD
AT FREEMAN, ILL., ON DECEMBER 8, 1934.

Inv. No. 1952
 Chicago, Burlington & Quincy R.R.,
 Freeman, Ill.
 Dec. 8, 1934.

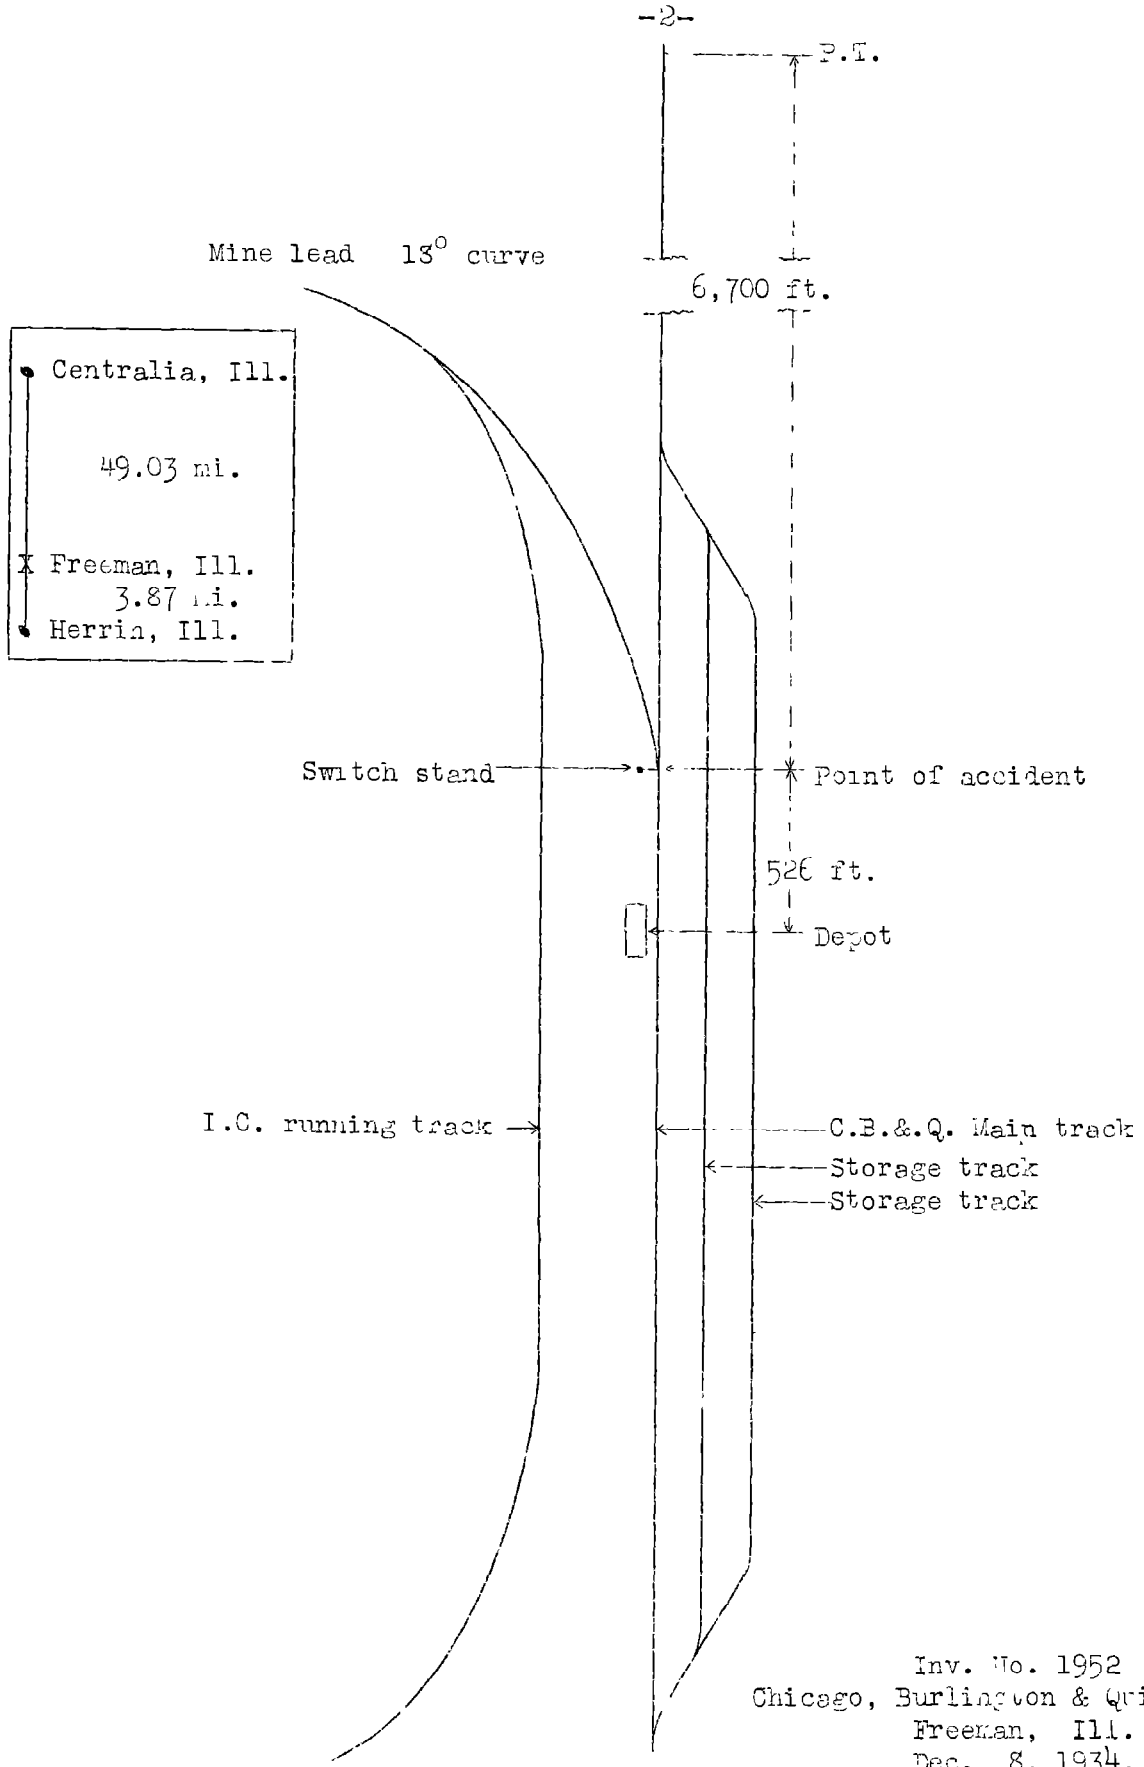
This accident occurred on the Centralia and Herrin Sub-Division of the Beardstown Division, which extends between Centralia and Herrin, Ill., a distance of 52.9 miles; in the vicinity of the point of accident this is a single-track line over which trains are operated by time table, train orders, and a manual block-signal system. The accident occurred within yard limits of the Herrin Switching District at a point approximately 1.9 miles south of the north yard-limit board and about 526 feet north of the station at Freeman. On the west side of the main track, which extends practically north and south at this point, there are several yard tracks of Franklin County No. 5 mine of the South Illinois Coal & Coke Company; they extend practically east and west, and connect with the main line through a lead track having a curvature of 18° towards the south, the accident occurring at the fouling point of this lead track. Approaching this point from the north on the main track, there is a 1° curve to the right 6,538 feet in length, followed by tangent track to the point of accident, a distance of about 6,700 feet, and for a considerable distance beyond that point. The grade for southbound trains is slightly descending, being 0.13 percent at the point of accident.

The lead-track switch stand is equipped with a switch lamp with the center of the lens 7 feet 7 inches above the tops of the rails; the stand is located on the engineman's side of a south-bound train. High coal cars in a train moving from the lead track to the main track would obscure his view of the switch lamp but it could be seen over the tops of low-side coal cars for a distance of at least one-fourth mile. Owing to the sharp curvature of the lead track the marker lights on a caboose moving

from the mine track can not be seen by the engineman of a south-bound train on the main track until the caboose is close to the main track.
