ACCIDENT ON THE

CHICAGO & NORTH WESTERN RAILWAY

EVANSTON, ILL.

INVESTIGATION NO. 2185

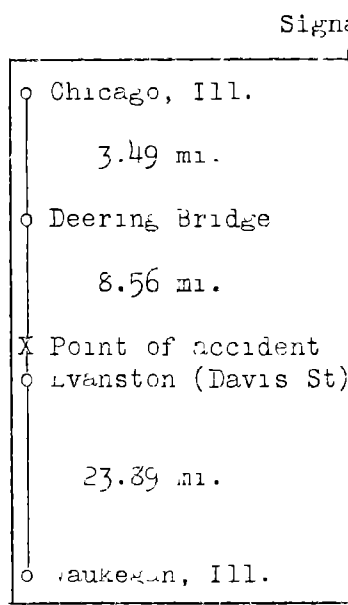
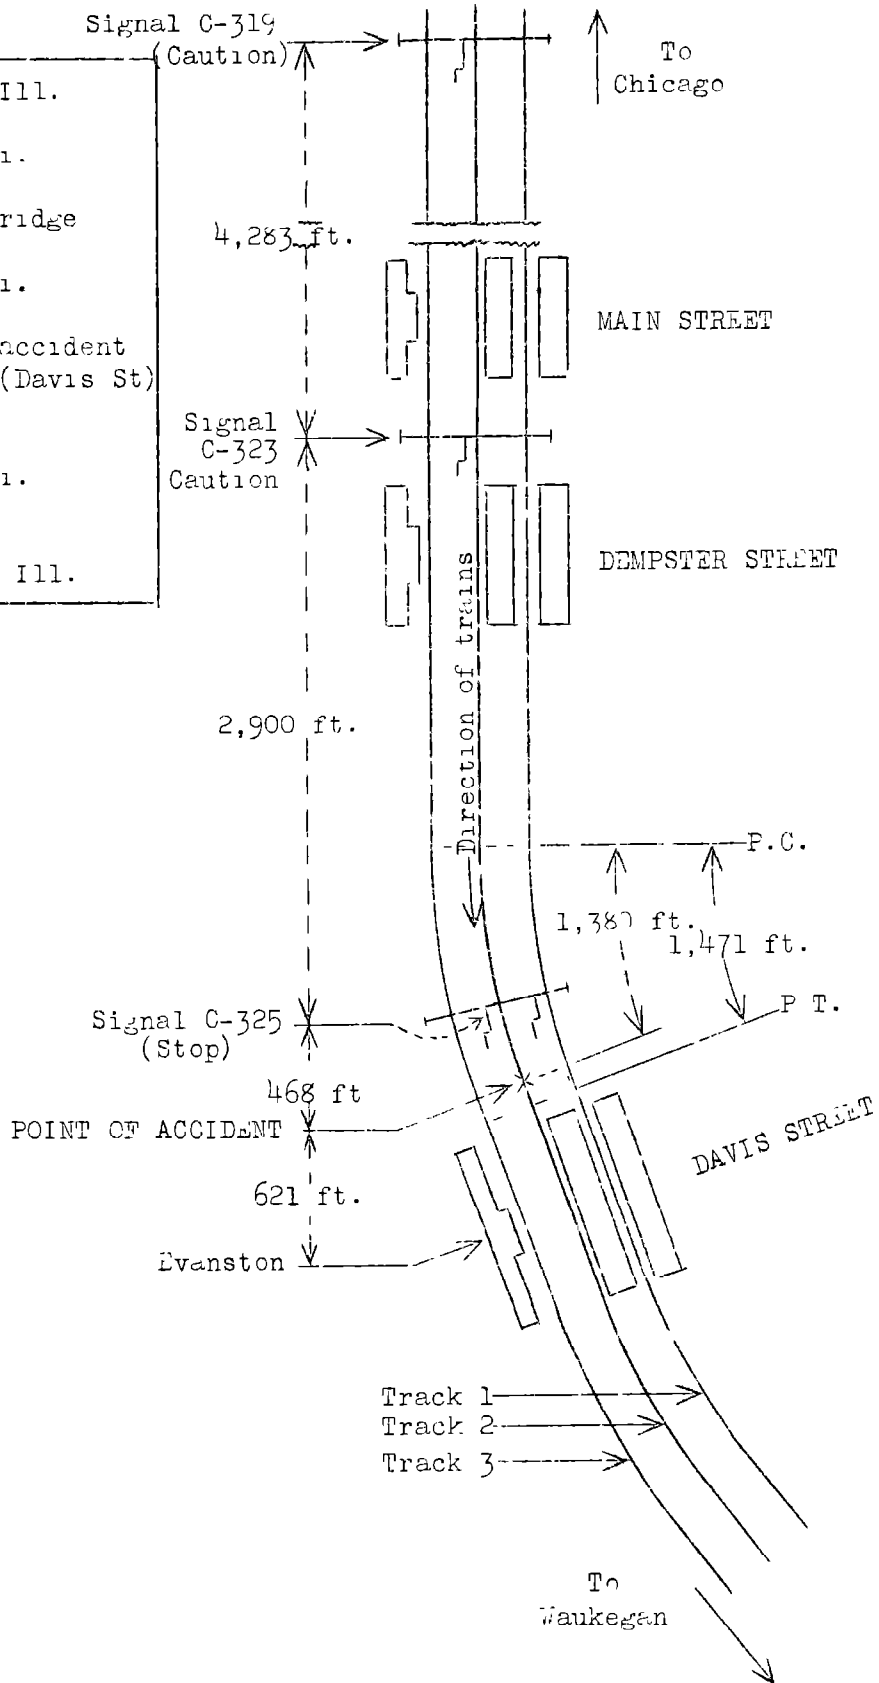
Inv. No. 2185
Chicago & North Western Ry.
Evanston, Ill.
July 2, 1937

The rear of a train standing at the point of accident could be seen from the engineman's side of an approaching west-bound engine for a distance of 330 feet, and from the fireman's side for 1,260 feet. The stop indication of signal C-325 could be seen through the front windows from both sides of the cab, for a distance of 5,400 feet, and this indication was continuously visible from a point 4,330 feet east of the signal until the signal was reached.
