ACCIDENT ON THE  
CHICAGO, MILWAUKEE, ST. PAUL & PACIFIC RAILROAD

MORTON GROVE, ILL.

NOVEMBER 14, 1937.

INVESTIGATION NO. 2223

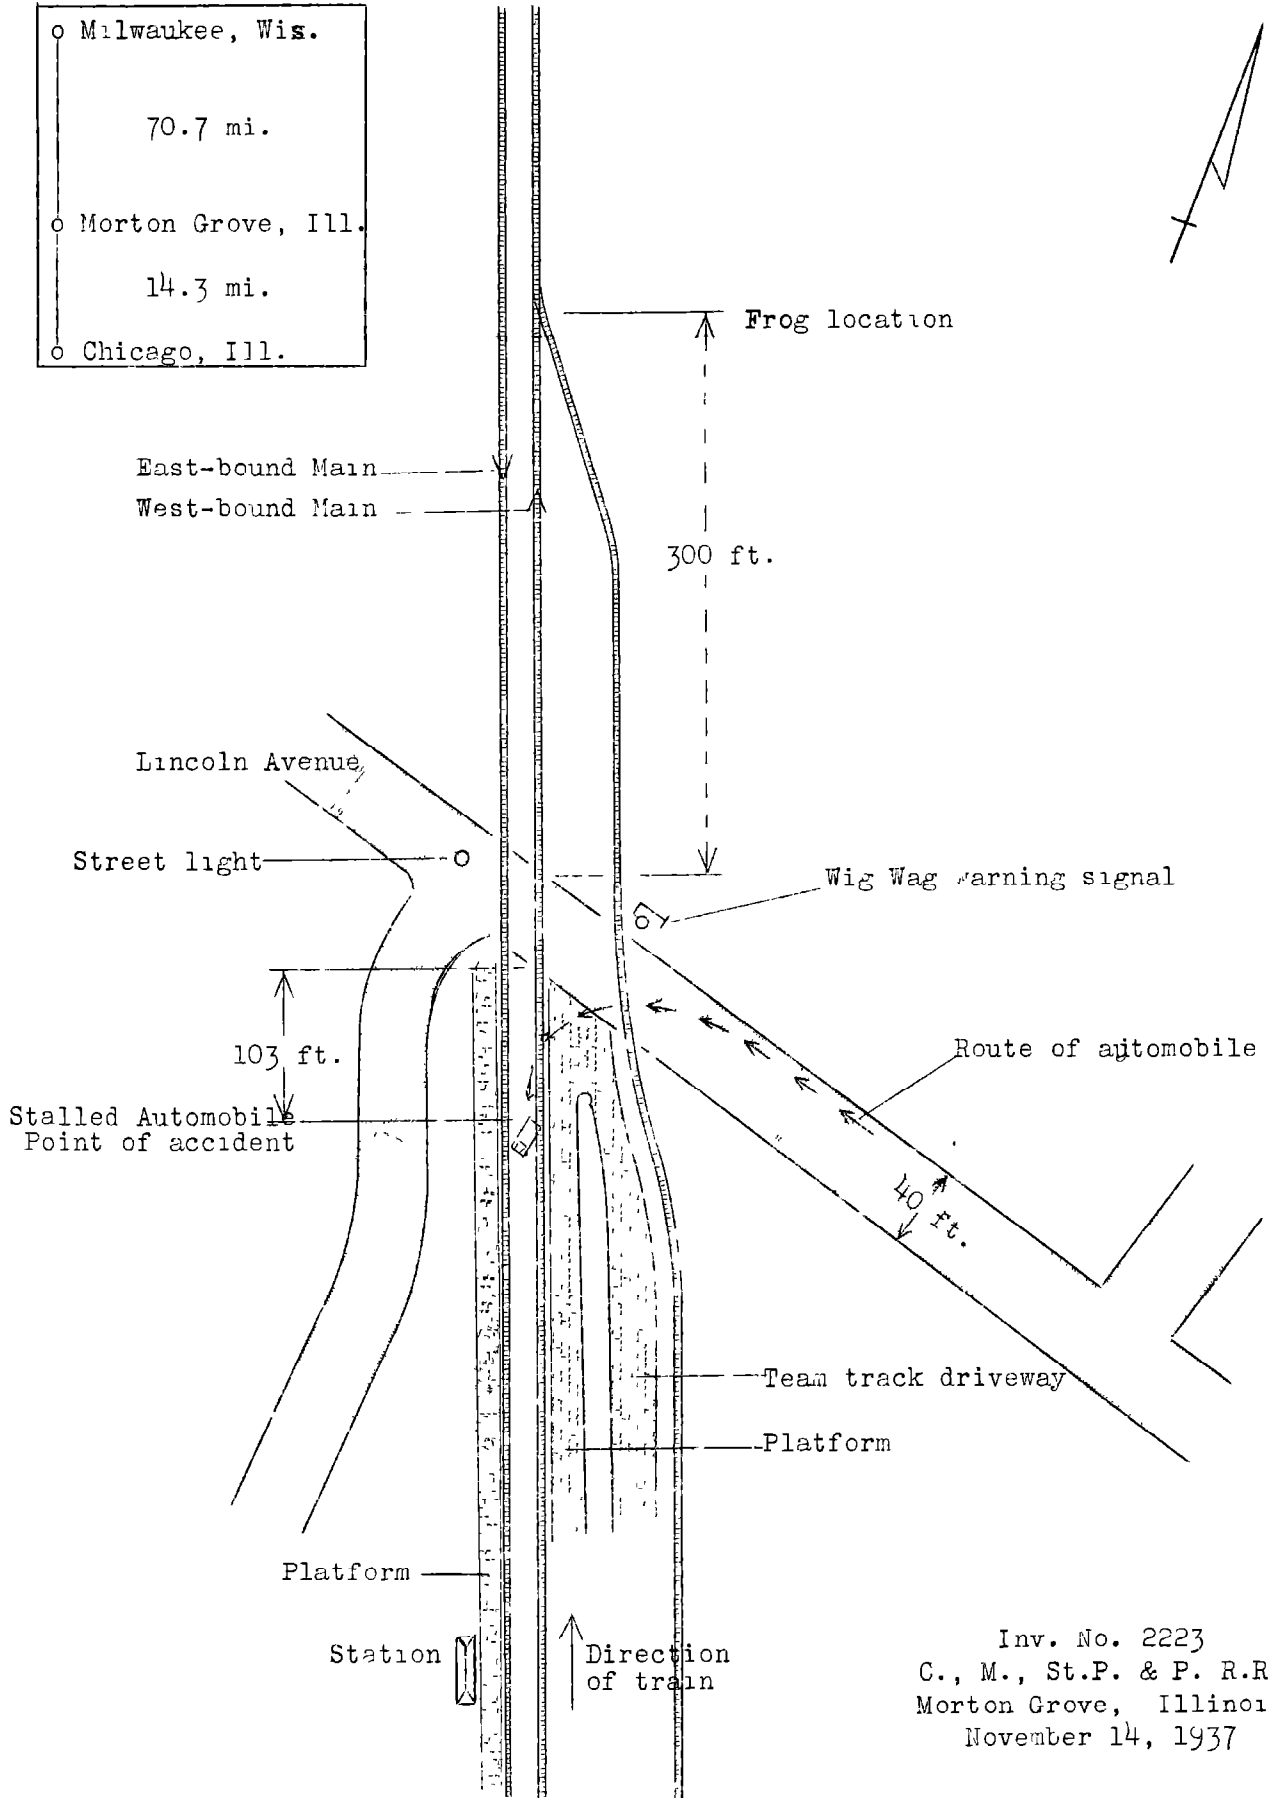
Inv. No. 2223  
C., M., St.P. & P. R.R.  
Morton Grove, Illinois  
November 14, 1937

The first marks of derailment appeared about 10 feet north of the point where the collision occurred. Apparently both pairs of engine truck wheels left the track at the same point and traveled along the ties close to the rails until the turnout leading to the team track was reached where a general derailment took place.

The progress of the derailment was clearly indicated. When the left rear wheel of the automobile was struck by the engine the housing of the back axle of the automobile was torn from its shackles and carried ahead of the engine-truck wheels until the left rear spring together with the weight of the wreckage was sufficient to offer enough resistance to hold the housing stationary. At this time the housing lay across the rail in such position that the left brake drum was close against the west rail and formed an angle of about 60° with the rail. At the same time that the wheel flanges mounted the housing they were brought into contact with the inner surface of the brake drum which then directed the wheels to the west so that they dropped upon the ties close to the rail. Apparently the engine truck wheels were the only ones derailed at this point as the flange marks were light. The engine-truck wheels remained close to the rails

until the turnout leading to the team track was reached when the engine slued to the right tearing up the track and causing a general derailment.
