ACCIDENT ON THE
CHICAGO, MILWAUKEE, ST. PAUL & PACIFIC RAILROAD

LANARK, ILL.

JANUARY 12, 1938.

INVESTIGATION NO. 2244

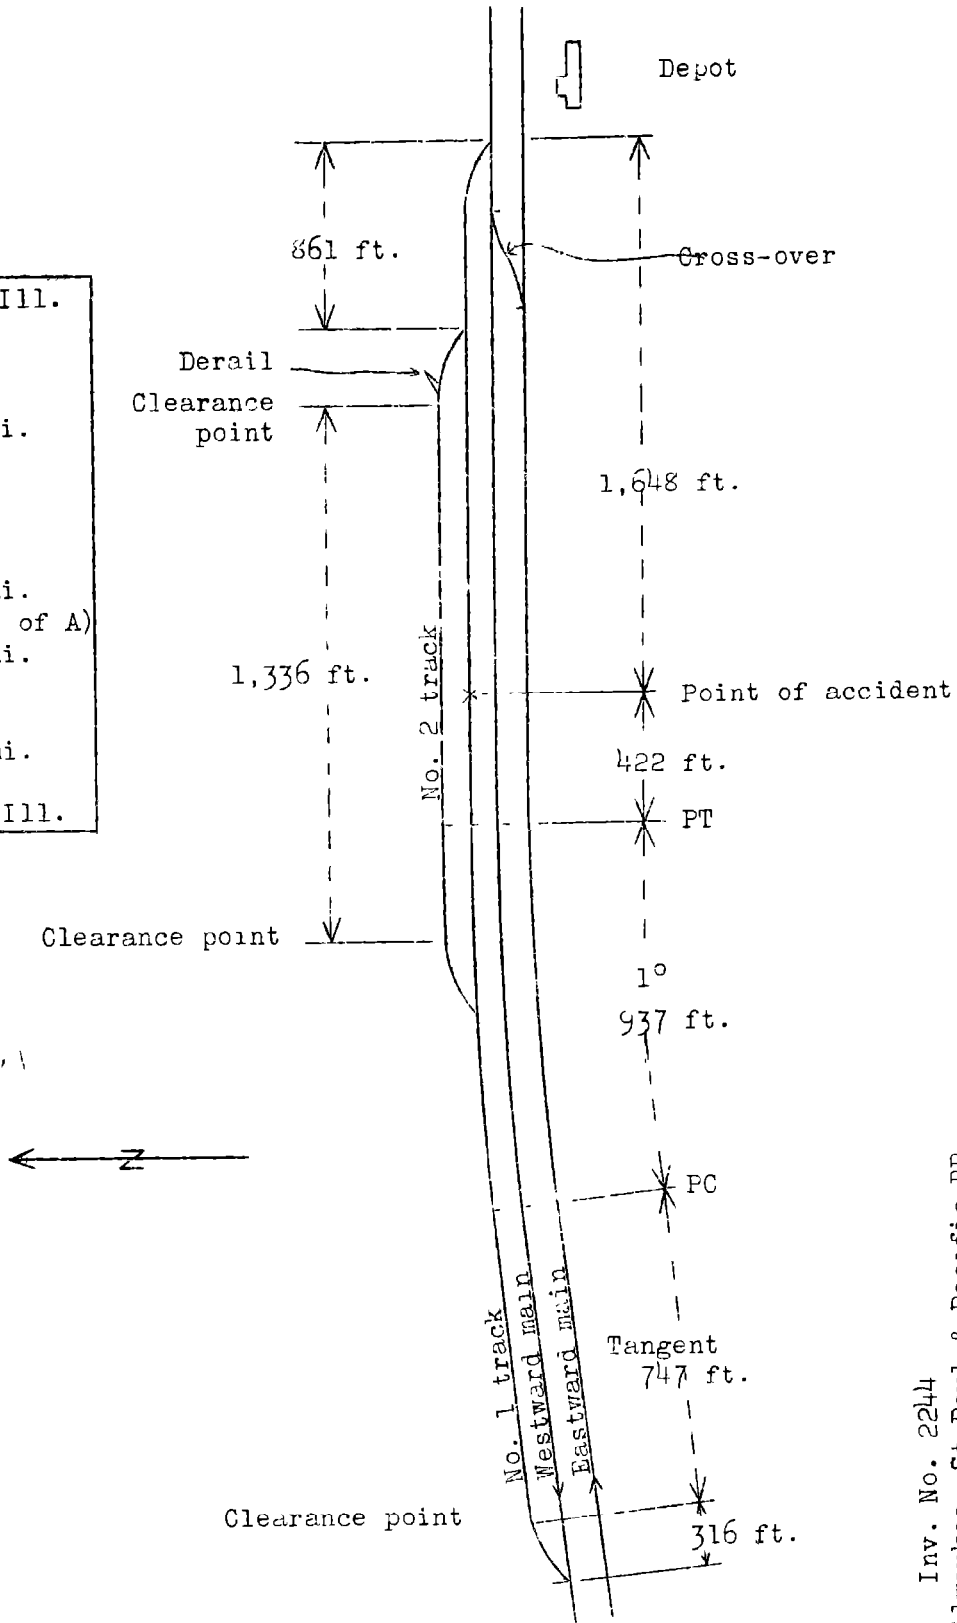
Inv. No. 2244
 Chicago, Milwaukee, St. Paul & Pacific RR,
 Lanark, Ill.
 Jan. 12, 1938

As a result of the collision the bottom frame together with the cistern of the empty tank car was lifted from the trucks and was telescoped into the wooden body of caboose 01516 for practically its entire length; the stove in the caboose overturned and the wreckage caught fire. Both trucks of the tank car were jammed against the west dragbar of the caboose. Engine 8655 was not derailed or damaged. Only the lead truck of the east car in the cut of cars being set out by Extra 8689 was derailed. The employee killed was the conductor, who was in caboose 01516.
