ACCIDENT ON THE  
CHICAGO GREAT WESTERN RAILROAD

-----  
CLARE, ILL.  
-----

APRIL 3, 1938.  
-----

INVESTIGATION NO. 2264

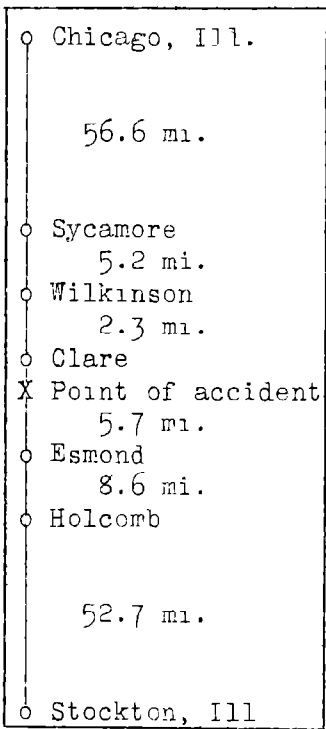
Inv. No. 2264  
 Chicago Great Western R.R.  
 Clare, Illinois  
 April 3, 1938

The automatic block-signal system is the overlap system, consisting of home signals at station sidings, distant signals approaching stations, and intermediate signals between stations. The signals are of the 2-position upper-quadrant, semaphore type, approach lighted; night indications of distant signals are yellow for approach home signal with caution, and green for proceed; night indications of home signals are red for stop and green for proceed. The signals governing west-bound movements are distant signal 63-1, home signal 63-5 and home signal 64-5, located 7,062 feet, 3,762 feet, and 400 feet, respectively, east of the point of accident. Intermediate signal 66-2 and distant signal 64-8, governing east-bound movements are located 8,392 feet and 2,287 feet respectively west of the point of accident; eastward home signal 64-4 is located 26 feet west of the west switch of the siding at Clare.

Point of accident

Supervisor of Telegraph and Signals Klass stated that on the evening following the accident the light on westward signal 64-5, located at the west switch at Clare, was checked and found to be somewhat out of line and did not show as well as the other lights, but it could be seen from the east switch at Clare, a distance of 5,376 feet.

On the evening following the accident, signal 64-5 was inspected and although the light was found to be slightly out of line it could be seen from the east siding switch, a distance of 3,376 feet; however, had Engineman Sheffer operated his train in compliance with the terms of Rule 27 he would have stopped short of signal 64-5 and the accident might have been averted.
