ACCIDENT ON THE
PENNSYLVANIA RAILROAD

CLEVELAND, OHIO

JUNE 25, 1938.

INVESTIGATION NO. 2280

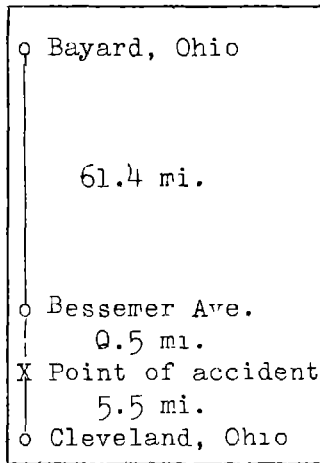
Inv. No. 2280
Pennsylvania Railroad
Cleveland, Ohio
June 25, 1938

At the time of the accident the eastward main track, the running track immediately north of track 2, and the running track immediately south of track 1 were clear. Under those conditions the view of the point of collision from the engine-man's side of an engine backing up was restricted to 1,073 feet, while from the fireman's side the point of accident was visible only while the engine was between points 1,348 and 1,148 feet east thereof.

Point of accident

Signal 1175

115 ft.
