INTERSTATE COMMERCE COMMISSION  
WASHINGTON

ACCIDENT ON THE  
LOUISVILLE & NASHVILLE RAILROAD

JULY 3, 1939

INVESTIGATION NO. 2368

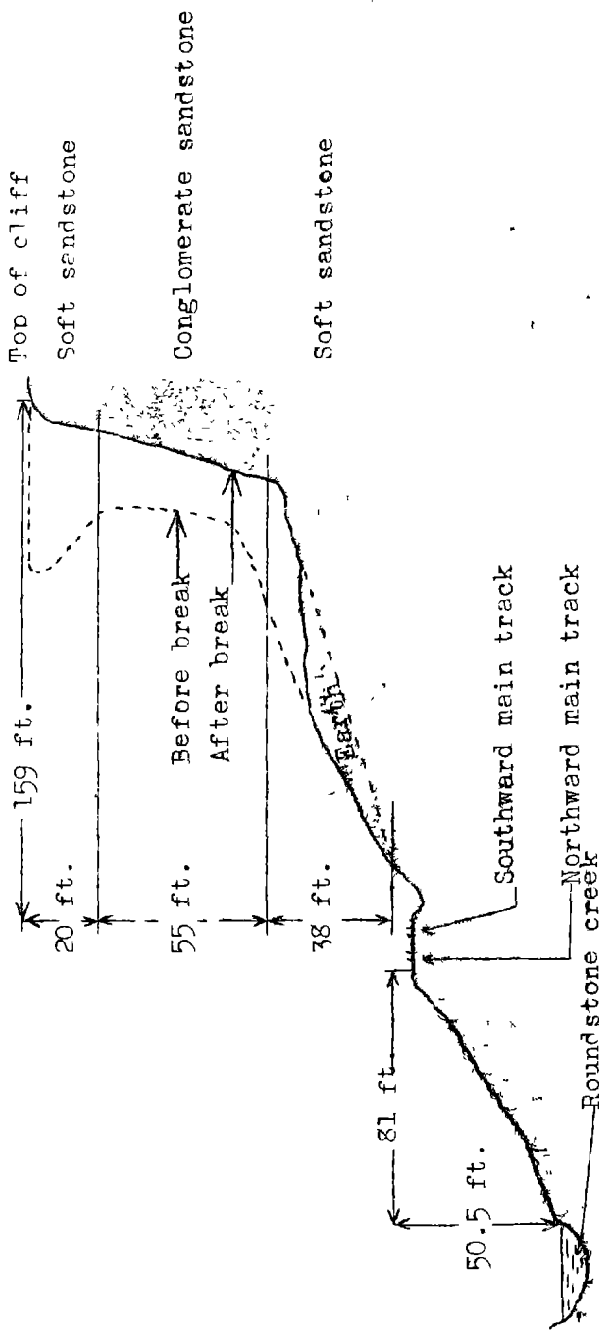
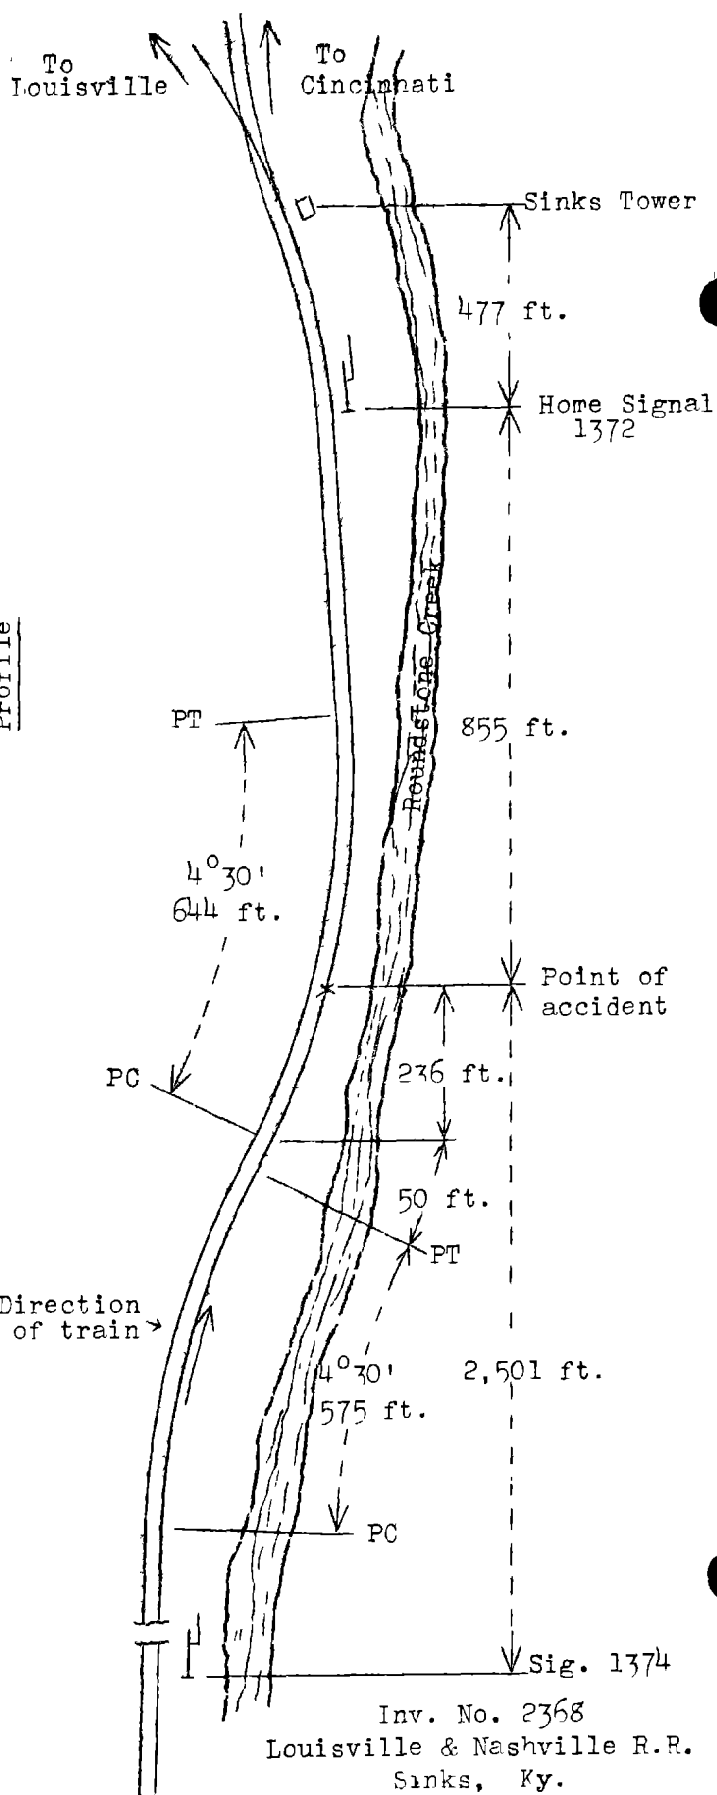
Profile

o Cincinnati, Ohio	
	152.6 mi.
o Sinks, Ky.	
x Point of accident	3.1 mi.
o Livingston,	
	32.2 mi.
o Corbin, Ky.

Inv. No. 2368  
 Louisville & Nashville R.R.  
 Sinks, Ky.  
 July 3, 1939
