INTERSTATE COMMERCE COMMISSION
WASHINGTON

REPORT OF THE DIRECTOR
BUREAU OF SAFETY

ACCIDENT ON THE
DENVER AND RIO GRANDE WESTERN RAILROAD
AND THE
ATCHISON, TOPEKA & SANTA FE RAILWAY-COLORADO
AND SOUTHERN RAILWAY

INVESTIGATION NO. 2374

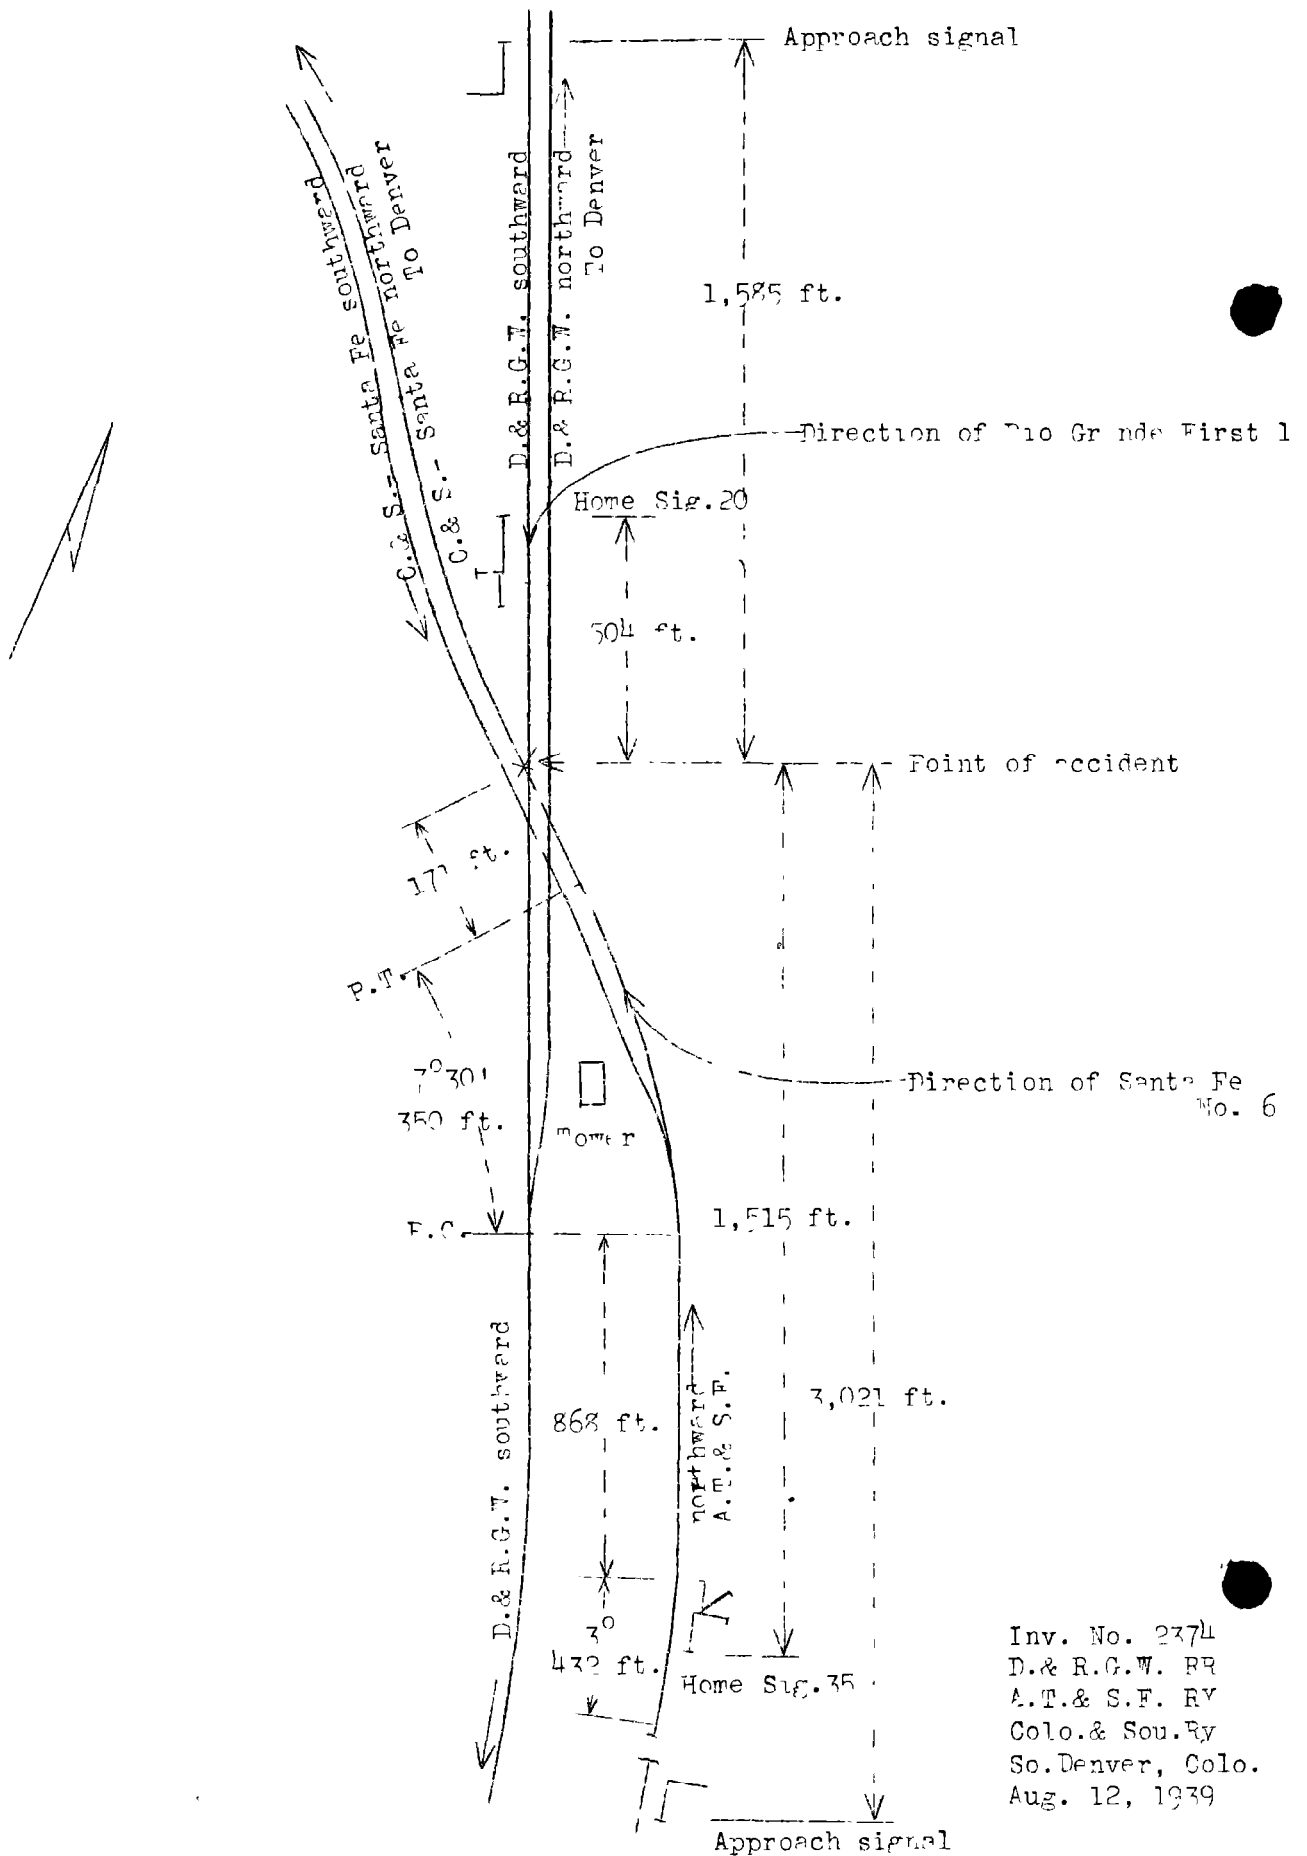
Inv. No. 2374
 D. & R.G.W. RR
 A.T. & S.F. Ry
 Colo. & Sou. Ry
 So. Denver, Colo.
 Aug. 12, 1939

The double-track line of the Santa Fe - C. & S. crosses the double track line of the Rio Grande at an angle of $25^{\circ}45'$. Approaching the crossing on the Rio Grande southward track there is a compound curve to the right 1,345 feet in length, which consists of a $0^{\circ}11'$ curve 1,145 feet long and a 2° curve 200 feet long, followed by a tangent 3,462 feet to the crossing and 1,010 feet beyond. The grade for southward trains is generally ascending, varying from 0.35 to 0.58 percent to within 1,200 feet of the crossing; it is then level. Approaching the crossing from the south on the Santa Fe - C. & S. track there are, successively, a 3° curve to the left 432 feet in

length, a tangent 868 feet in length, a 7°30' curve to the left 350 feet in length, and a tangent 171 feet to the crossing. The grade for north-bound trains is 0.31 percent descending a distance of 1,300 feet then level 1,950 feet, 0.9 percent descending a distance of 250 feet, and then level a distance of 100 feet to the crossing.

At the time of this accident the interlocking machine, located in a tower in the southeast angle of the crossing, was a Saxby-Farmer mechanical machine with 26 working levers. There were no track circuits in this interlocking. In addition to mechanical locking on the machine, normal-indication electric locks were attached to the signal levers. The signals involved were of the 1-arm, upper-quadrant, semaphore type. The approach signal on each line was fixed in horizontal position; it was oil lighted and displayed a yellow aspect; its indication was "proceed at restricted speed." The home signal was electrically operated from the tower and its normal position was stop. The approach signal and home signal No. 35, governing northward movements on the Santa Fe - C. & S., were located 3,021 and 1,515 feet, respectively, south of the crossing. The indications and aspects of home signal No. 35 were as follows:
