ACCIDENT ON THE
PENNSYLVANIA RAILROAD

FORT WAYNE, IND.

October 24, 1939

INVESTIGATION NO. 2389

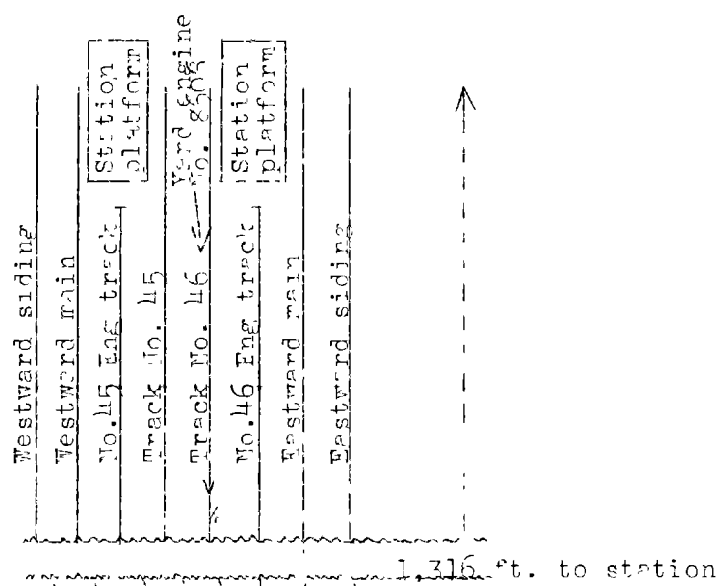
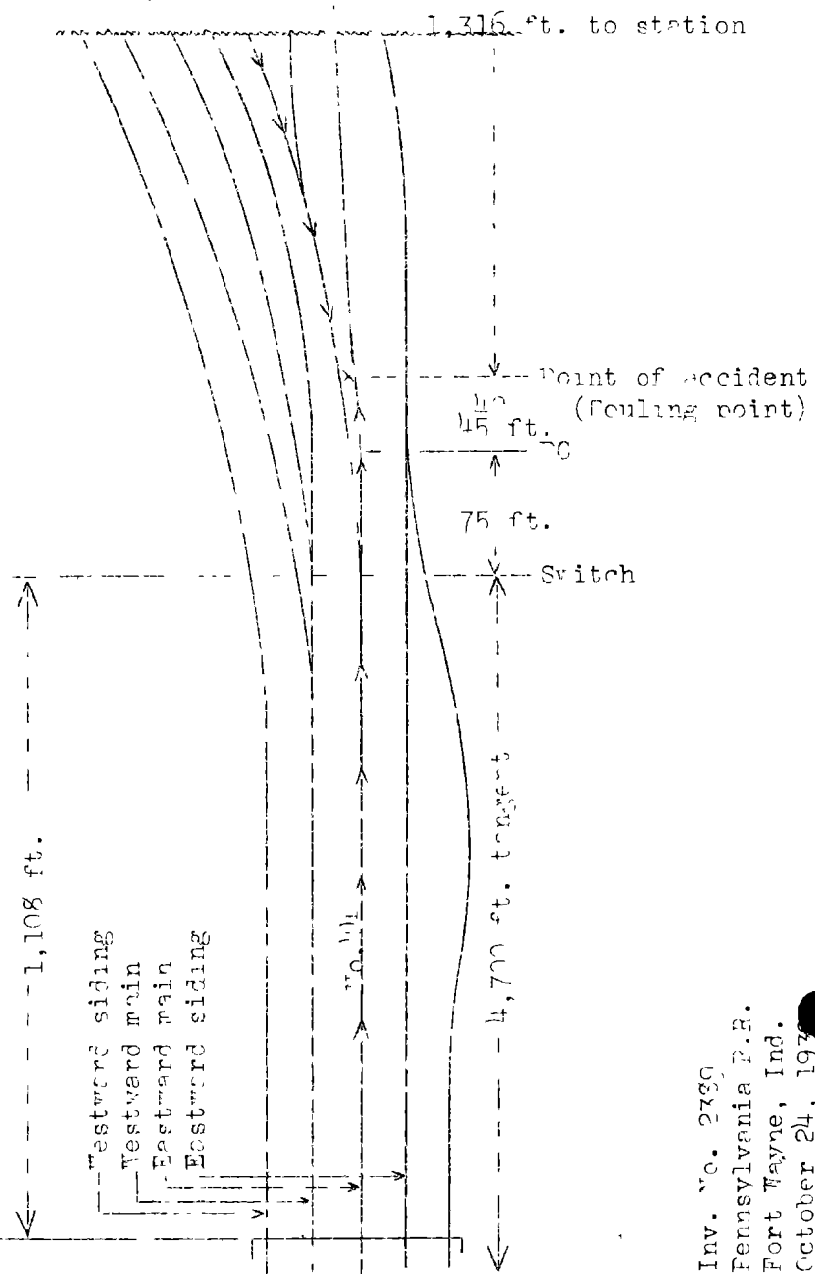
Inv. No. 2739
Pennsylvania P.R.
Fort Wayne, Ind.
October 24, 1937

The switch involved is a facing-point hand-throw switch for east-bound trains; entry to track No. 46 from the eastward main track is made through a No. 10 turnout which leads to the north. The center of the lens of an electrically lighted switch lamp, which is located to the south side of the eastward main track, is 10 inches above the ties; this switch lamp displays a green aspect when the switch is set for main-track movements.

Signal "A," located on a signal bridge 1,108 feet west of the switch involved, is a semiautomatic, non-stick, position-light signal and governs eastward movements; a train receiving a slow-speed indication at this signal is required to proceed at not exceeding 15 miles per hour prepared to stop at the next signal.
