ACCIDENT ON THE  
TERMINAL RAILROAD ASSOCIATION OF ST. LOUIS

ST. LOUIS, MO.

MARCH 29, 1940

INVESTIGATION NO. 2421

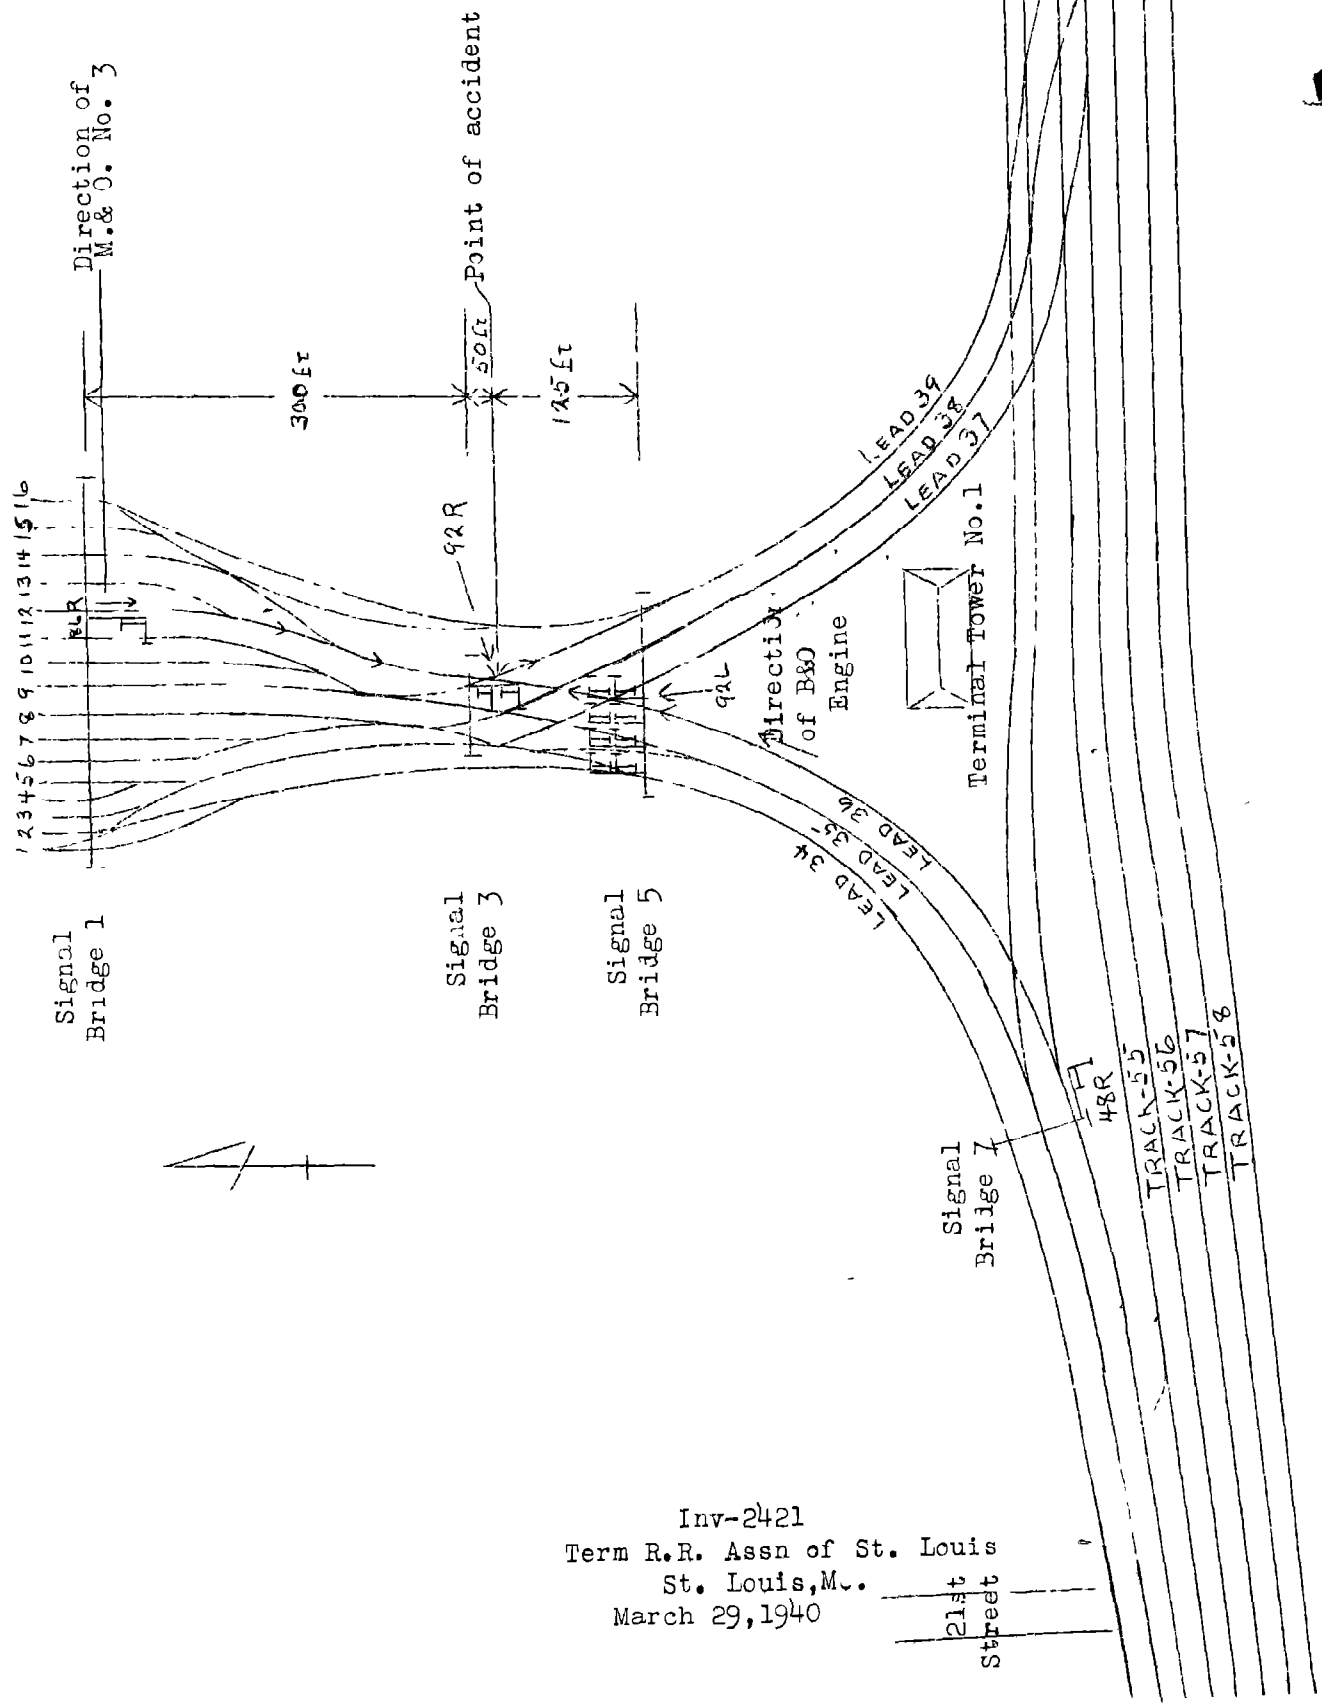
Inv-2421  
 Term R.R. Assn of St. Louis  
 St. Louis, Mo.  
 March 29, 1940

Trains enter and leave St. Louis Union Station over the tracks of the Terminal Railroad Association of St. Louis. This accident occurred within interlocking limits on the Eads Division which extends between Theresa Avenue, St. Louis, Mo., and Relay Station, East St. Louis, Ill., a distance of 3.27 miles. The union station is located approximately 800 feet north of the main tracks, which extend eastward and westward. There are 42 station tracks extending southward from the station. From west to east, the first 10 of these tracks are designated by letters and the other 32 tracks are numbered consecutively 1 to 32. Entry from the main tracks to station tracks 1 to 16, inclusive, is made through a Y, each leg of which has three parallel tracks; the tracks of the west leg are designated from west to east as lead tracks 34, 35, and 36, and the tracks of the east leg are designated from west to east as lead tracks, 37, 38, and 39. The Y and the station tracks are within the limits of the interlocking controlled from Terminal Tower No. 1, which is located inside the Y. Within these interlocking limits trains are operated by signal indication. The accident occurred at the south end of a double-slip cross-over at the intersection of lead tracks Nos. 36 and 39, which is located approximately 400 feet south of the station. From the station to the point of accident, station track 12 and lead track 39 are practically tangent. Approaching the point of accident from the south on lead track 36 there is a 12° curve to the left 300 feet in length, which is followed by a tangent 100 feet long to the point of accident. The grade in this vicinity is level.

Two interlocking machines are located in Terminal Tower No. 1; these machines control 96 single switches, 7 movable-point frogs; 120 double-slip switches, 296 signals, and 1 traffic lock. Switches and signals are of the electro-pneumatic type and are electrically and mechanically interlocked. Of the signals involved, those governing out-bound movements starting on track 12 are signals 86R on bridge 1 and 92R on bridge 3, located, respectively, 350 feet and 50 feet north of the point of accident, and those governing in-bound movements on lead track 36 are signals 48R on bridge 7 and 92L on bridge 5, located, respectively, 400 feet and 125 feet south of the point of accident. These signals are of the lower-quadrant semaphore type. Signals 86R and 48R are of the 1-arm type; signals 92R and 92L are of the 2-arm type; all are non-automatic signals except the lower arm of signal 92L which is semi-automatic and indicates track occupancy of station tracks 9 to 16, inclusive, according to the track for which the route is lined. The upper arm of signal 92R governs the route for a westward movement to lead track 36 and the lower arm governs the route for an eastward movement to lead track 39. The signals involved are two-position signals indicating stop or proceed. When the route is lined for an out-bound movement from station track 12 to lead track 39, signals 86R and 92R display proceed indications; under these conditions the most favorable indications that can be displayed for an in-bound movement from lead track 36 to station track 15 are a proceed indication at signal 48R and a stop indication at signal 92L.
