INVESTIGATION NO. 2461  
THE BALTIMORE AND OHIO RAILROAD COMPANY  
AND  
THE CHESAPEAKE AND OHIO RAILWAY COMPANY  
REPORT IN RE ACCIDENT  
AT FOSTORIA, OHIO, ON  
NOVEMBER 12, 1940

Accident at Fostoria, Ohio, on November 12, 1940, caused by failure of C. & O. yard engine properly to observe and to obey a crossing signal indication.

Inv-2461  
 Baltimore & Ohio R. R.  
 Chesapeake & Ohio Ry.  
 Fostoria, Ohio  
 November 12, 1940

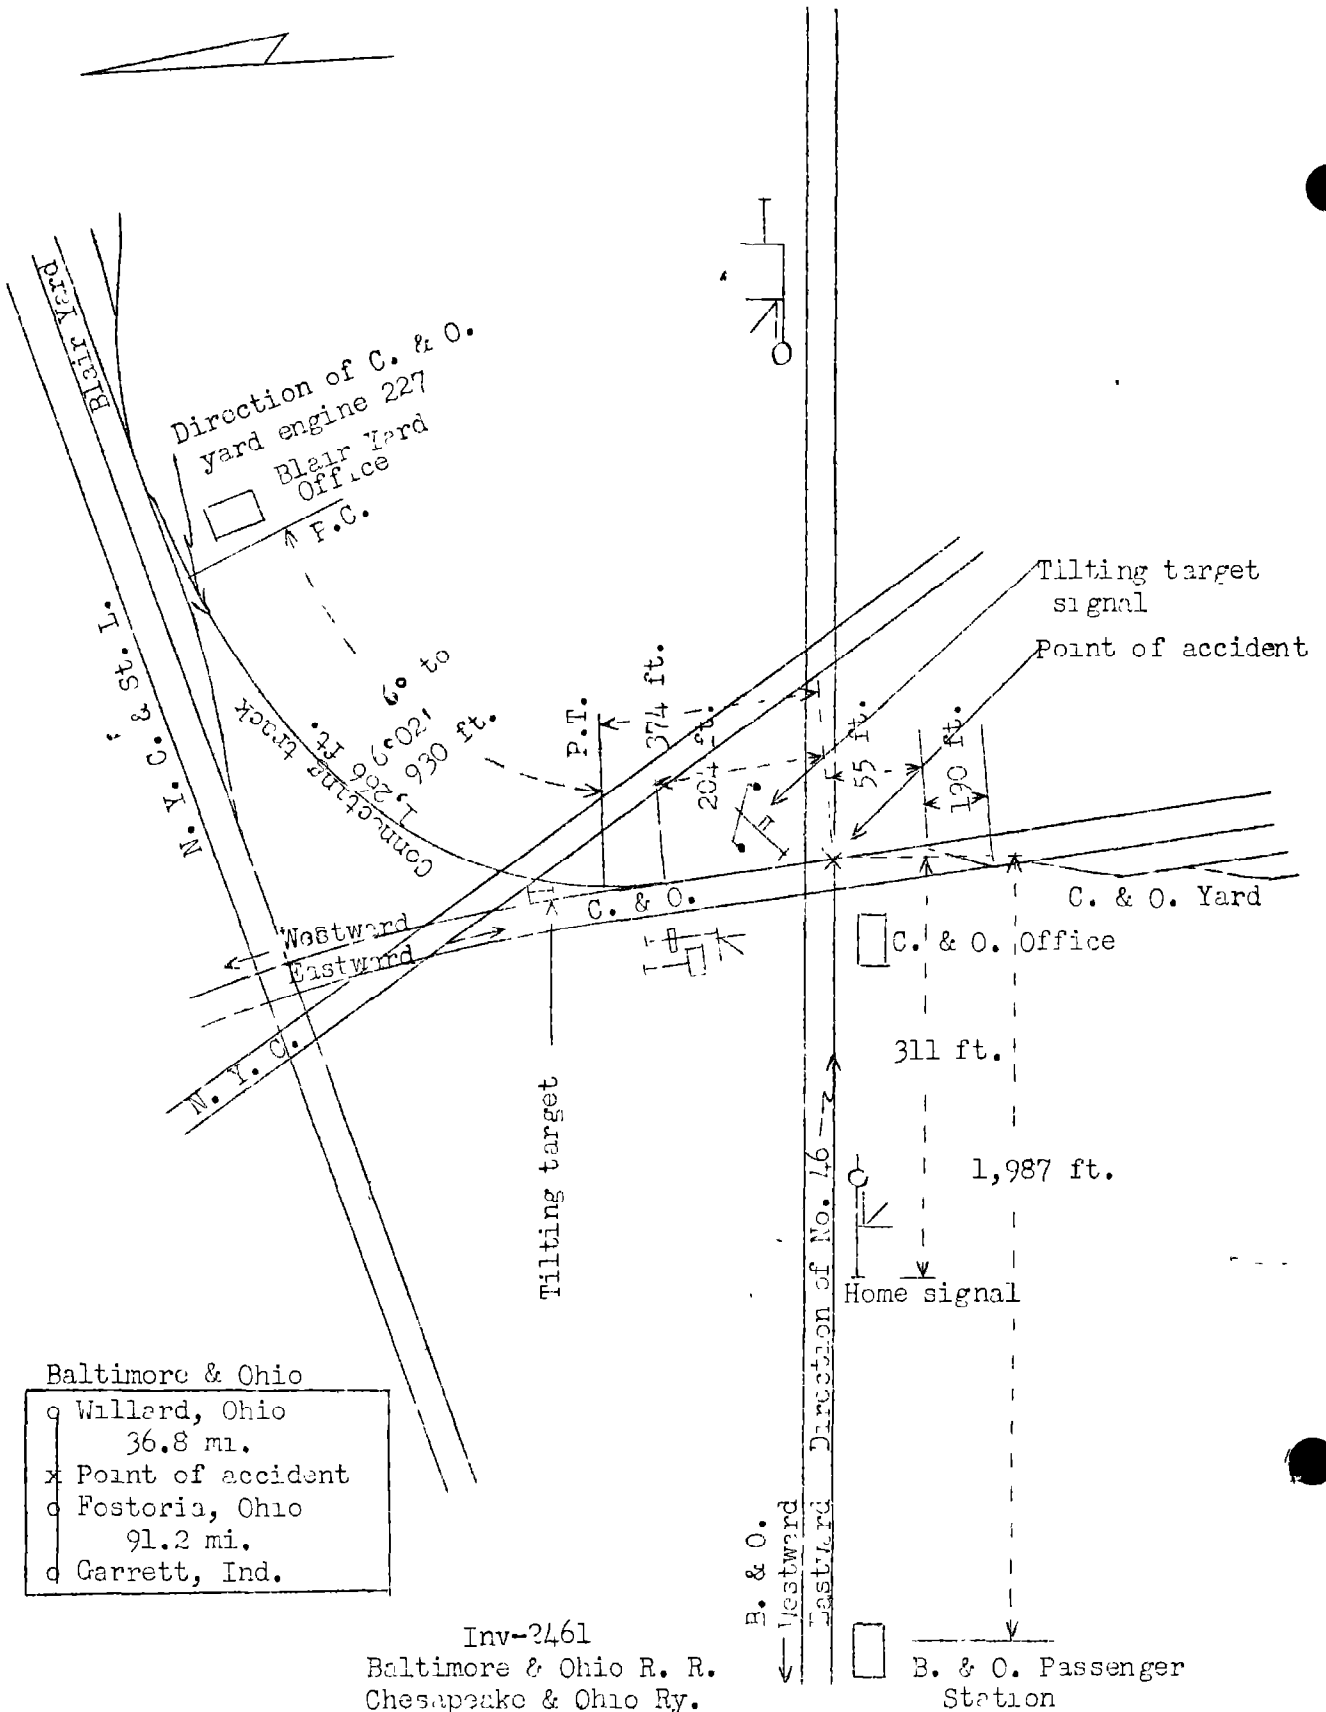
Hereinafter the Baltimore and Ohio Railroad, the Chesapeake and Ohio Railway, and the New York, Chicago & St. Louis Railroad will be referred to respectively as the B. & O., the C. & O. and the Nickel Plate. The accident occurred at the intersection of the E. & O. and C. & O. tracks. Fostoria is located on that part of the Akron-Chicago Division of the B. & O. designated as the Chicago Subdivision which extends between Garrett, Ind., and Willard, Ohio, a distance of 128 miles, and on that part of the Hocking Division of the C. & O. designated as the Toledo Sub-Division which extends between Mosel, Columbus, Ohio, and Rockwell Junction, Toledo, Ohio, a distance of 127.1 miles. Both are double-track lines. Trains are operated on the B. & O. by an automatic block-signal system, the indications of which supersede time-table superiority; trains are operated on the C. & O. by time-table, train orders and an automatic block-signal system. These lines intersect at an angle of  $78^{\circ}58'$ . Time-table directions on both railroads are east and west; however, according to compass directions, the westward and eastward tracks of the C. & O. extend, respectively, north and south, and the tracks of the B. & O. extend east and west. The crossing is located 1,987 feet east of the B. & O. passenger station.

As the crossing is approached from the west on the B. & O., the track is tangent and level. As the crossing is approached from Blair yard via the connecting track, there is a compound curve to the left consisting of  $6^{\circ}$  curvature a distance of 727 feet and  $6^{\circ}02'$  curvature a distance of 203 feet, then a tangent 204 feet to the crossing and some distance beyond. Between Blair yard and the B. & O. crossing the grade varies from 0.35 to 1.10 percent ascending 1,000 feet, 0.093 percent descending a distance of 300 feet to the switch of the C. & O. westward

The Commission's inspectors observed that an engineman in the cab of an engine moving backward on the connecting track toward the crossing involved could see the tilting-target signal at a point 908 feet from it; it remained in view a distance of 25 feet, then was obscured from view a distance of 136 feet by a building and an advertising sign, and then was in view throughout a distance of 747 feet to the crossing.
