INVESTIGATION NO. 2627

THE CLEVELAND, CINCINNATI, CHICAGO & ST. LOUIS
RAILWAY COMPANY

REPORT IN RE ACCIDENT

SEPTEMBER 16, 1942

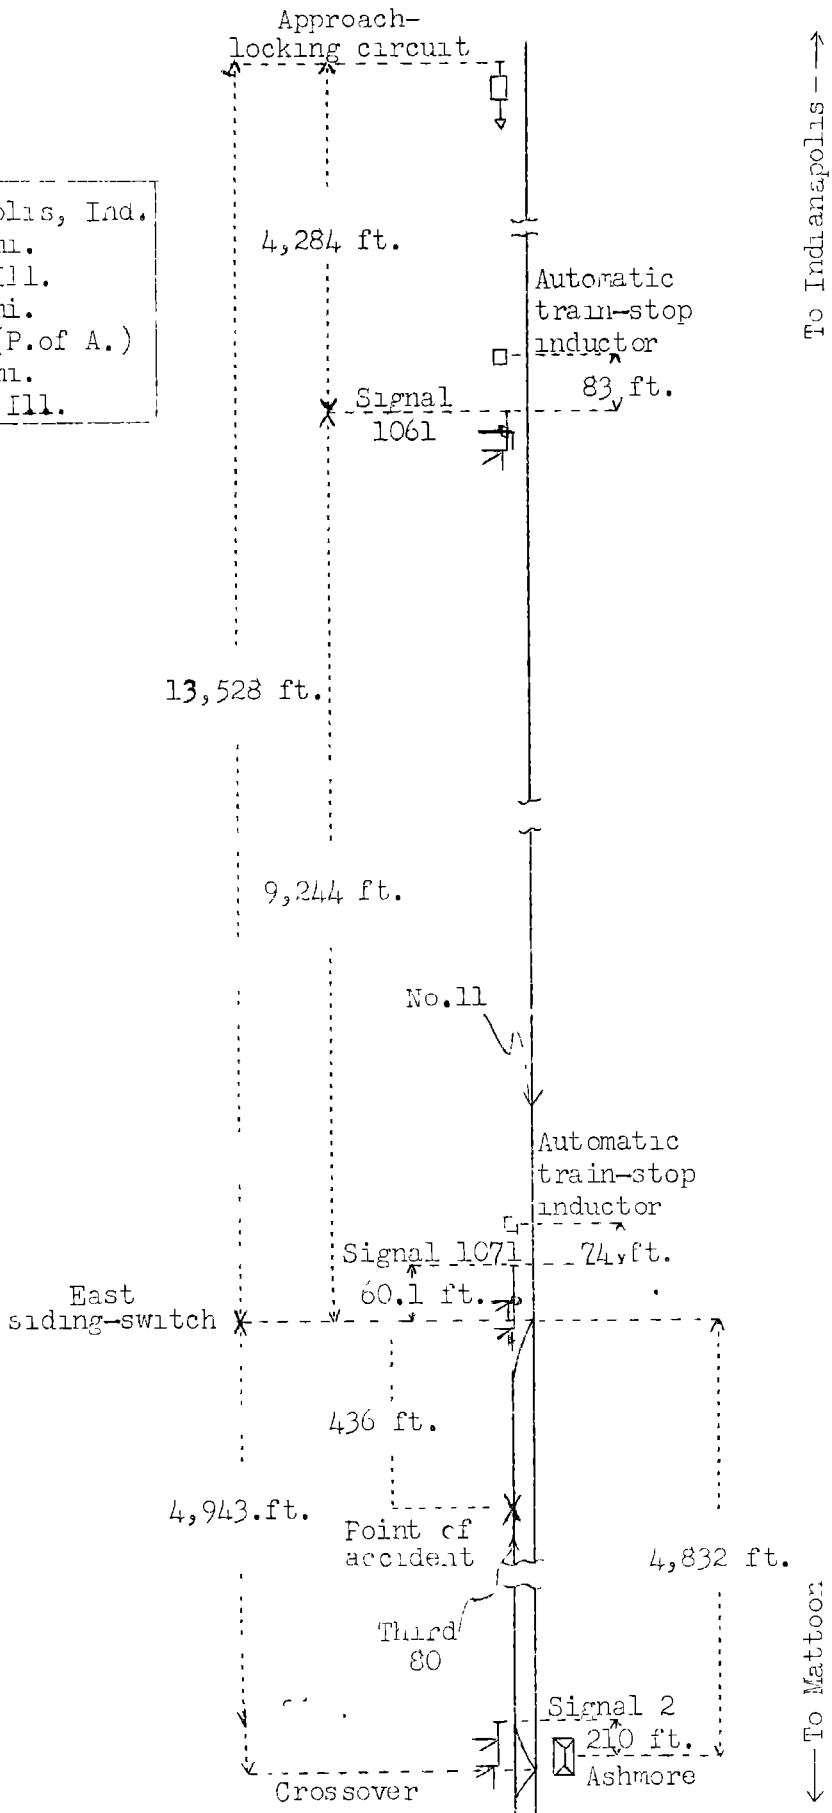
Inv. No. 2627
 Cleveland, Cincinnati, Chicago & St. Louis Railway
 Ashmore, Ill.
 September 16, 1942

Location of Accident and Method of Operation
