INVESTIGATION NO. 2649
THE BALTIMORE & OHIO RAILROAD COMPANY
REPORT IN RE ACCIDENT
AT BROOK, PA., ON
NOVEMBER 14, 1942

Accident at Brook, Pa., on November 14, 1942, caused by
failure to operate train in accordance with inter-
locking signal indications.

Inv. No. 2649
 Baltimore & Ohio Railroad
 Brook, Pa.
 November 14, 1942

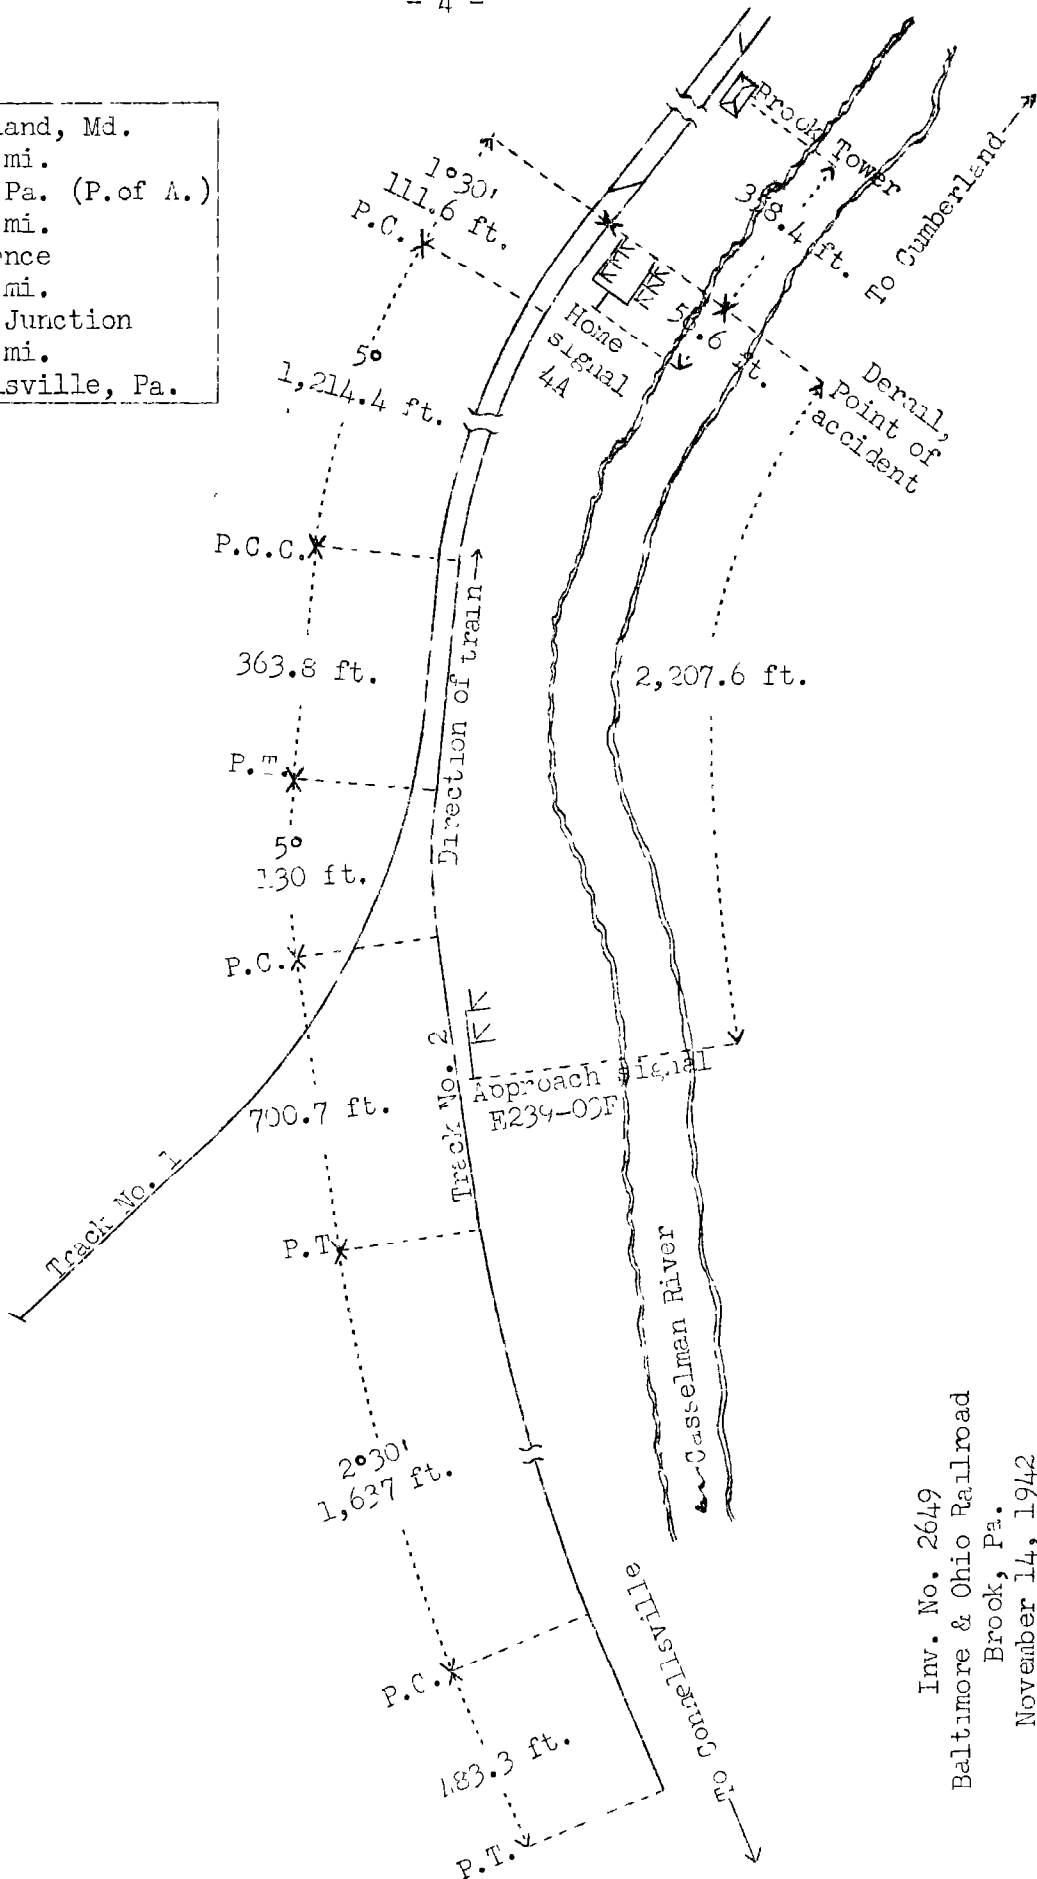
Approach signal E239-03F and home signal 4A, governing east-bound movements on track 2, are located, respectively, 2,207.6 feet and 56.6 feet west of the point of accident. The involved derail is located 56.6 feet east of home signal 4A. Approach signal E239-03F is of the automatic, two-arm, three-position, upper-quadrant, semaphore type, and is continuously lighted. The involved aspect and corresponding indication and name of this signal are as follows:

departed from Greene Junction, 29.9 miles west of Brook, at 6:54 a. m., according to the dispatcher's record of movement of trains, departed on track 2 from Confluence, the last open office, at 8:43 a. m., passed approach signal E239-03F, which displayed approach, passed home signal 4A, which displayed stop, and while moving at an estimated speed of 15 to 18 miles per hour it was derailed at the derail located 358.4 feet west of the tower at Brook.

Engine 6223 was derailed to the right and stopped, badly damaged, at a 15-degree angle to the track, with the front end of the engine down the embankment and about 215 feet east of the point of derailment. The cab was practically demolished and the main frame was bent. The tender remaining coupled to the engine was derailed and stopped on its right side with its rear end near the track. The front truck of the first car was derailed and the car was slightly damaged. The fifty-ninth to sixty-first cars, inclusive, were slightly damaged. The sixty-second car was derailed and demolished. The sixty-third car was derailed and stopped, badly damaged, north of the track, and the sixty-fourth car was slightly damaged.
