INVESTIGATION NO. 2809
THE WABASH RAILROAD COMPANY
REPORT IN RE ACCIDENT
AT MOBERLY, MO., ON
MAY 19, 1944

Accident at Moberly, Mo., on May 19, 1944, caused by a train entering a diverging route at a high rate of speed, as a result of an improper aspect being displayed for the route.

Inv-2809
 Wabash Railroad
 Moberly, Mo.
 May 19, 1944

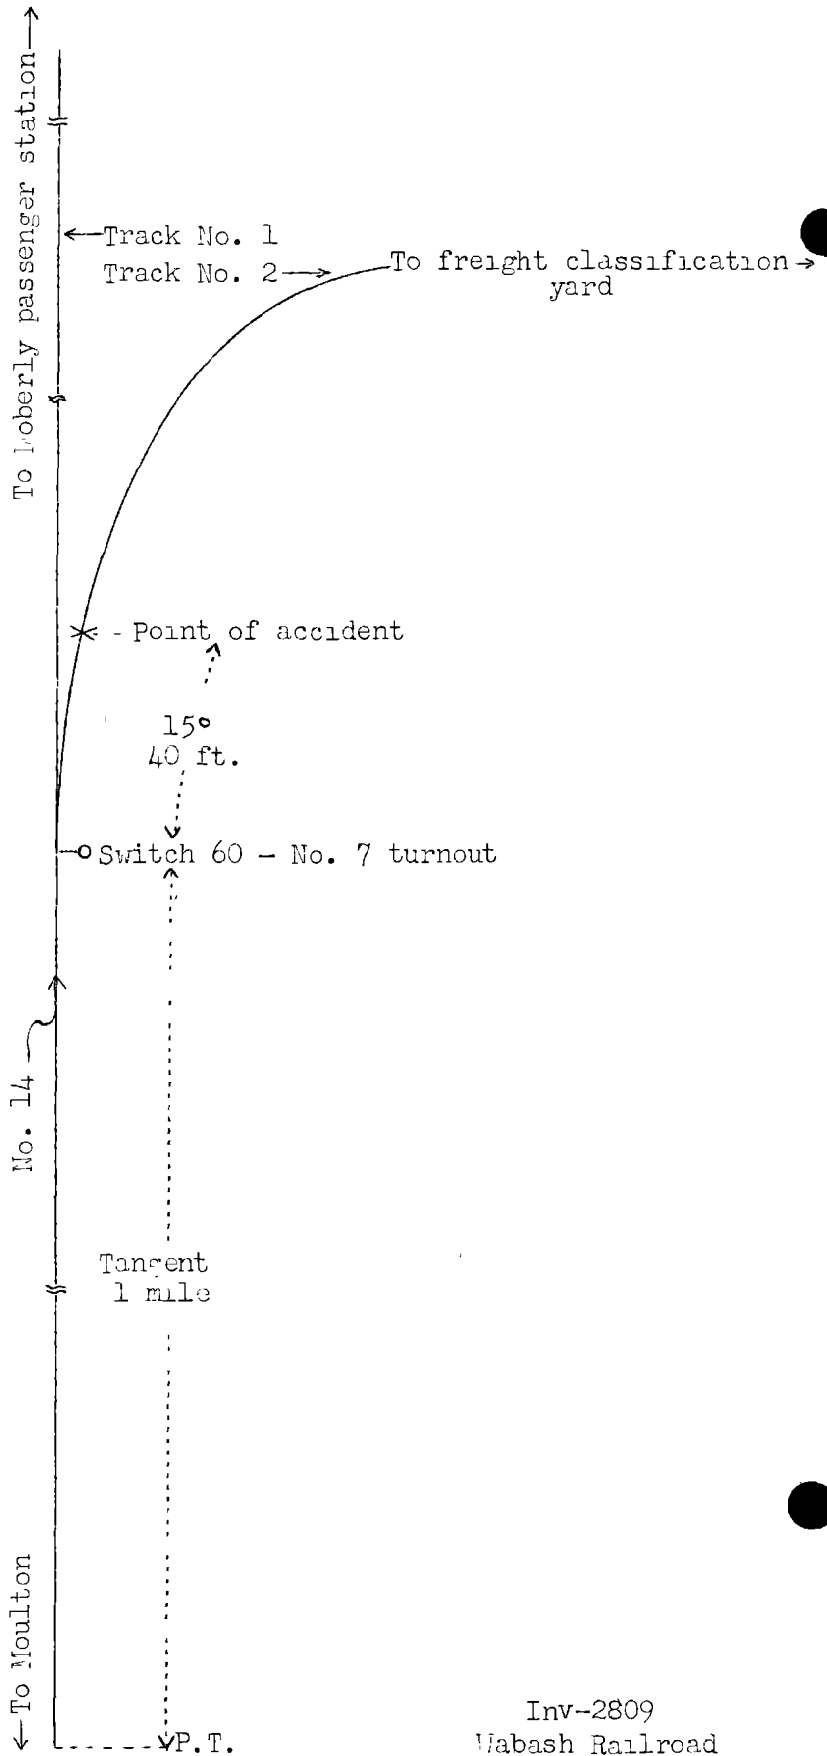
This accident occurred on that part of the Moberly Division designated as the 15th District and extending eastward from Moulton, Iowa, to Moberly, Mo., 95.3 miles. This was a single-track line over which trains were operated by timetable and train orders, and a manual-block system for following movements only. On this line east-bound trains en route to the passenger station at Moberly entered a lead track, hereinafter referred to as track No. 1, at switch 60, located some distance west of the passenger station, and east-bound trains en route to the freight classification yard, located to the south of track No. 1, entered a lead track, hereinafter referred to as track No. 2, at switch 60. Entry to track No. 2 at switch 60 was made through a No. 7 turnout to the right. The accident occurred on the turnout of track No. 2 about 40 feet east of switch 60. From the west the main track was tangent 1 mile to switch 60, and track No. 1 was tangent a considerable distance eastward from switch 60. At the point of accident on track No. 2 the curvature was 15°. The grade was practically level.

The switch-stand of switch 60 was on the south side of the track and was of the hand-throw, intermediate type. The switch-stand was provided with an oil lamp and a red circular target. When the switch was lined for entry to track No. 1 the target and a red light were displayed. When the switch was lined for entry to track No. 2 a green light was displayed. A switchtender was regularly assigned in this vicinity between 11 p. m. and 7 a. m.

The engine and the first car were derailed and damaged. The engine and tender stopped on their left sides, north of track No. 2 and at right angles to it, with the front end of the engine about 300 feet east of the point of derailment. The first car stopped practically upright, north of the track and at an angle of about 15 degrees to it. The front end of the second car was slightly damaged.

In view of the hazardous situation disclosed in this investigation, operating officials of this railroad should immediately change the aspects at this switch to conform to the practice at other turnouts on this railroad.
