INTERSTATE COMMERCE COMMISSION

REPORT OF THE CHIEF OF THE DIVISION OF SAFETY COVERING THE INVESTIGATION OF AN ACCIDENT ON THE BALTIMORE & OHIO SOUTHWESTERN RAILROAD AT ORIENT, OHIO, ON AU- GUST 12, 1915

OCTOBER 12, 1915

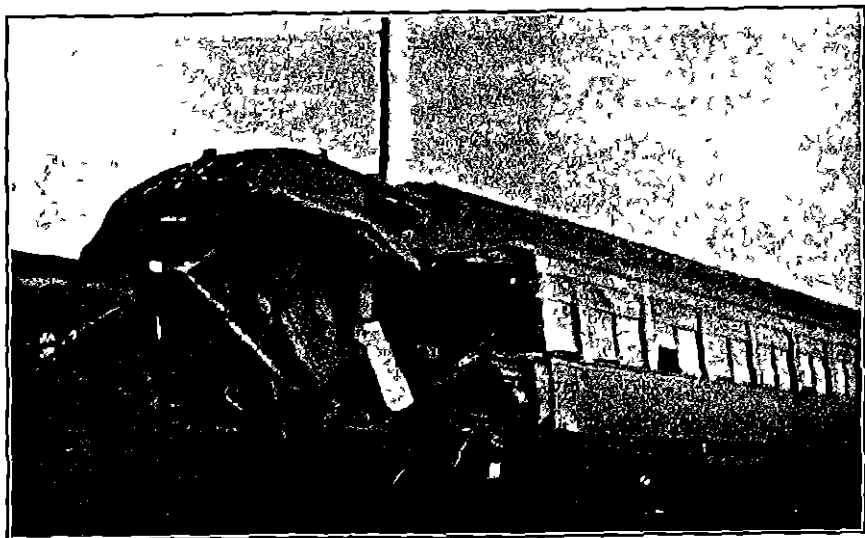
No 2—Damaged end of the car next to the rear

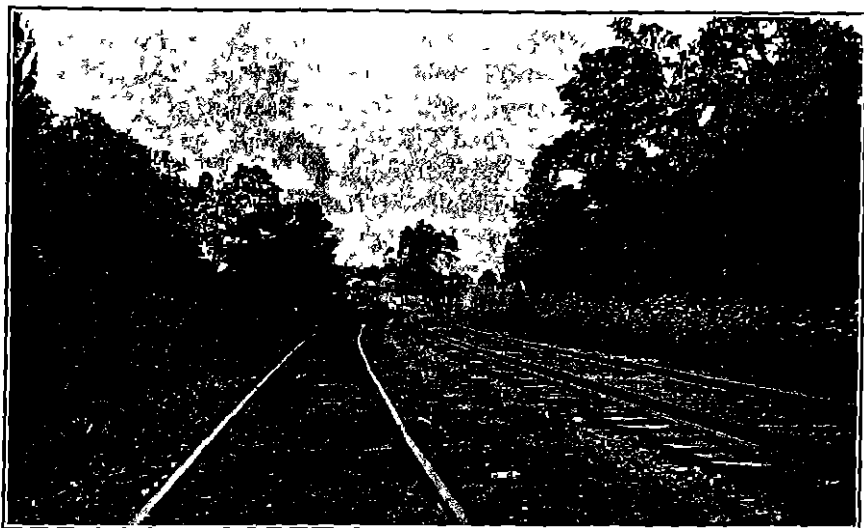
Beginning at a point about 0.7 of a mile east of Orient station and proceeding westward the track is tangent for about 850 feet This is followed by a 2° curve to the right 2,700 feet in length, followed in turn by a $1^\circ 14'$ curve to the right 1,200 feet in length It was 2,300 feet west of the east end of the first mentioned curve that the accident occurred A view of about 750 feet may be ob

tained from the engine of an approaching west bound train At this point there is a grade of 05 per cent descending westward Illustration No 3 shows the view approaching the point of accident from the east

No 3—View approaching point of accident from the east
