INVESTIGATION NO. 3090
THE PENNSYLVANIA RAILROAD COMPANY
REPORT IN RE ACCIDENT
AT ALBION, PA., ON
MARCH 31, 1947

Accident at Albion, Pa., on March 31, 1947, caused by
failure properly to control speed of train in
accordance with manual-block authority and
approaching a meeting point.

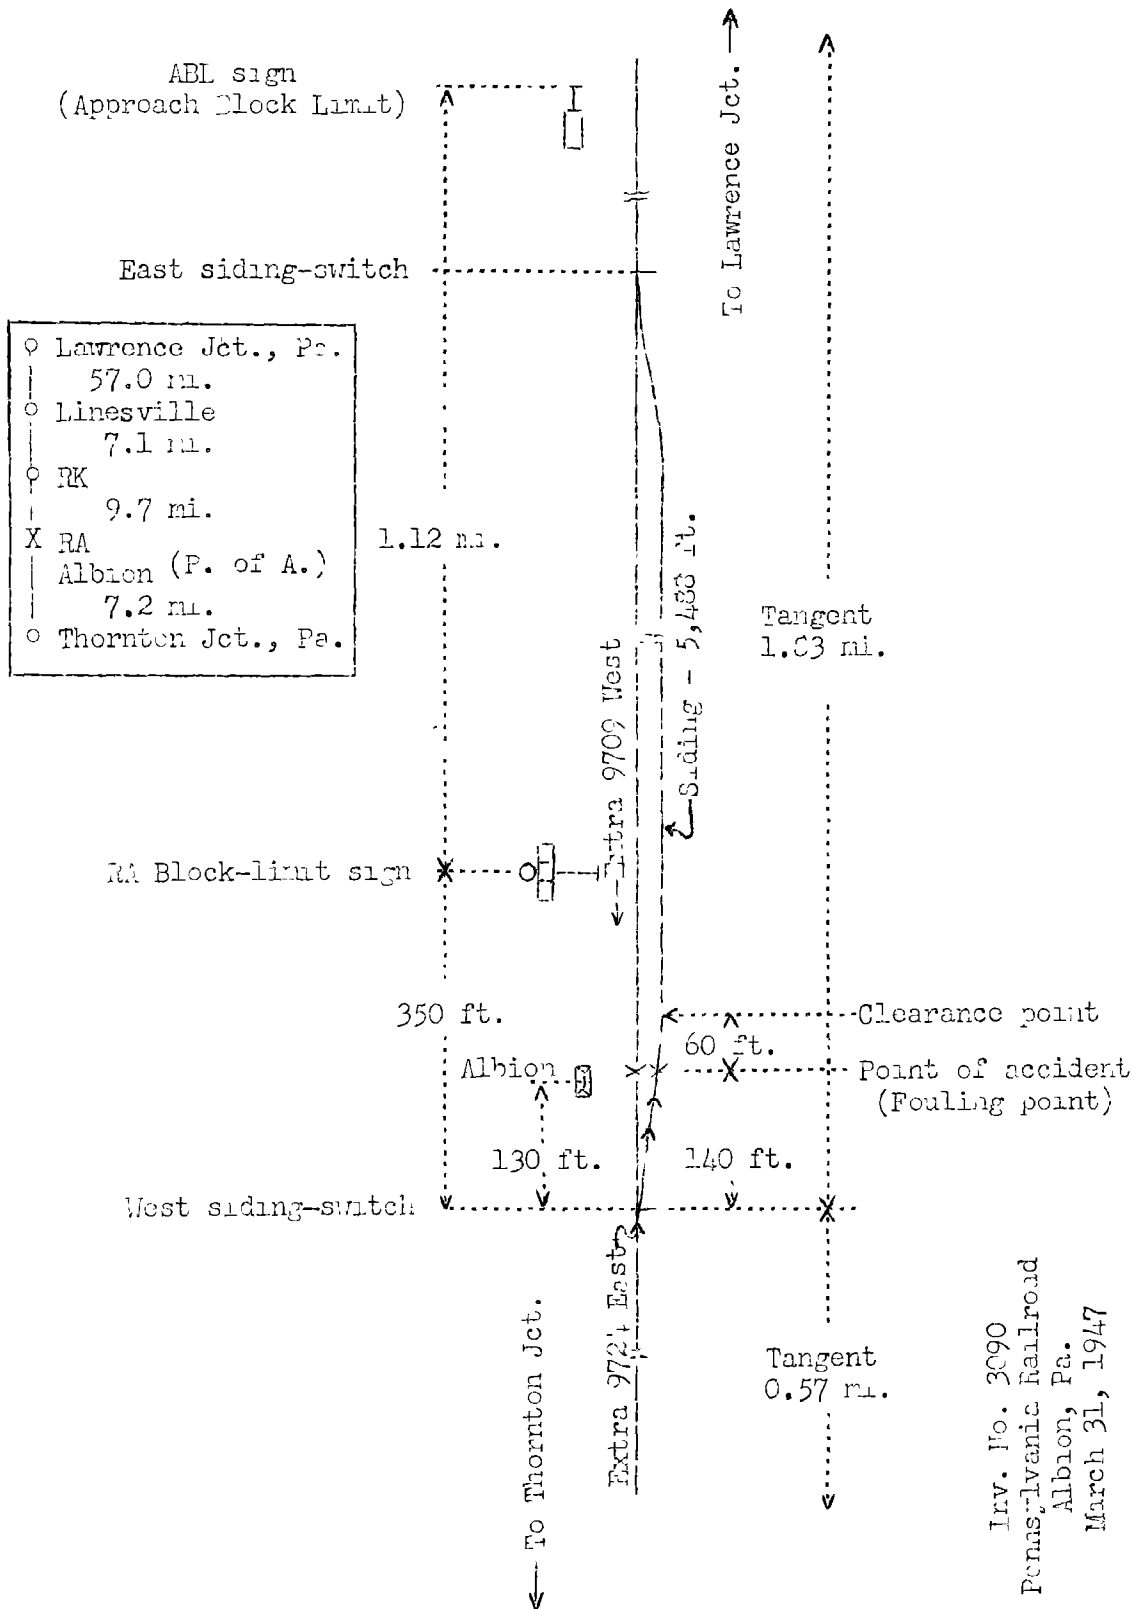
Inv. No. 3090
 Pennsylvanic Railroad
 Albion, Pa.
 March 31, 1947

This accident occurred on that part of the Erie & Ashtabula Division extending between Thornton Jct. and Lawrence Jct., Pa., 81 miles, a single-track line in the vicinity of the point of accident, over which trains are operated by timetable, train orders and a manual-block system. At Albion, 7.2 miles east of Thornton Jct., a siding 5,488 feet long parallels the main track on the south. The west switch of this siding is 130 feet west of the station. The accident occurred at the fouling point of the main track and the turnout of the west siding-switch, at a point 60 feet west of the clearance point and 140 feet east of the switch. The main track is tangent throughout a distance of 0.57 mile immediately west of the west siding-switch and 1.83 miles eastward. At the point of accident the grade is 0.6 percent descending westward.

The manual block involved extends between Albion and Block-limit station RK, 9.7 miles east of Albion. At Albion the block limit is indicated by a sign located 350 feet east of the west siding-switch. This sign consists of the letters RA in white on a black signboard 7 inches wide and 24 inches long, mounted vertically approximately 7 feet above the level of the tops of the rails on a mast 10 feet north of the north rail of the main track. The night indication consists of a red and a yellow lens 5-3/8 inches in diameter, mounted horizontally on a mast 8 feet 5 inches above the level of the tops of the rails. It is lighted continuously, and the yellow lens is next to the main track. Both the sign and the night indication are visible from either direction. An approach block-limit sign governing west-bound movements is located 1.12 miles east of the block-limit sign. The approach block-limit sign consists of the letters ABL in black letters and in colorless reflector buttons on a yellow signboard. It is 8 inches wide and 29 inches long, and is mounted vertically approximately 6 feet 5 inches above the level of the tops of the rails and 10 feet north of the north rail of the main track. The indications and names of these signals are as follows:
