INVESTIGATION NO. 3112
THE NEW YORK CENTRAL RAILROAD COMPANY
REPORT IN RE ACCIDENT
AT SHILOH, OHIO, CN
JUNE 25, 1947

Accident at Shiloh, Ohio, on June 25, 1947, caused by
a train entering a crossover at a high rate of
speed.

Inv. No. 3112
New York Central Railroad
Shiloh, Ohio
June 25, 1947

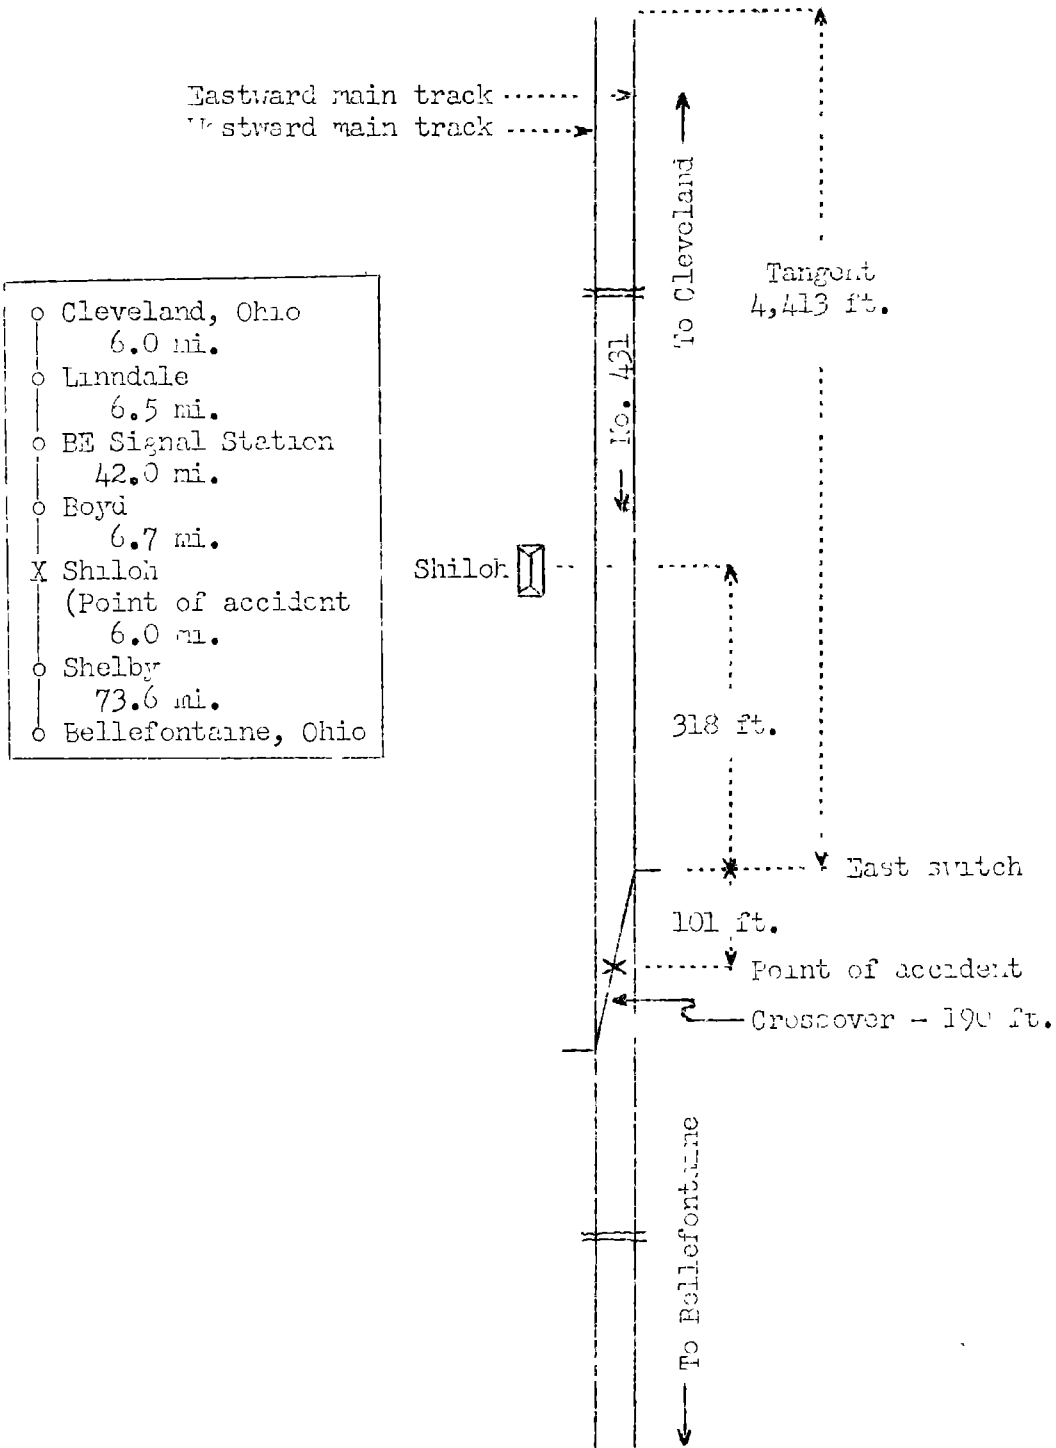
This accident occurred on that part of the Ohio Division extending between BE Signal Station, near Cleveland, and Bellefontaine, Ohio, 128.3 miles, a double-track line in the vicinity of the point of accident, over which trains moving with the current of traffic are operated by signal indications, and trains moving against the current of traffic are operated by train orders and a manual-block system. At Shiloh, 48.7 miles west of BE Signal Station, a trailing-point crossover 190 feet long connects the two main tracks. The east switch of this crossover is 318 feet west of the train-order station. At the time the accident occurred trains moving in either direction were being operated on the eastward main track between Boyd, 6.7 miles east of Shiloh, and Shiloh. The derailment occurred on the turnout of the east crossover-switch at Shiloh, at a point 101 feet west of the switch. The main tracks are tangent throughout a distance of 4,413 feet immediately east of the east crossover-switch and a considerable distance westward. The grade is level.

The structure of the crossover consists of No. 10 turnouts, spring-type frogs 18 feet 6 inches in length, 127-pound switch points and rail sections, and 15-foot guard rails. The curvature of each turnout is $7^{\circ}25'10''$, and the angle of each frog is $5^{\circ}45'29''$. The crossover is laid on about 115 switch ties. No superelevation is provided. The distance between the centerlines of the main tracks is 13 feet. In this vicinity the track is laid on a 15-foot fill, and is ballasted with crushed rock to a depth of about 24 inches. The switches of the crossover are hand-operated, and at the time of the accident were in the charge of the operator. The switchstands are of the intermediate-stand type, and are provided with switch lamps and double-vane targets. When the switches are lined normally a green light and a green rectangular-shape target are displayed. When the switches are lined for movement through the crossover a red light and a red oval-shape target are displayed.
