# INTERSTATE COMMERCE COMMISSION.

## REPORT OF THE CHIEF OF THE DIVISION OF SAFETY COVERING THE INVESTIGATION OF AN ACCIDENT ON THE BALTIMORE & OHIO RAILROAD AT FELTON, PA., ON DECEMBER 17, 1915.

JANUARY 28, 1916.

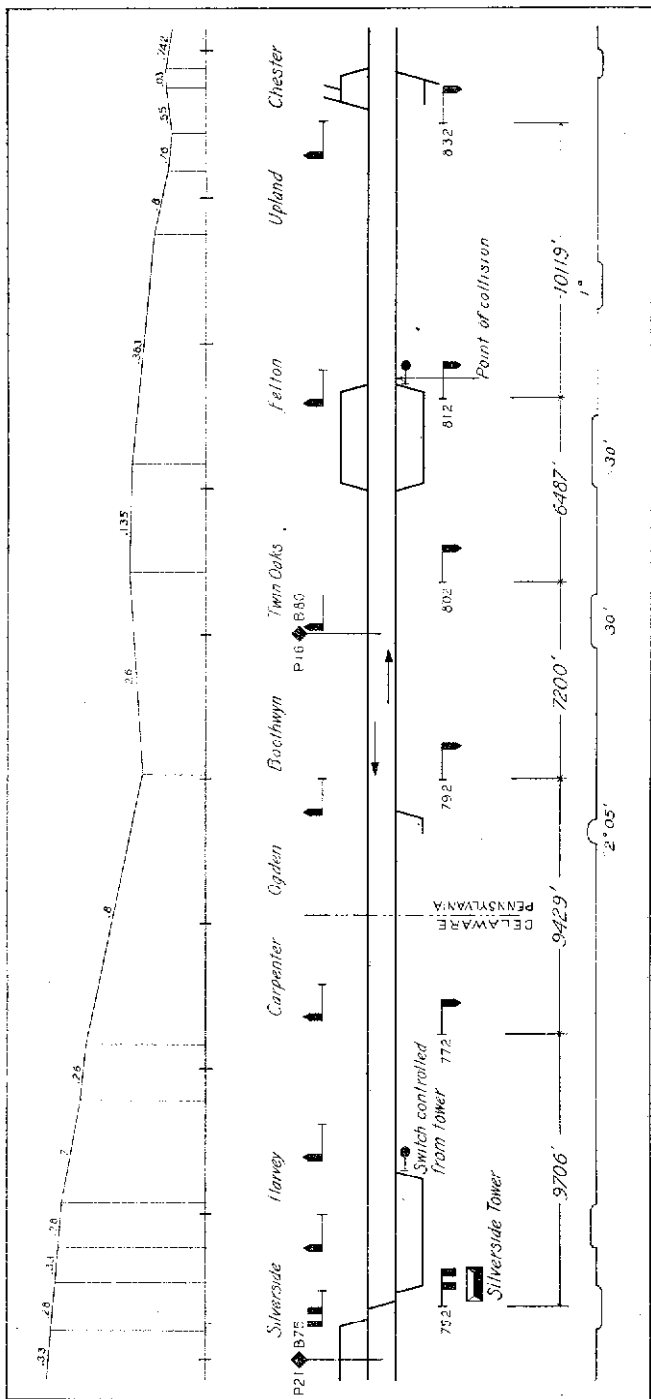
Block signal No. 812 at Felton is 545 feet in the rear of, or south of, the switch at the north end of the passing track, and signal No. 802, which gives the caution indication when the Felton signal is at stop, is at Twin Oaks, 6,487 feet farther south. The first signal north of Felton, No. 832, is located 10,119 feet from the Felton signal. The length of blocks in this vicinity varies considerably, but none is less than a mile long. The Felton signal is about 600 feet north of a curve, and the Twin Oaks signal is located at the north end of the curve; but as the curvature is only 30 minutes, a good view is had of both of these signals in ordinary weather.

Sketch showing profile and alignment of track between Silverside and Chester, with location of sidings, signals, and switch indicators.
