REPORT NO. 3384

CHICAGO, ROCK ISLAND AND PACIFIC
RAILROAD COMPANY

NEAR CLIO, IOWA, ON

DECEMBER 26, 1950

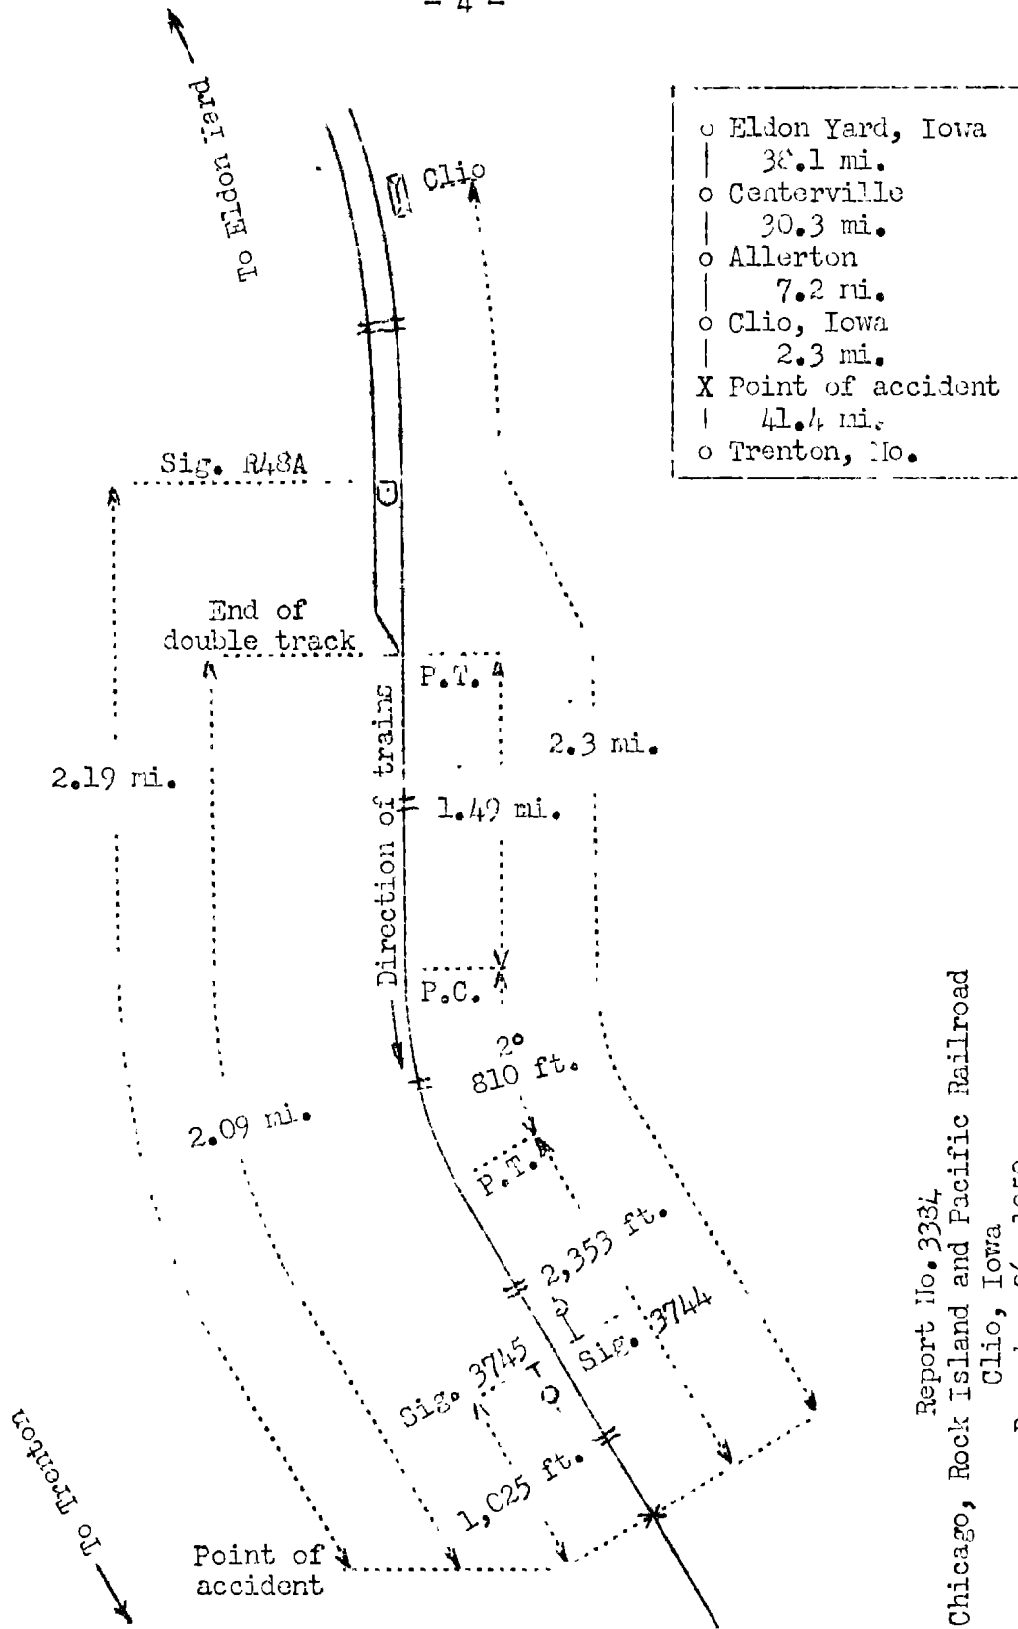
Report No. 3334
 Chicago, Rock Island and Pacific Railroad
 Clio, Iowa
 December 26, 1950

This accident occurred on that part of the Missouri-Kansas Division extending between Eldon Yard, Iowa, and Trenton, Mo., 119.3 miles. Between Allerton and Clio, Iowa, located, respectively, 68.4 miles and 75.6 miles west of Eldon Yard, this is a double-track line, over which trains are operated in either direction on either track by signal indications. Between Clio and Tindall, Mo., 113.7 miles west of Eldon Yard, it is a single-track line, over which trains are operated by signal indications. Between Allerton and Clio the main tracks are designated from south to north as south track and north track. The accident occurred on the main track at a point 2.09 miles west of the end of double track at Clio. Westward from the end of double track there are, in succession, a tangent 1.49 miles in length, a 2° curve to the left 810 feet, and a tangent 2,553 feet to the point of accident and a considerable distance westward. The grade for west-bound trains is, successively, 0.35 percent ascending 900 feet, level 400 feet, 0.18 percent descending 400 feet, and 0.96 percent descending 200 feet to the point of accident.

Semi-automatic signal R48A, governing west-bound movements from the south track to the single track at Clio, and automatic signal 3745, governing west-bound movements on the single track, are located, respectively, 2.19 miles and 1,025 feet east of the point of accident. Signal R48A is a dwarf signal of the color-light type, and is continuously lighted. Signal 3745 is of the color-light type, and is approach lighted. Each signal displays three aspects. Aspects applicable to this investigation and the corresponding indications and names are as follows:
