## INTERSTATE COMMERCE COMMISSION

Ex Parte No. 173

ACCIDENT AT WOODBRIDGE, N. J.

Accident at Woodbridge, N. J., on February 6, 1951, caused by excessive speed on a curve of a temporary track.

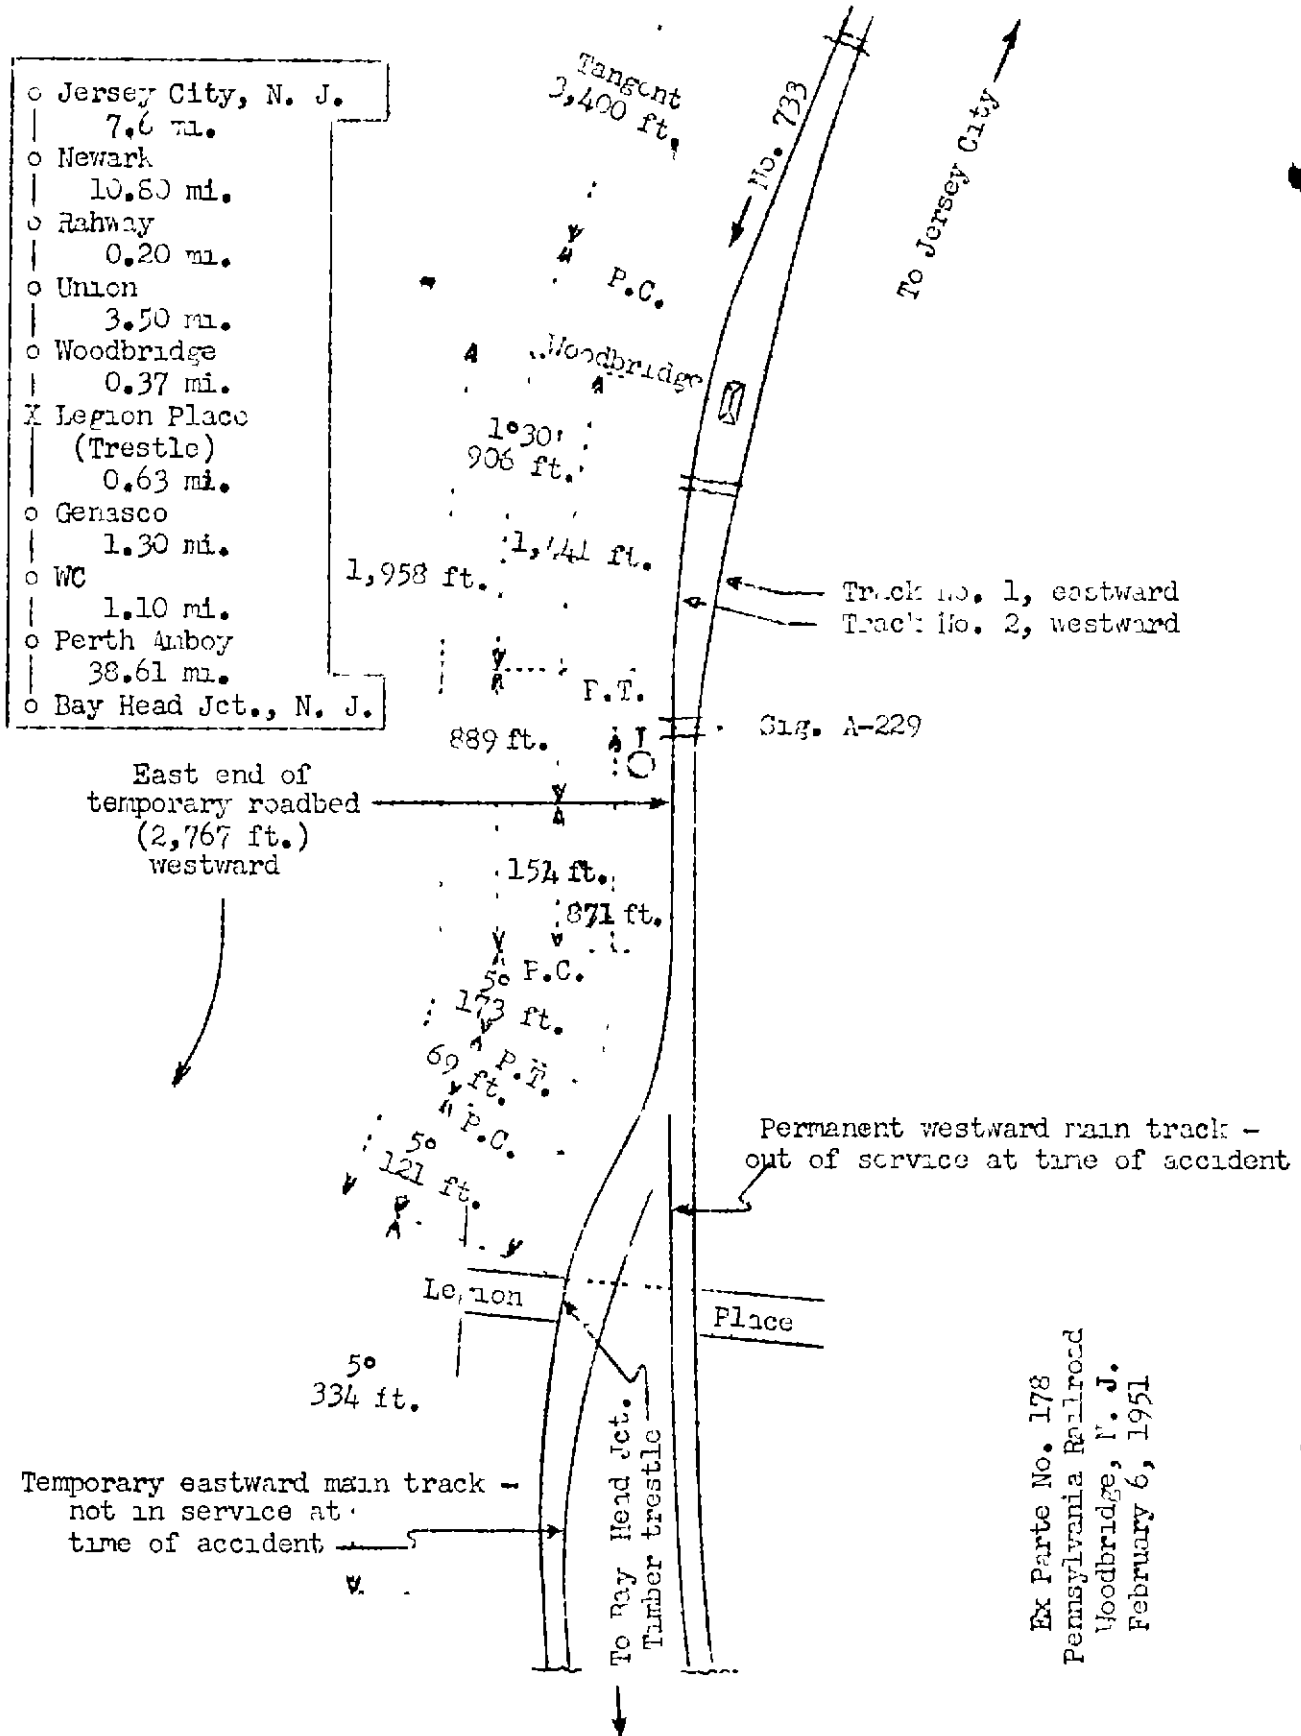
Ex Parte No. 178  
 Pennsylvania Railroad  
 Woodbridge, N. J.  
 February 6, 1951

Location of Accident and Method of Operation

Examination of the track after the accident occurred disclosed no indication of dragging equipment. The track structure on the first curve of the temporary track was displaced to the south a maximum distance of 6-1/2 inches. At a point about 72 feet east of the east end of the trestle, the north rail was pulled apart at a rail joint. From this point westward the track was destroyed throughout a distance of about 275 feet. The track structure on the trestle was displaced to the outside of the curve and clear of the trestle. The north batter pile of the westerly bent of the trestle was broken, the north ends of the caps were splintered and cut, the two outside stringers on the north side of the trestle

The track on the curve to the right which was displaced a maximum of 6-1/2 inches was ballasted with crushed stone to a depth of 18 inches. On each side of the trestle the track on the curve on which the accident occurred was ballasted with cinders to a depth of 12 inches. Chafe marks on the upper south edge of the south stringer of the trestle indicated that the dapped bridge ties had been pulled laterally to the north. However, no such marks appeared throughout a distance of about 6 feet immediately west of the east end of the trestle. The engineer testified that the engine seemed to slip to one side in the vicinity of the trestle, and it was his opinion that the tender was the first unit to become derailed. The damage to the equipment of No. 733 and the locations of the units after the derailment occurred indicate that the speed was about 50 miles per hour when the accident occurred. Both the conductor and the flagman testified that they did not notice any reduction in speed immediately before the derailment occurred. It is apparent that the track structure immediately east of the east abutment of the trestle was displaced to the outside of the curve and also was depressed in the cinder ballast by the engine of No. 733. When the engine was closely approaching the trestle, the lateral force on the track toward the outside of the curve was transmitted ahead of the engine-truck wheels to the track structure on the trestle through the track rails. The absence of chafe marks on the south stringer immediately west of the east abutment indicates that the first ties were raised, probably, by the fulcrum action of the concrete abutment, sufficiently to permit their lateral movement on the stringers. After the lateral movement of the track was started at the east end of the trestle, the 1/2-inch daps in the ties did not afford sufficient resistance to prevent the lateral movement of the track throughout the length of the trestle. The fact that the engine continued in line with the track a distance of about 280 feet west of the trestle indicates that it was not entirely derailed until after it crossed the trestle. However, the track evidently was a considerable distance

out of alignment when the engine passed the west abutment. With the track in normal alignment, the drawbar and the safety bar between the engine and the tender, which were 41 inches long, would have prevented the tender from moving laterally a sufficient distance to strike the abutment. After the track shifted laterally on the stringers, it did not afford sufficient support for the train, and the general derailment followed.

On the temporary track on which this accident occurred, a super-elevation of only 1 inch was provided on the 5-degree curves because of the limited space available for the construction of spirals to the curves. The track structure on the approach to the trestle was ballasted with cinders to a depth of about 12 inches and it was necessary to raise the track about 1/2 inch after the third train passed over it, at which time the ballast was shovel-tamped. Cinder ballast does not provide the same resistance against lateral forces exerted against the track structure nor does it distribute vertical loads to the sub-grade as does stone ballast. Two consulting civil engineers, specializing in bridge design and construction, testified that they examined the plans for the construction of the trestle at Woodbridge and that the design was adequate for the service for which the trestle was intended. They were familiar with the specifications of the American Railway Engineering Association which provide that every third tie be anchored to the stringer by boat spikes extending through the tie and about 4 inches into the stringer. It was the opinion of each that the dapping of bridge ties, which is standard practice on the Pennsylvania Railroad, provides greater resistance to lateral thrusts on the track structure than does the anchoring of every third tie by boat spikes. However, this type of construction, especially on curves, requires that the track immediately in approach of the trestle be maintained within close limits, both in alignment and surface, to insure that abnormal lateral thrusts are not exerted against the track structure at the abutment.

It is found that this accident was caused by excessive speed on a curve of a temporary track.

We recommend that the Pennsylvania Railroad Company install an automatic train-control system, in accordance with their public announcement, and that it first install such system on its New York Division where such system will automatically and continuously enforce a speed restriction of not exceeding 20 miles per hour while proceeding through a block occupied by a preceding or opposing train and so arranged that it will enforce, in like manner, a safe speed under temporary conditions similar to those which existed at Woodbridge when this accident occurred. We further recommend that the carrier provide adequate warning signs to indicate to engineers the limits of temporary speed restriction areas on its line unless such restricted areas are protected by automatic train-control.
