INTERSTATE COMMERCE COMMISSION

REPORT OF THE CHIEF OF THE DIVISION OF SAFETY COVERING HIS INVESTIGATION OF AN ACCIDENT WHICH OCCURRED ON THE NEW YORK CENTRAL RAILROAD NEAR AMHERST, OHIO, MARCH 29, 1916

APRIL 25, 1916

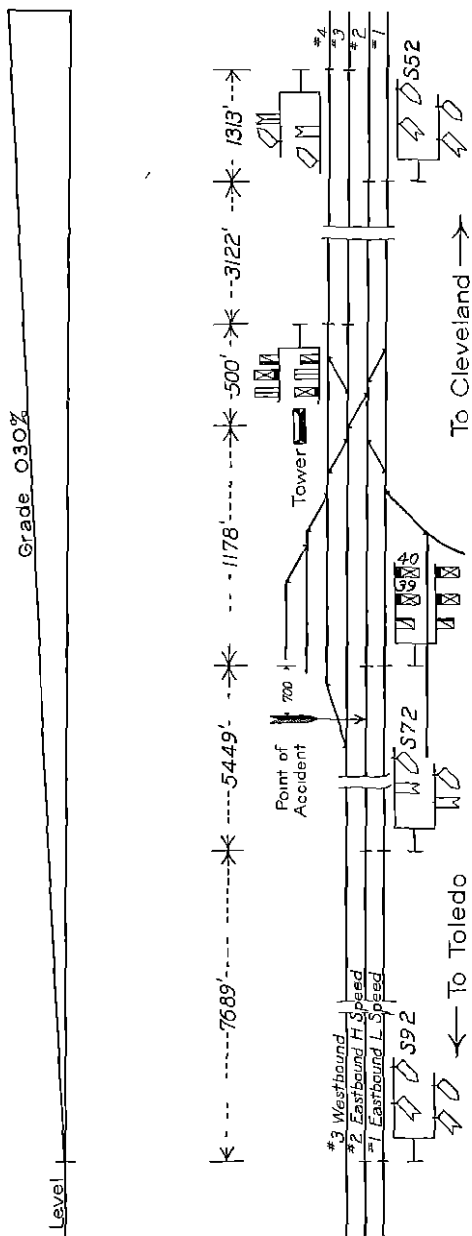
ILLUSTRATION No 1 —Diagram showing track layout and signal locations in vicinity of accident

The accident occurred on the Toledo Division of the New York Central Railroad at a point about 1 mile west of Amherst, Ohio. The line at this point has three main tracks, and the general direction is east and west. The tracks numbered from north to south are 3, 2, and 1, track 3 being used by westbound trains, track 2 by high-speed and track 1 by low-speed eastbound trains. The movement of trains is governed by time-table and an automatic block signal system. The signals governing eastbound movements over this line are located on the south side of the track on bracket poles, the right-hand doll, or short mast, carrying the signals for track 1, those for track 2 being on the left-hand doll, the arrangement of tracks and locations of signals being shown by the accompanying diagram.

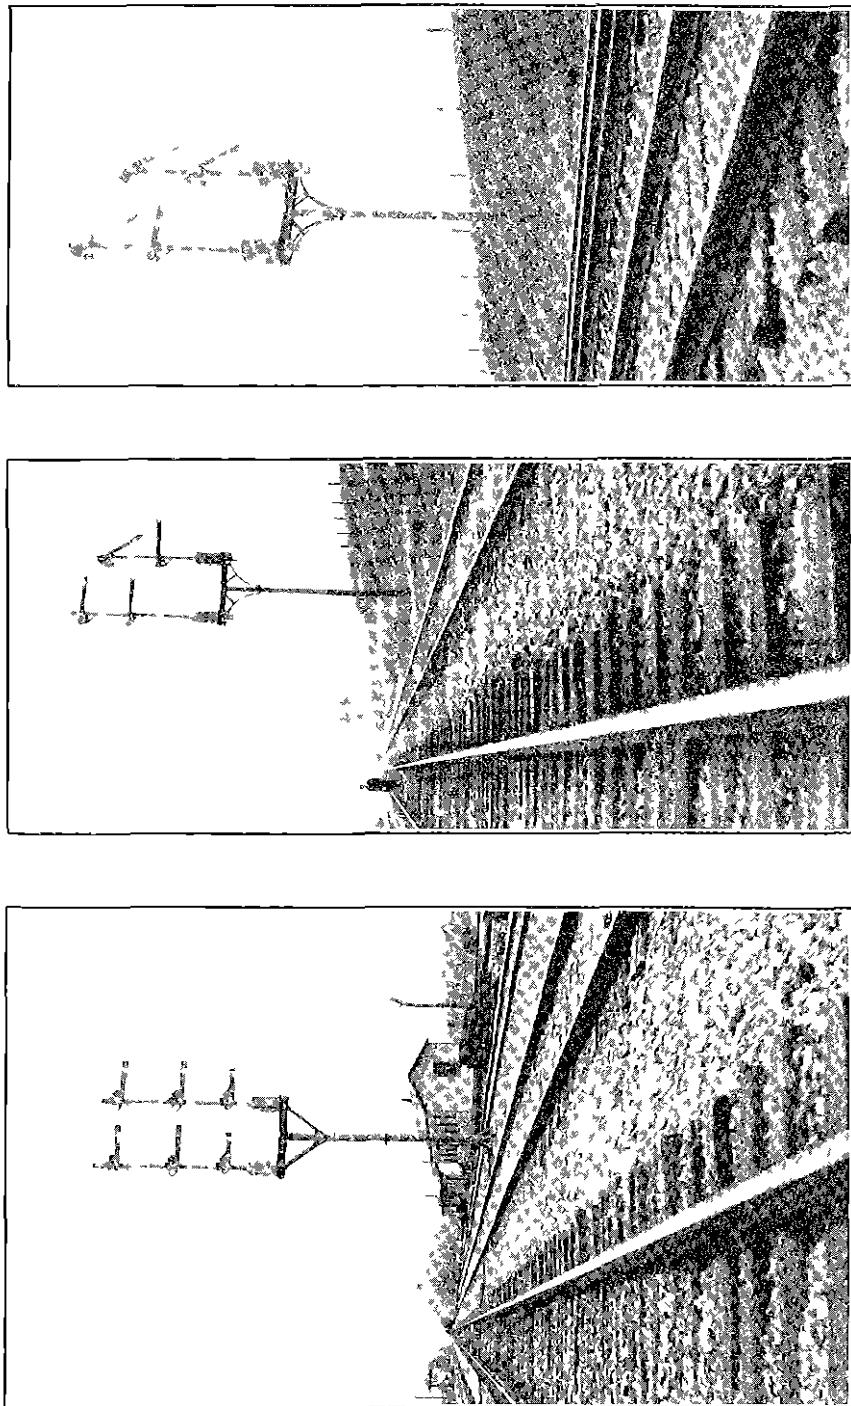
ILLUSTRATION No. 2.—Home interlocking signal with all arms in normal position, two views of automatic signals displaying stop and caution indications for track 2

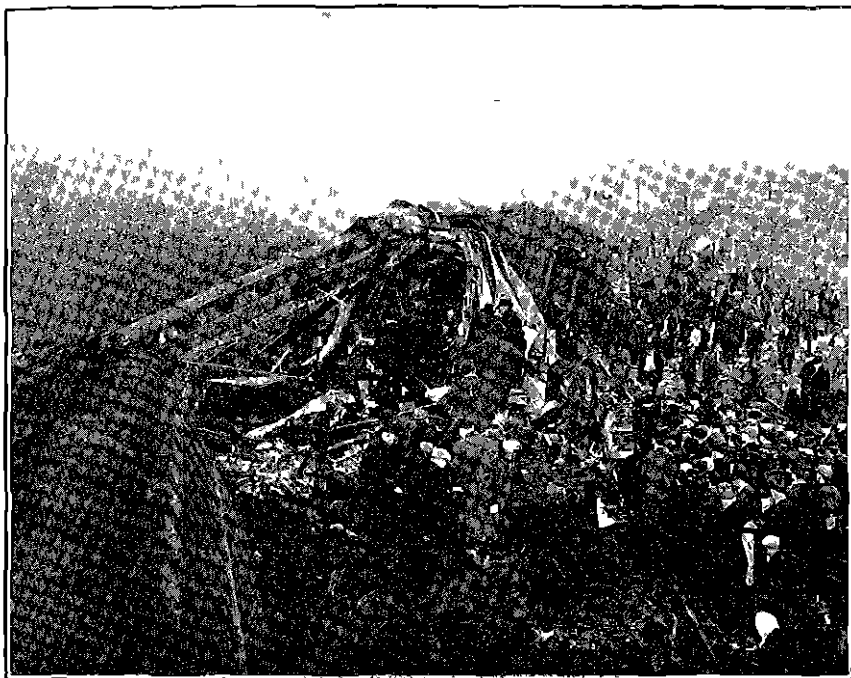
The locomotive of train No 25 practically cut the club car in two, forcing one end of it westward, and through the superstructure of the steel coach, destroying the entire superstructure of the coach.

Train No 25 was derailed by the collision with the club car, the train continued on the roadbed, overturning several of the cars in train second No 86, finally coming to a stop with its locomotive about 700 feet west of the point where it first struck the club car. The locomotive and the first seven cars of train first No 86 and the two rear cars of train second No 86 remained upon the rails and were practically undamaged. The condition of the wreckage indicates that

ILLUSTRATION No 3 —General view of wreck, looking west

the greatest damage and loss of life was caused by train No 25 colliding with the wreckage. Illustration No 3 is a general view of the wreck.

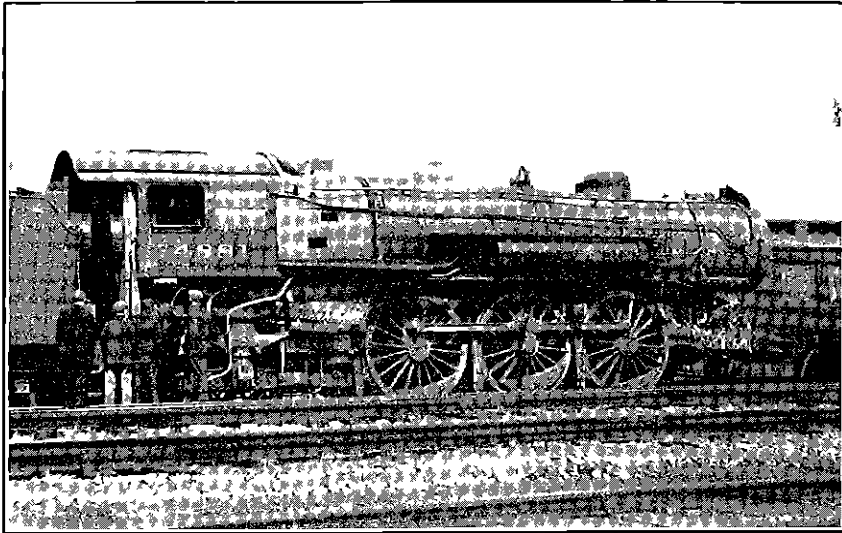
It is to be noted that the rear car of train first No. 86, in which all but two of the fatalities occurred, was a modern steel car built in 1914. It is thought that the collision between trains first and second No. 86 resulted in no great damage to this car, and that but few passengers were killed in this collision. It is believed that when train No. 25 struck the wooden club car, with steel underframe ends, the force of the impact carried one of these steel end castings length-

wise through the steel superstructure of coach 874, causing the greater number of deaths and serious injuries

ILLUSTRATION No 4—Showing damaged condition of locomotive 4881 of train second No 86 after removal from wreckage

This conclusion is borne out by the fact that, as shown in illustration No 4, locomotive 4881, hauling train second No 86, was not seri-

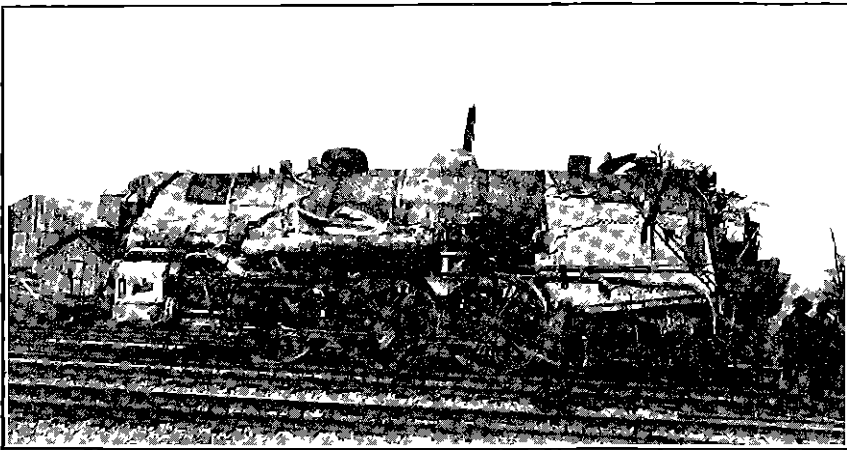
ILLUSTRATION No 5—Showing damaged condition of locomotive 4813 of train No 25 after removal from wreckage

ously damaged, by illustration No 5, showing the seriously damaged condition of locomotive 4813, hauling train No 25, and by the further
