REPORT NO. 3567
ILLINOIS CENTRAL RAILROAD COMPANY
IN RE ACCIDENT
AT VAN BUREN STREET,
CHICAGO, ILL., ON
APRIL 25, 1954

Accident at Van Buren Street, Chicago, Ill., on
April 25, 1954, caused by failure to operate
the following train in accordance with
special instructions governing movements at
designated points within yard limits.

Report No. 3567
 Illinois Central Railroad
 Van Buren St., Chicago, Ill.
 April 25, 1954

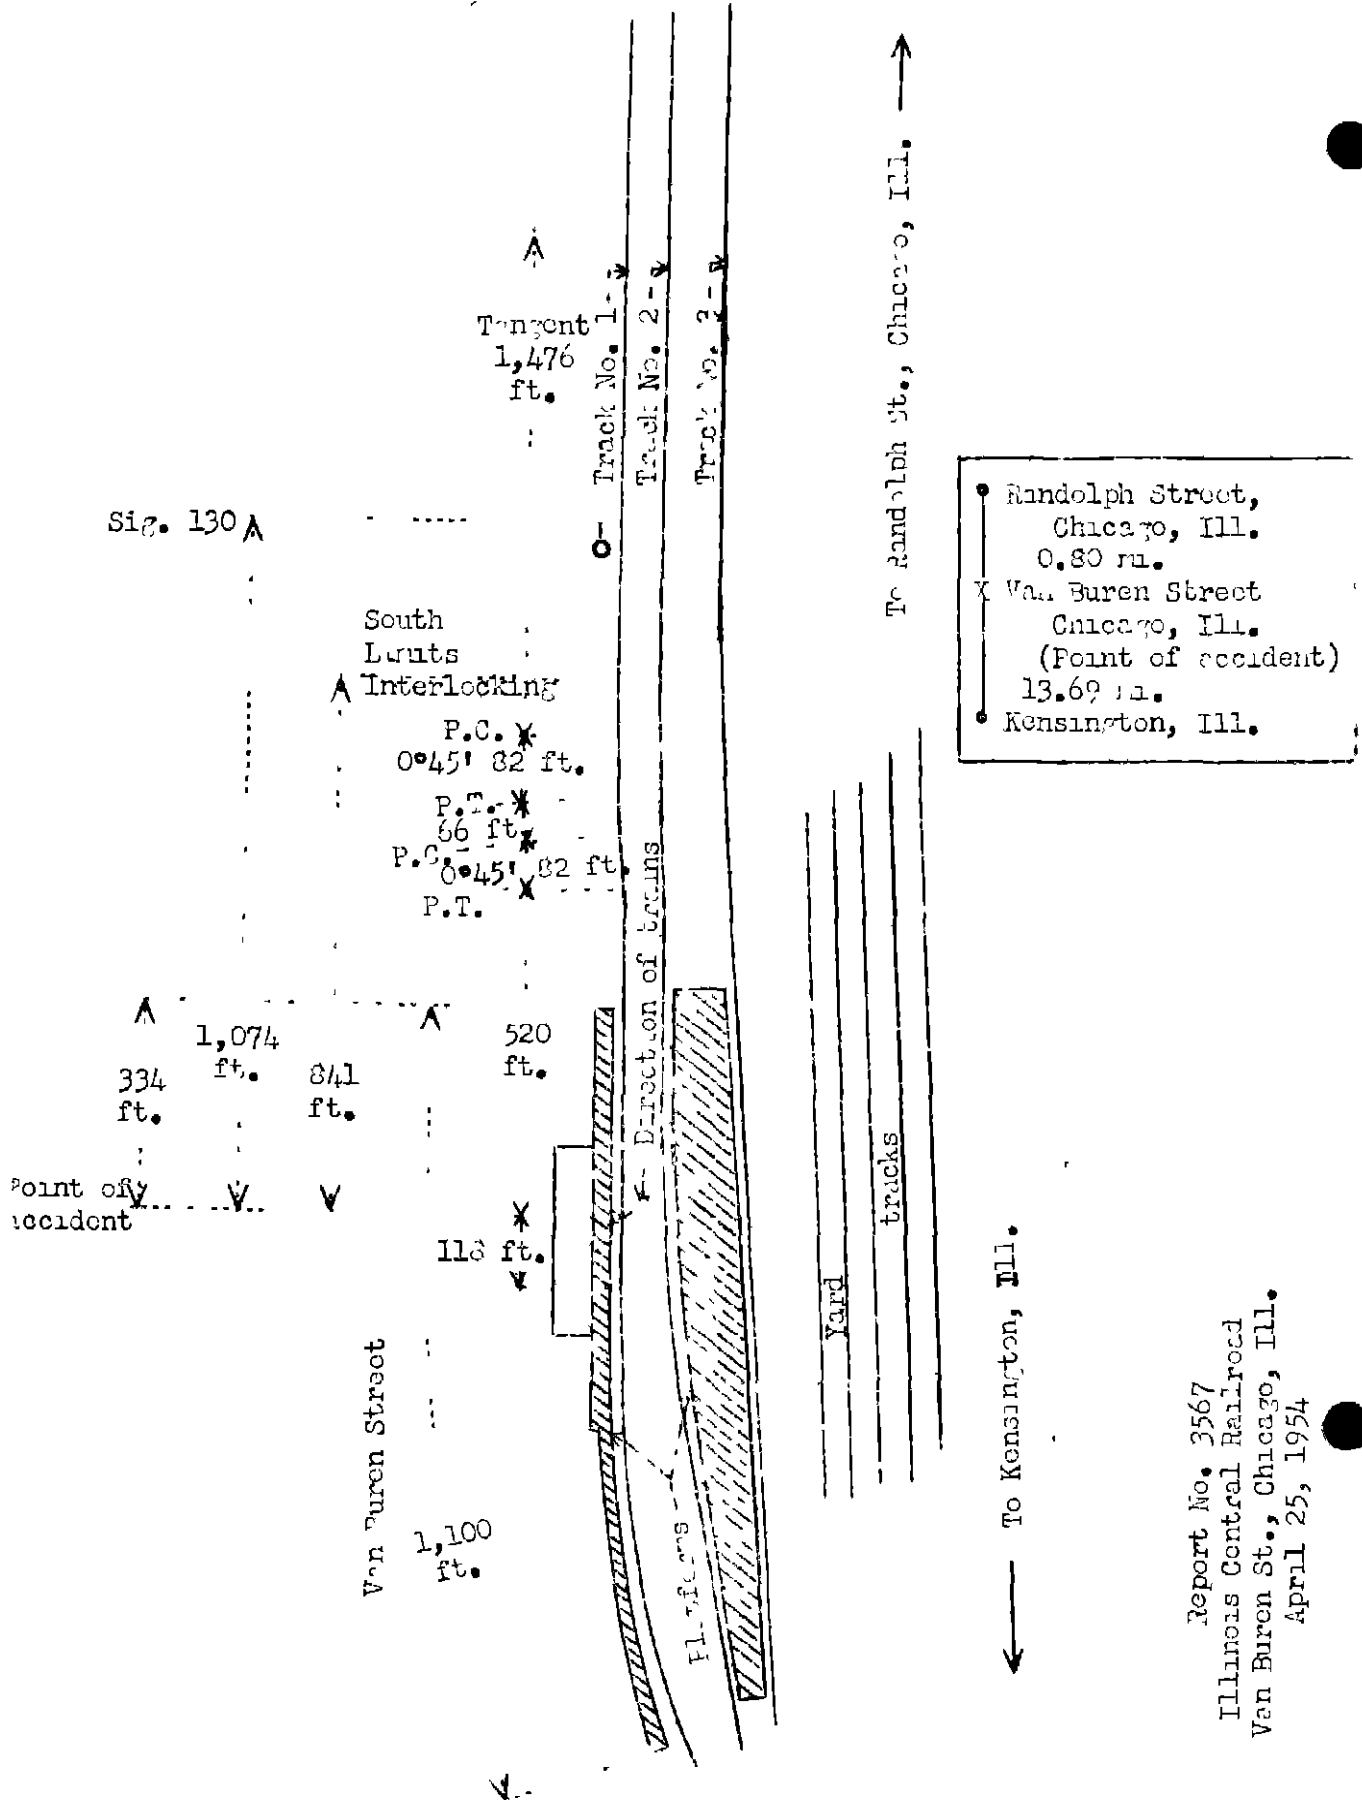
This accident occurred on that part of the Chicago Terminal Division extending between Randolph Street, Chicago, and Kensington, Ill., 14.49 miles. Trains of the Chicago, South Shore and South Bend Railroad regularly are operated over this portion of the Illinois Central Railroad. In the vicinity of the point of accident this is a three-track line, over which trains moving with the current of traffic are operated by timetable and operating rules. There is no block system in use in the immediate vicinity of the point of accident. A catenary system is provided for the electric propulsion of trains. From west to east the main tracks are designated as No. 1, southward, and Nos. 2 and 3, northward. Yard limits extend between Randolph Street and 11th Place, 1.15 miles south of Randolph Street, on these tracks. At Van Buren Street, 2,660 feet south of the station at Randolph Street, a platform 1,100 feet long is provided for passenger traffic on track No. 1. This platform is located on the west side of the track. A retaining wall and the station structure extend along the west side of the platform. A canopy type roof is provided. The accident occurred within yard limits on track No. 1 at a point 334 feet south of the north end of the station platform at Van Buren Street. From the north on track No. 1 there are, in succession, a tangent 1,476 feet in length, a 0°45' curve to the left 82 feet, a tangent 66 feet, a 0°45' curve to the right 82 feet, and a tangent 520 feet to the point of accident and 118 feet southward. The grade is level at the point of accident. In the vicinity of Van Buren Street, yard tracks parallel the main tracks on the east.

Interlocking limits extend between Randolph Street and a point 841 feet north of the point of accident. Interlocking signal 130, governing south-bound movements on track No. 1, is located 1,074 feet north of the point of accident. The aspect applicable to this investigation and the corresponding indication and name are as follows:

No. 901, a south-bound first-class Chicago, South Shore and South Bend passenger train, consisted of two electrically propelled passenger units in multiple operation. Both units were of all-steel construction, and both were power units. This train was being operated from unit 28, the first unit of the train. It departed from station track No. 9 of the upper level at Randolph Street at 12:30 a. m., on time, was routed to track No. 1, proceeded to Van Buren Street, and stopped in the vicinity of the center of the station platform to load passengers. It started from this station at 12:32 a. m., on time. A few seconds later, while moving at an estimated speed of 4 miles per hour, the rear end was struck by No. 205 at a point 334 feet south of the north end of the station platform.

No. 205, a south-bound first-class Illinois Central passenger train, consisted of four electrically propelled passenger units in multiple operation. These units were of all-steel construction. The first and third were power units, and the second and fourth were trailers. This train was being operated from the control compartment at the front of unit 1117, the first unit of the train. It departed from station track No. 6 of the lower level at Randolph Street at 12:31 a. m., on time, was routed to track No. 1, passed signal 130, which indicated Restricting, and while moving at a speed of between 10 and 15 miles per hour it struck the rear end of No. 901.

No equipment of either train was derailed. No. 901 stopped with the rear end a few feet south of the point of collision. The rear unit was somewhat damaged, and the other unit was slightly damaged. No. 205 stopped with the front end about 15 feet to the rear of the preceding train. A separation occurred between the second and third units. The front end of the first unit was considerably damaged, the second unit was somewhat damaged, and the other units were slightly damaged.
