INTERSTATE COMMERCE COMMISSION
WASHINGTON

REPORT NO. 3644
CHICAGO UNION STATION COMPANY
IN RE ACCIDENT
AT CHICAGO, ILL., ON
JULY 12, 1955

September 9, 1955

Accident at Chicago, Ill., on July 12, 1955, caused by
failure to operate Extra 16 North in accordance
with a signal indication.

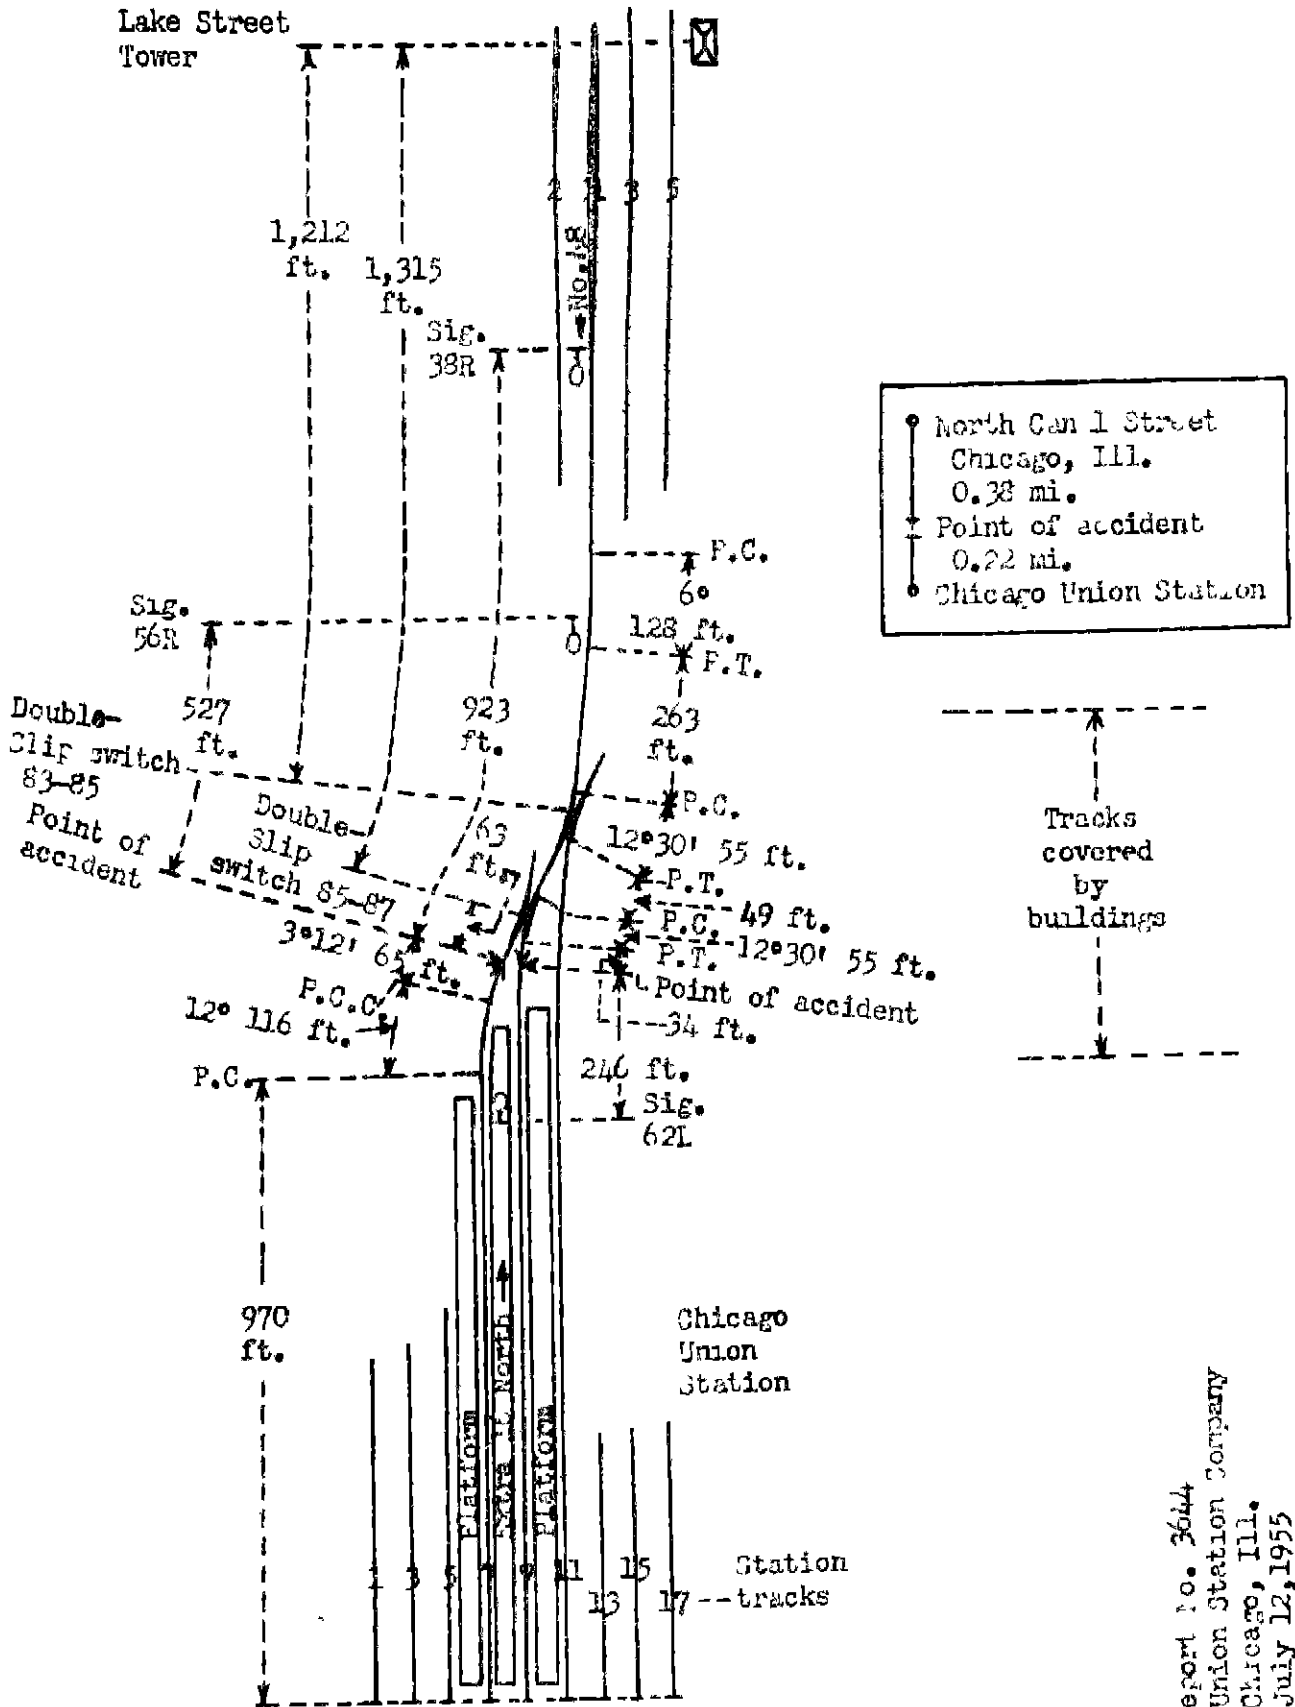
Report No. 3644
 Chicago Union Station Company
 Chicago, Ill.
 July 12, 1955

This accident occurred on that part of the railroad extending between Chicago Union Station and North Canal Street, Chicago, Ill., 0.60 mile. Trains of the Chicago, Milwaukee, St. Paul and Pacific Railroad are regularly operated over this portion of the line of the Chicago Union Station Company. At Chicago Union Station nine stub-end station tracks extend northward from a point a short distance north of the station concourse. These tracks are designated from west to east by odd numbers consecutively as tracks Nos. 1 to 17, inclusive. Tracks Nos. 7 and 9 are each 1,214 feet in length. North of the north ends of the station platforms the station tracks converge with four tracks designated, from west to east, as tracks Nos. 2, 4, 6, and 8. These four tracks converge with a double-track line a short distance south of North Canal Street. Station track No. 11 is in line with track No. 1. A lead track connects with the north ends of station tracks Nos. 7 and 9 at double-slip switch 85-87 and crosses track No. 1 at double-slip switch 83-85. These switches are within the interlocking limits of Lake Street Tower and are located, respectively, 1,315 feet and 1,212 feet south of the interlocking station. The tracks in this vicinity are below street level, and between points approximately 240 feet south and 325 feet north of double-slip switch 85-87 a building and other structures have been erected over the tracks. The accident occurred at a point 26 feet north of the fouling point of station tracks Nos. 7 and 9, and 63 feet south of the center of double-slip switch 85-87. From the south on station track No. 7 there are, in succession, a tangent 970 feet in length, a 12° curve to the right 116 feet, and a 3°12' curve to the right 65 feet to the point of accident. From the north via track No. 1, double-slip switches 85-83 and 87-85, and station track No. 9 there are, in succession, a 6° curve to the right 128 feet in length, a tangent 263 feet, a 12°30' curve to the right 55 feet, a tangent 49 feet, a 12°30' curve to the left 55 feet, and a tangent 34 feet to the point of accident. The grade is 0.85 percent ascending northward at the point of accident.

Semi-automatic signal 62L, governing north-bound movements on station track No. 7, is located 246 feet south of the point of accident. Semi-automatic signals 38R and 56R, governing south-bound movements on track No. 1 and from track No. 1 to station track No. 9, are located, respectively, 923 feet and 527 feet north of the point of accident. These are dwarf signals of the position-light type and are continuously lighted. Signal 62L is located on the west edge of a baggage platform between station tracks Nos. 7 and 9 and is 2 feet 6 inches above the level of the tops of the rails. The aspects of these signals applicable to this investigation and the corresponding indications and names are as follows:
