RAILROAD ACCIDENT INVESTIGATION

Report No 3810

THE NEW YORK CENTRAL RAILROAD COMPANY

JULY 5, 1958

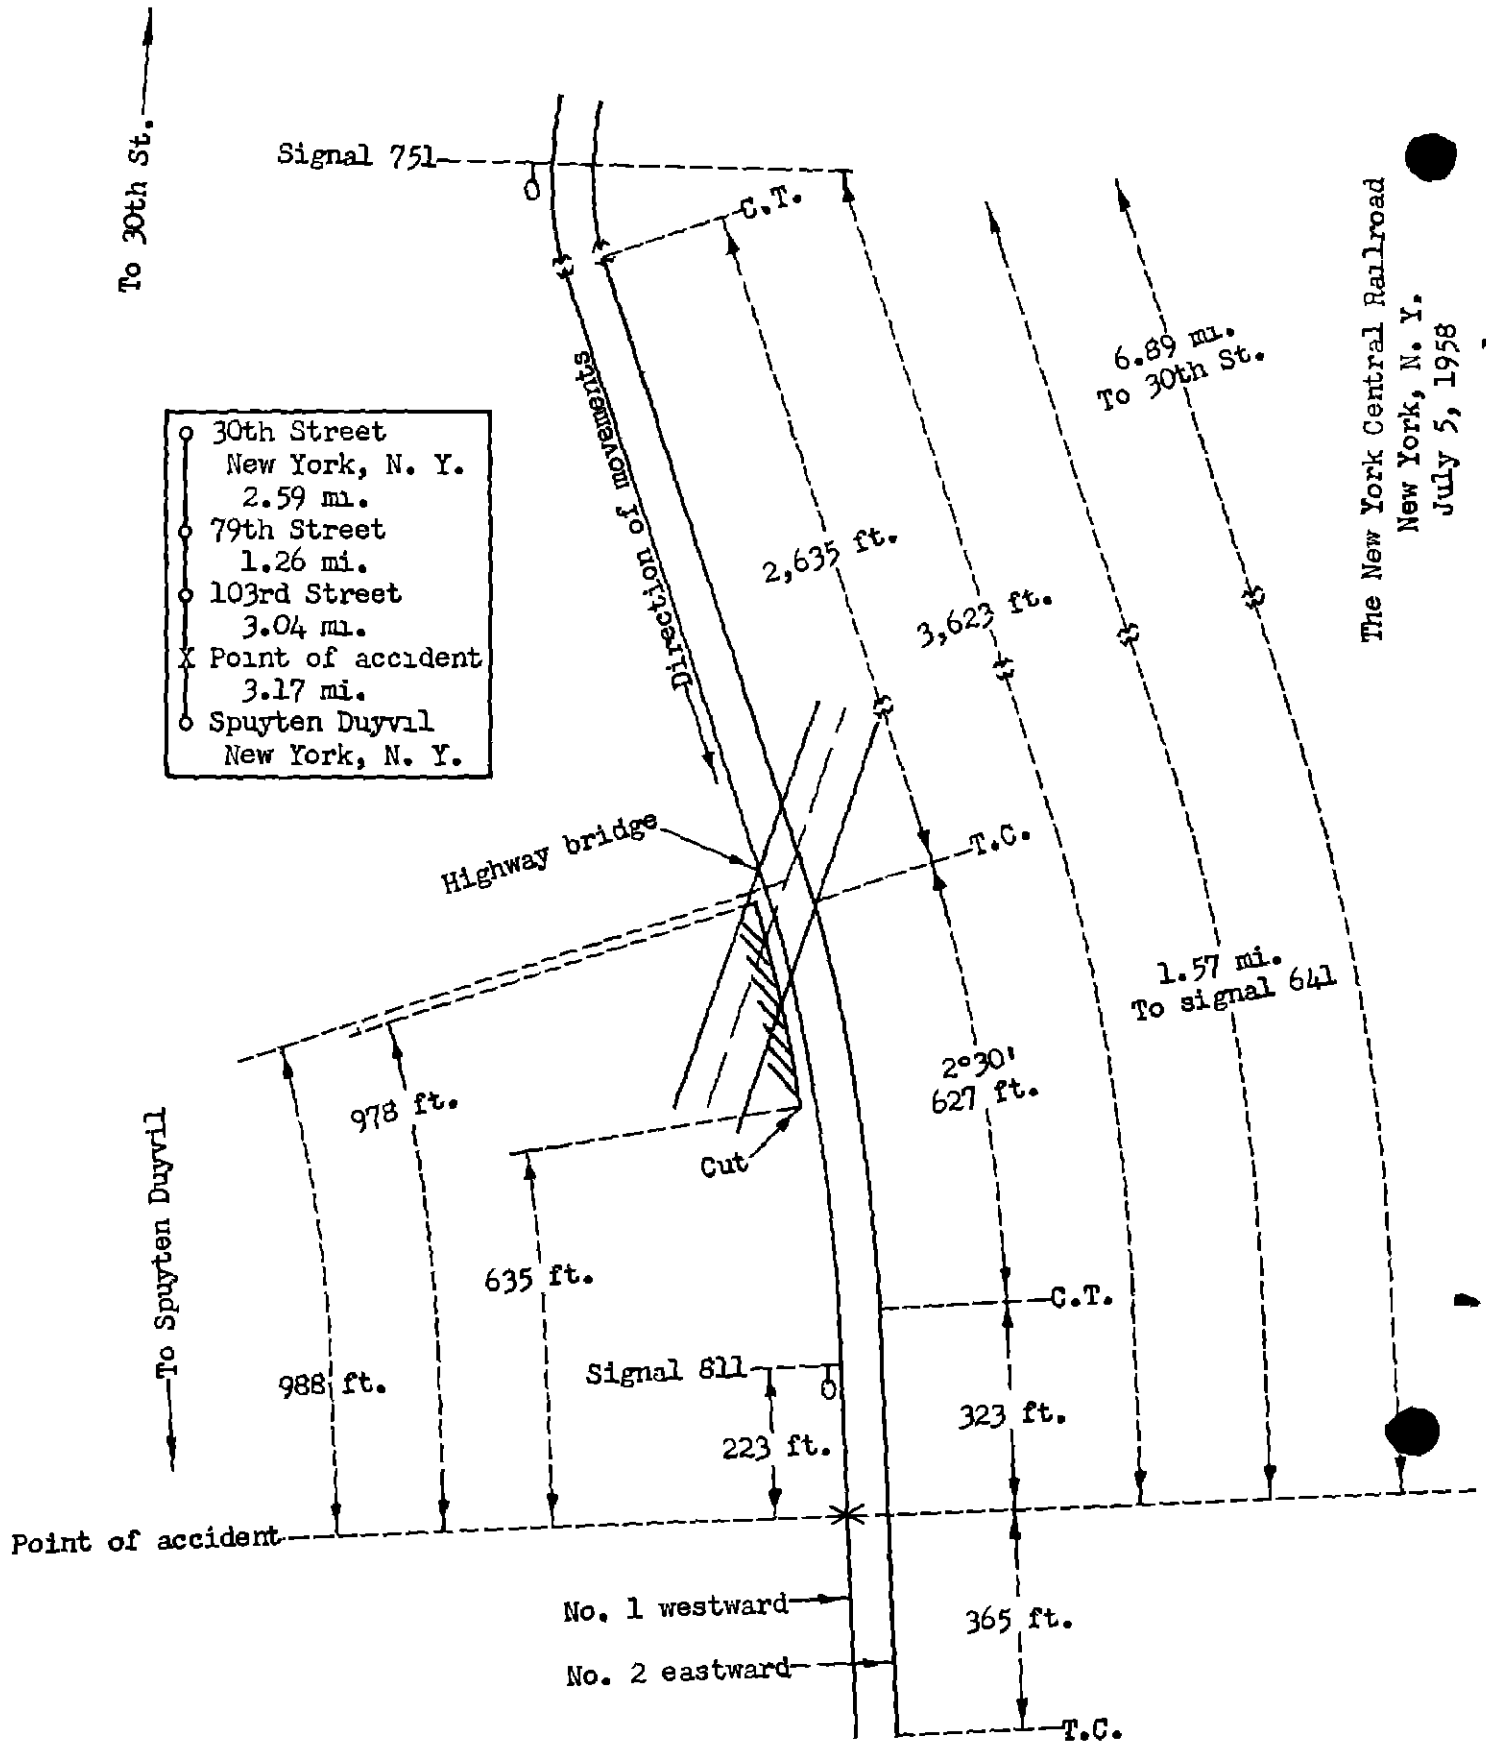
The New York Central Railroad
 New York, N. Y.
 July 5, 1958

A rock cut with a retaining wall at each end is located north of track No. 1. The east end of the easterly retaining wall and the west end of the westerly retaining wall are located, respectively, 978 feet and 635 feet east of the point of accident. A highway bridge spans the main tracks at an angle of approximately 20 degrees. The centerline of the bridge is located 388 feet east of the point of accident. In the vicinity of the point of accident the range of vision is materially restricted by curvature of the track, the rock cut and retaining walls, and the highway bridge.

Automatic signals 641, 751, and 811, governing westbound movements on track No. 1, are located, respectively, 1.75 miles, 3,623 feet, and 223 feet east of the point of accident. These signals are of the searchlight type and are approach lighted. The aspects applicable to this investigation, and the corresponding indications and names are as follows:
