RAILROAD ACCIDENT INVESTIGATION

Report No 3818

THE ERIE RAILROAD COMPANY

SLOATSBURG, N Y

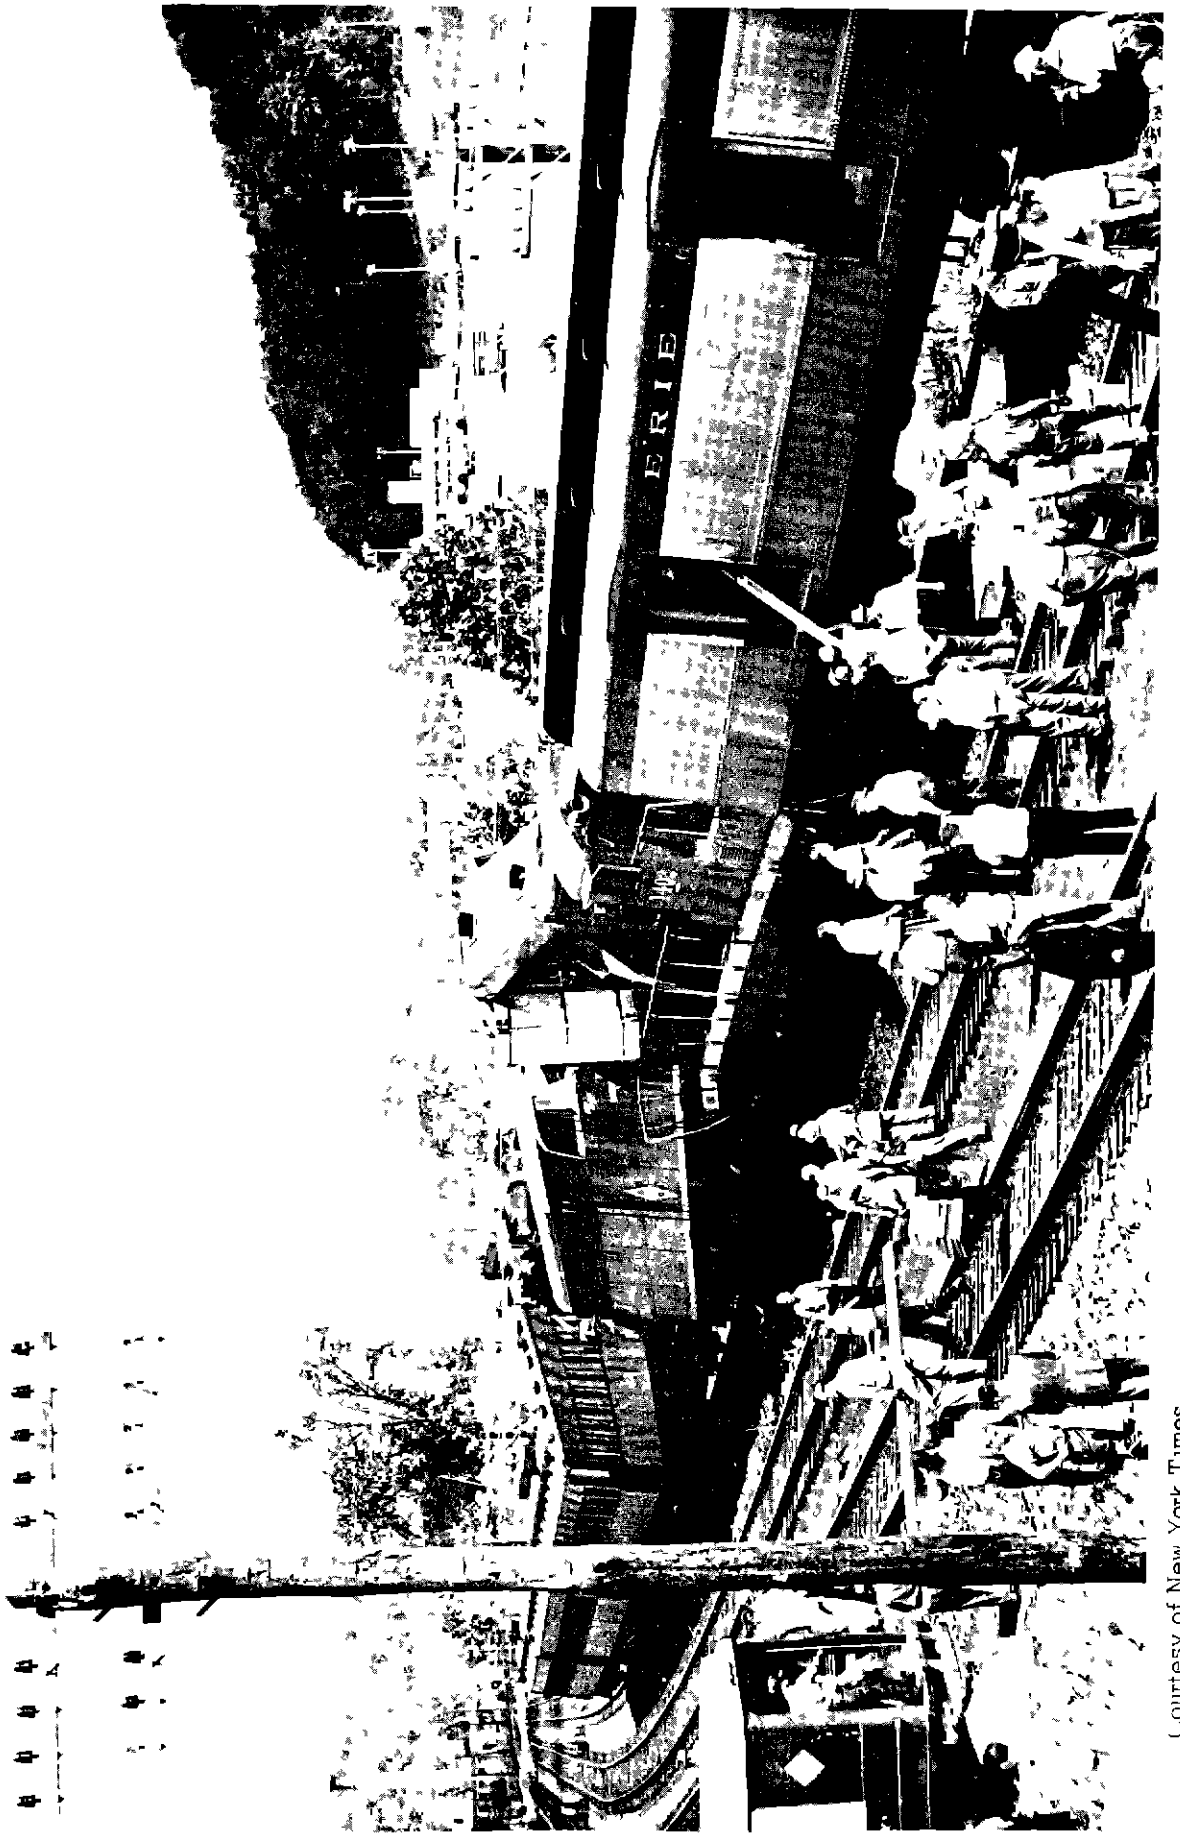
Courtesy of New York Times

The front truck of the diesel-electric unit and the front truck of the first car of No 50 were derailed. The underframe of the diesel-electric unit of No 50 overrode the underframe of the diesel-electric unit of No 53. The superstructure of the diesel-electric unit of No 53 was telescoped throughout a distance of approximately 25 feet. The underframe of the first car of No 50 overrode the underframe of the diesel-electric unit and the superstructure of the car was telescoped throughout a distance of approximately 17 feet. Both diesel-electric units were heavily damaged. The first car of each train was destroyed and the other cars were somewhat damaged.

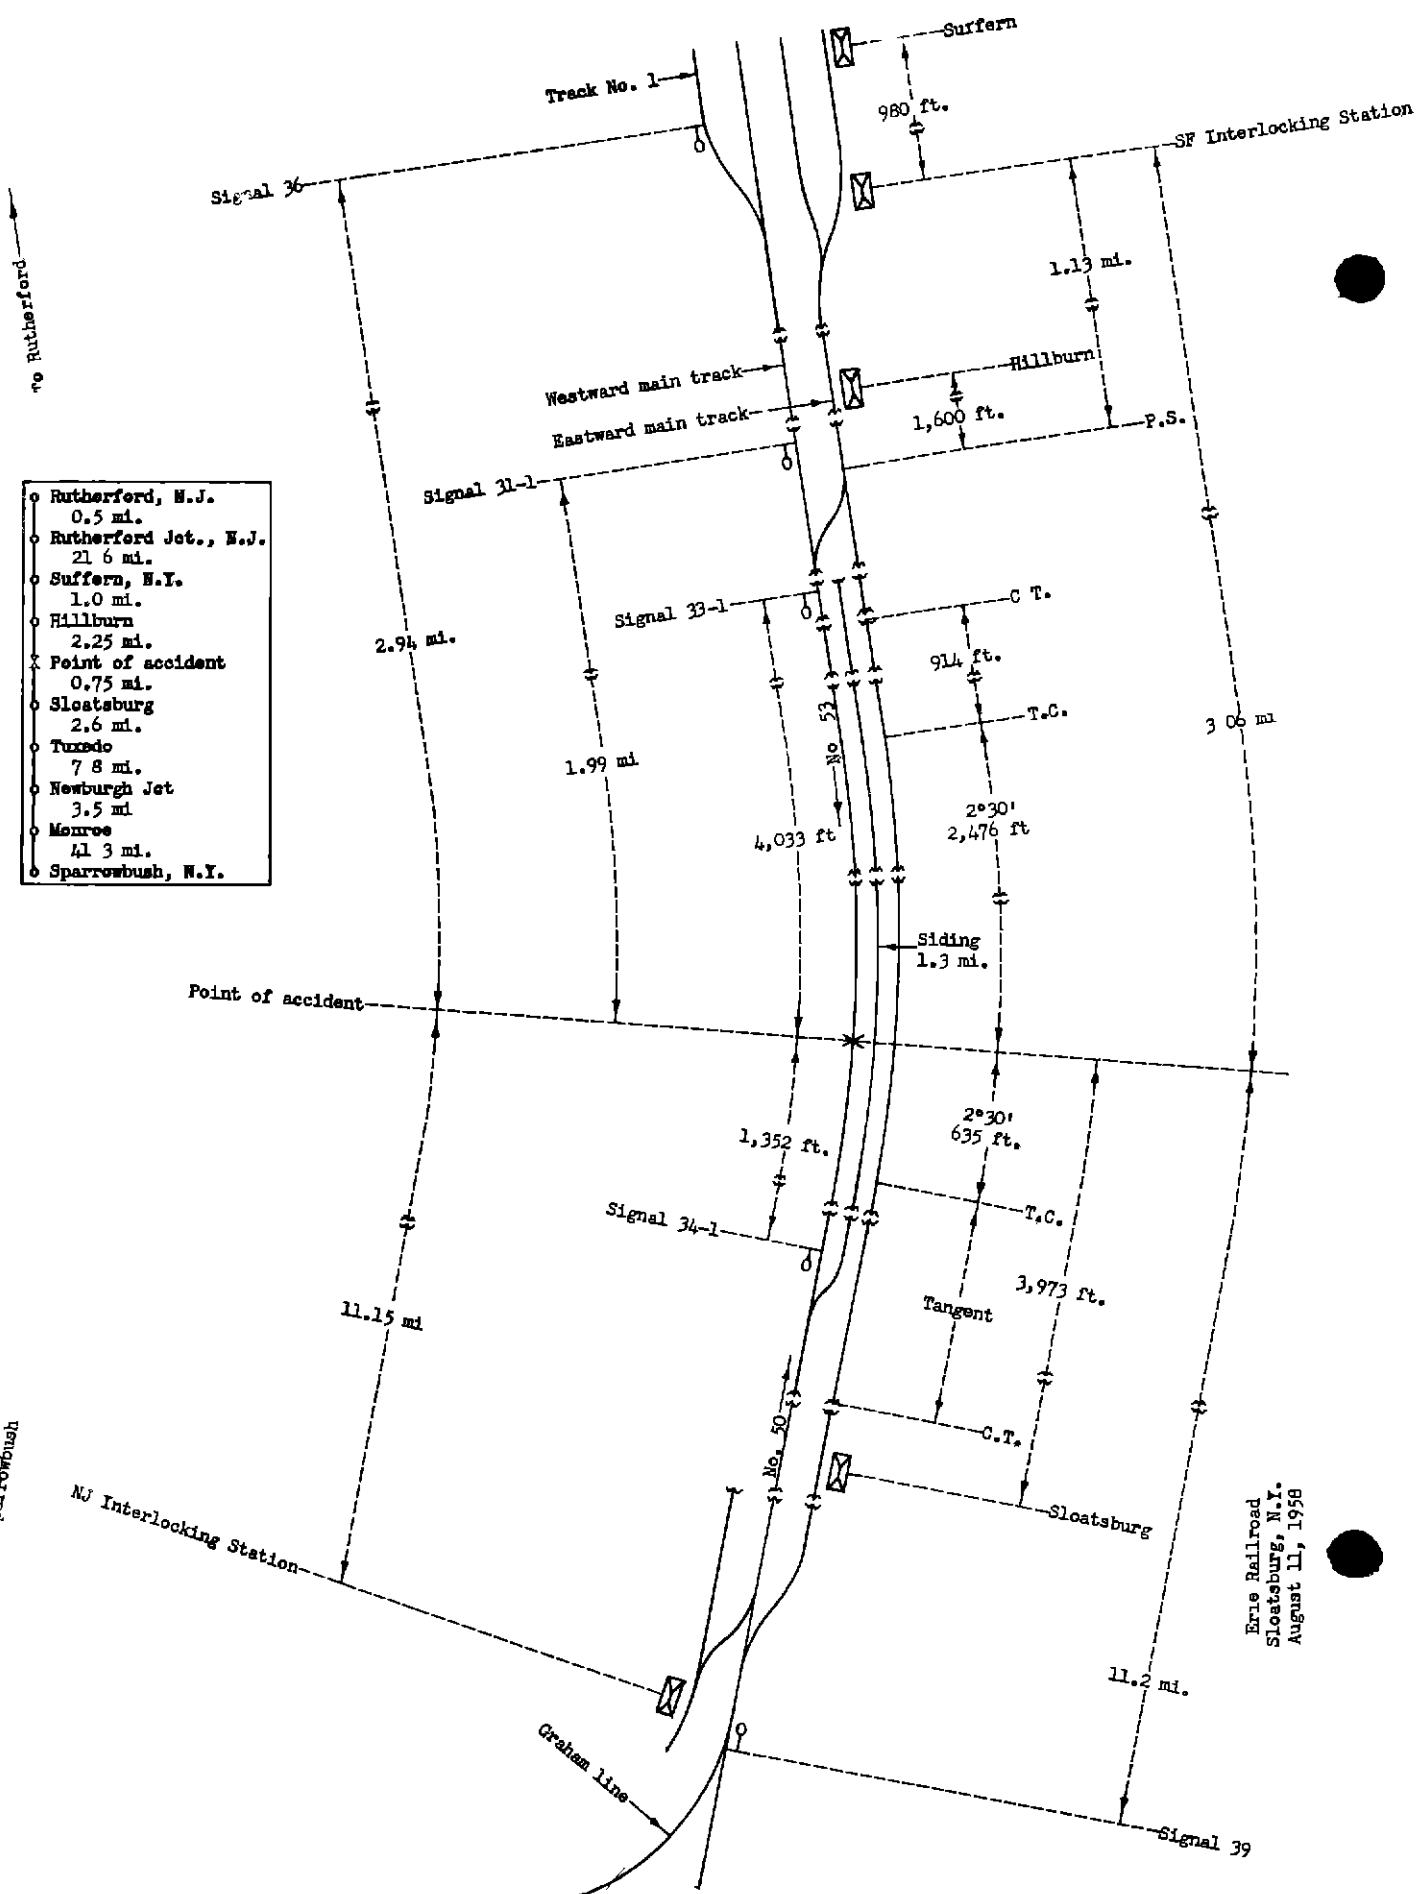
Errie Railroad
Sloatsburg, N.Y.
August 11, 1958

- Rutherford, N.J. 0.5 mi.
- Rutherford Jet., N.J. 21.6 mi.
- Suffern, N.Y. 1.0 mi.
- Hillburn 2.25 mi.
- ✕ Point of accident 0.75 mi.
- Sloatsburg 2.6 mi.
- Tuxedo 7.8 mi.
- Newburgh Jet 3.5 mi.
- Monroe 41.3 mi.
- Sparrowbush, N.Y.
