RAILROAD ACCIDENT INVESTIGATION

Report No 3897

CHICAGO, BURLINGTON AND QUINCY RAILROAD COMPANY

AUGUST 22, 1960

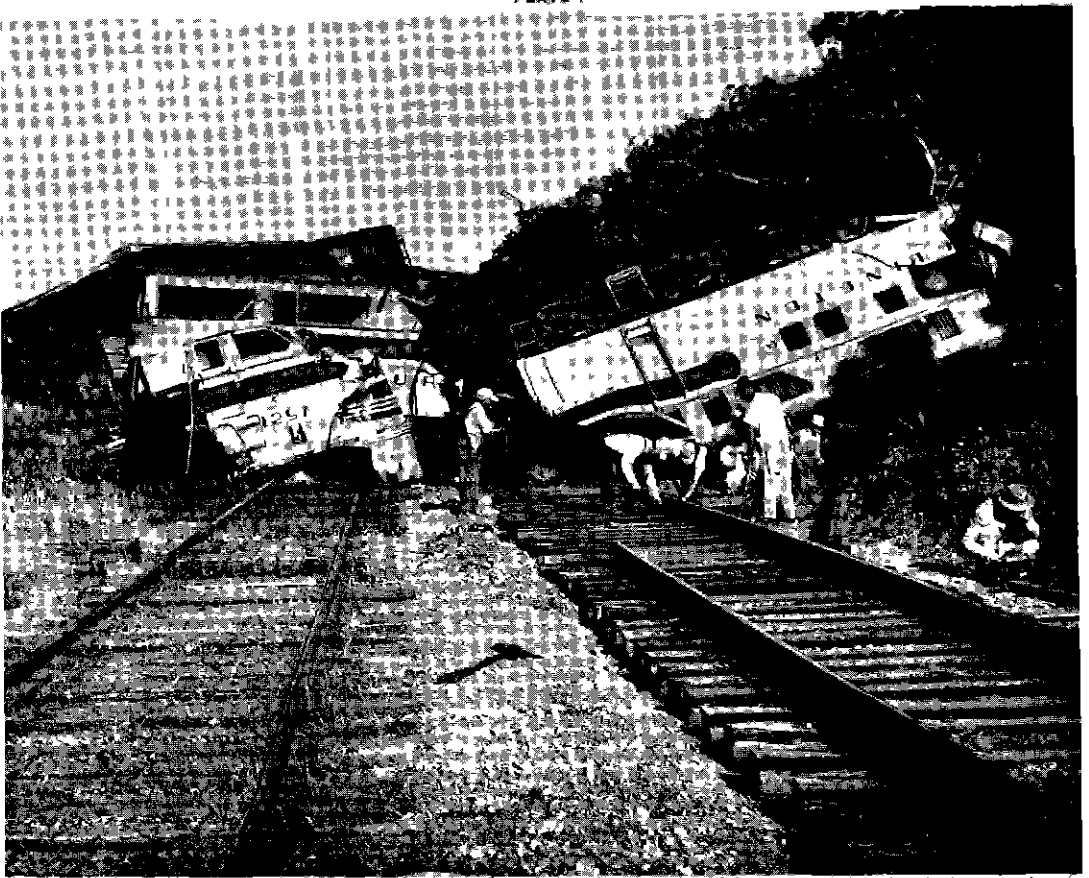
First diesel electric unit of No. 70 shown at right of picture. Torn-off control compartment of this unit is on ground at the left, after having been removed by wrecking operations from top of front end of the locomotive of No. 23. Second unit of the locomotive of No. 70 is shown beyond the torn-off control compartment.

Both diesel-electric units of No 70 and the 1st to the 9th cars, inclusive, were derailed. The 1st unit stopped upside down on the east side of the main track and at right angles to the track structure (PLATE 1). The control compartment at the front end of the locomotive was torn loose from the underframe and stopped on top of the control compartment at the front of the locomotive of No 23. The 2nd unit stopped upright across the main track and the siding, and adjacent to the 1st unit. The derailed cars stopped in various positions on or near the structures of the main track and the siding. The 1st diesel-electric unit was destroyed and the 2nd unit was heavily damaged. Of the derailed cars, 4 were destroyed, 2 were somewhat damaged, 2 were slightly damaged, and 1 was undamaged.

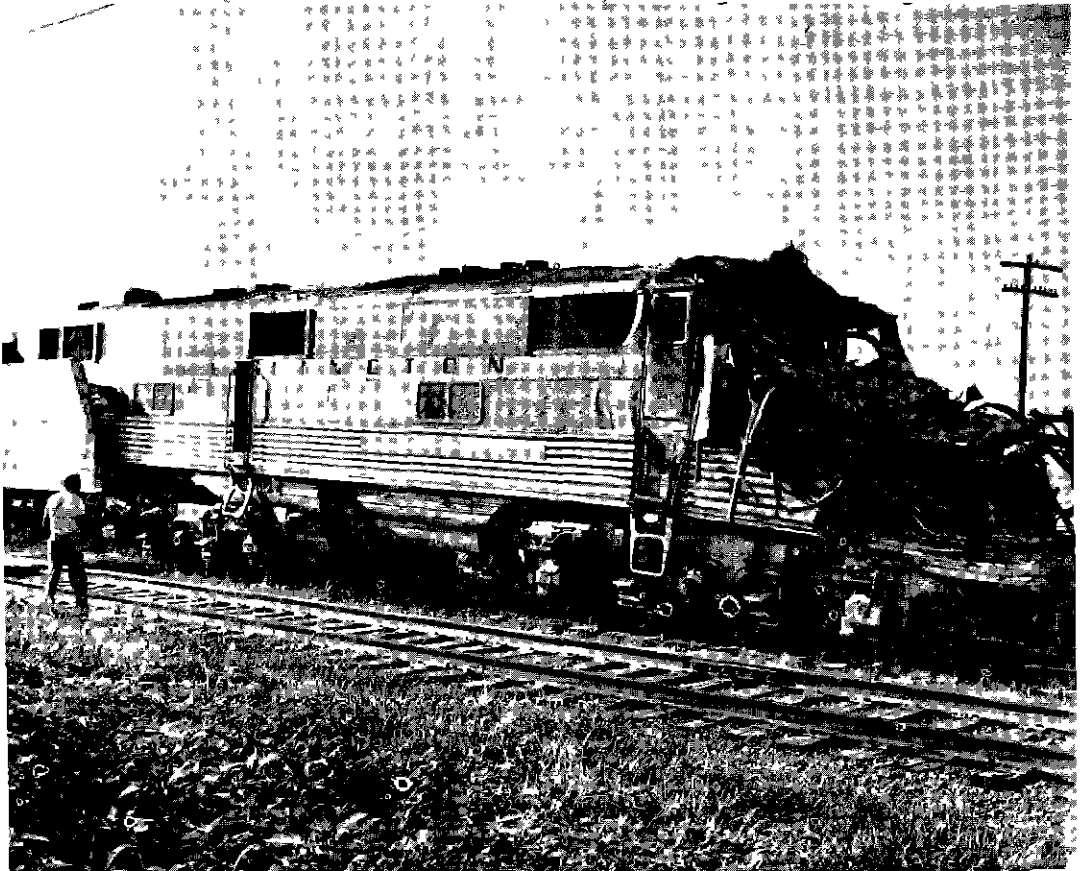
Locomotive of No. 23

No 23 was moved southward approximately 50 feet by the force of the impact. None of the equipment was derailed. The superstructure at the front end of the locomotive was crushed by the front end of No 70 throughout a distance of about 12 feet (PLATE 2). The front end of the 1st car

was telescoped throughout a distance of about 15 feet by the rear end of the locomotive. The locomotive and the 1st car were heavily damaged, the 2nd car was somewhat damaged, and the 3rd and the 5th cars were slightly damaged.
