RAILROAD ACCIDENT INVESTIGATION

Report No 4002

THE PENNSYLVANIA RAILROAD COMPANY

JULY 24, 1963

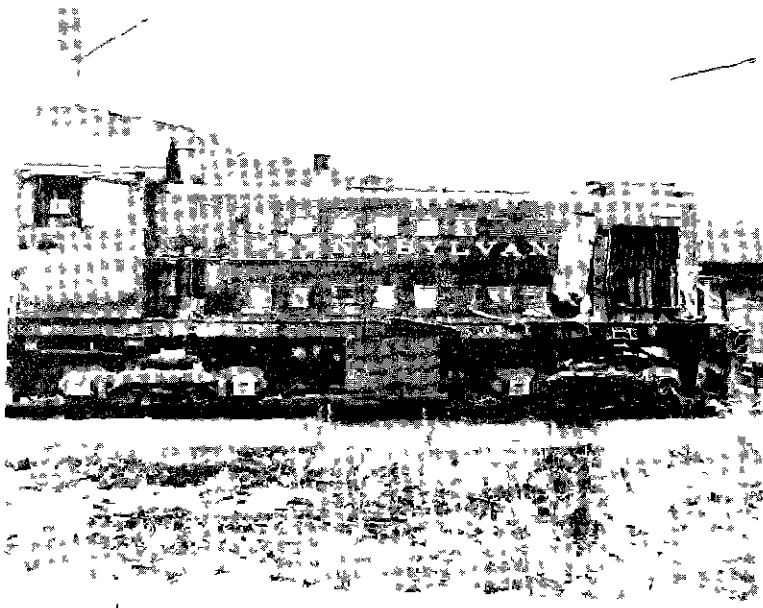
Locomotive 9240 with damaged front end showing at right

No. 3319 stopped on track No. 4 with the front end 148 feet west of the point of accident. There were no separations. The rear wheels of the front truck of the first unit were derailed. The north side of the superstructure of the first three units was torn out as a result of contact with the right side of the front end of locomotive 9240. Two passengers were killed. The conductor, a ticket collector, and 25 passengers were injured.

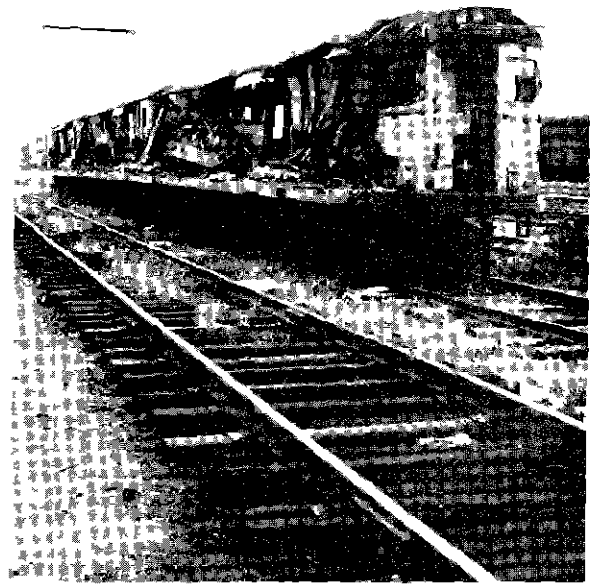
Damage to first three cars of No. 3319

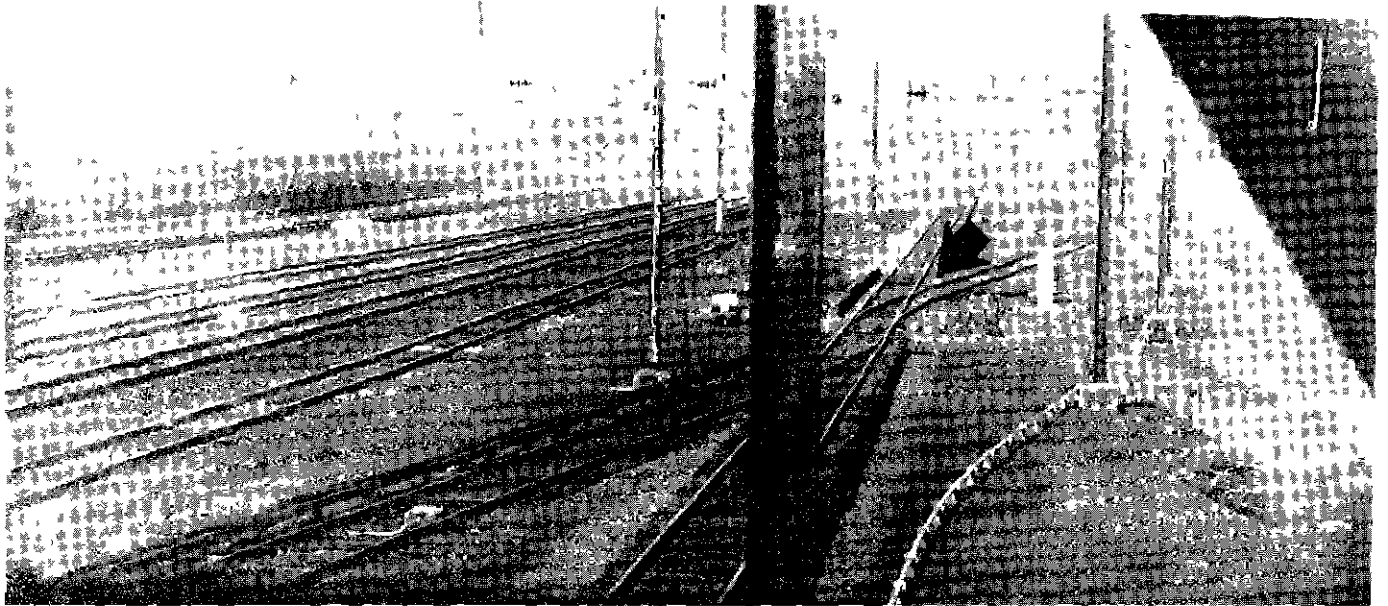
View westward from operator's station at Hudson interlocking. Point of accident marked by arrow at fouling point of tracks No. 4 and No. 8 at right

Examination of the track structure involved revealed that the heads of the rails of track No. 8 between signal 74Rb and switch 77 were heavily coated with rust.
