**RAILROAD ACCIDENT INVESTIGATION**

**Report No 4009**

THE BALTIMORE AND OHIO RAILROAD COMPANY

WEBSTER, IND

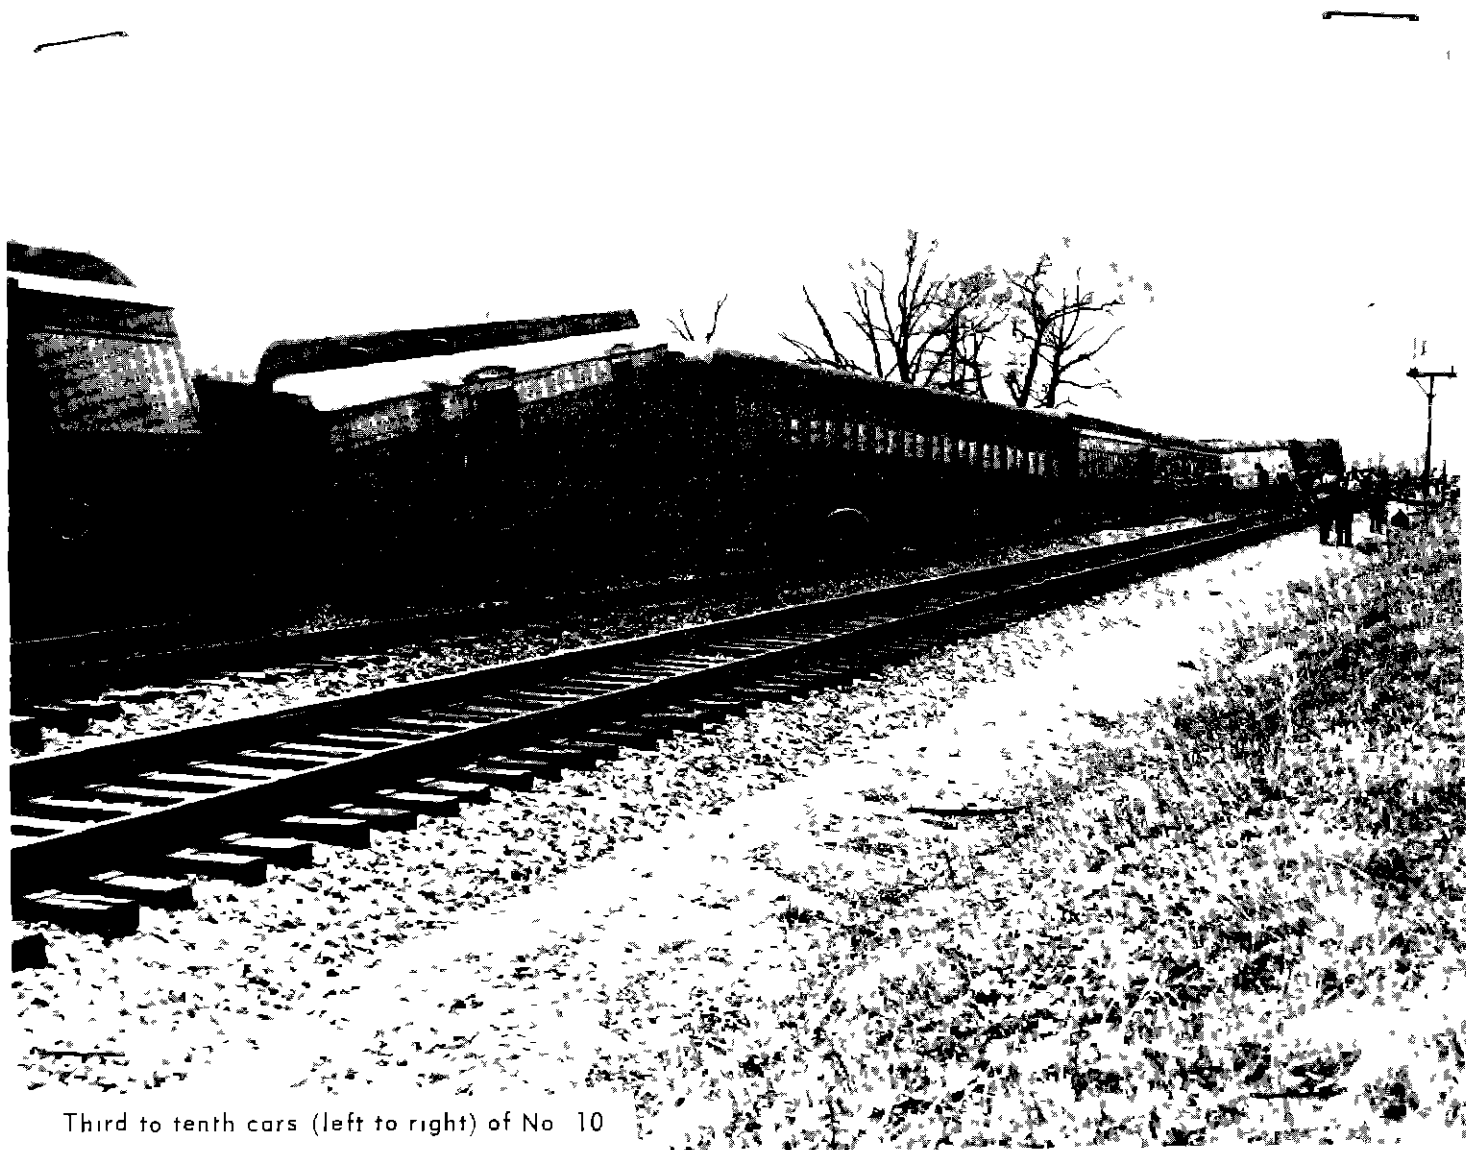
Third to tenth cars (left to right) of No 10

All ten cars of the train derailed at Webster, but the locomotive units were not derailed. A separation occurred between the second and third cars. The locomotive with the first two cars stopped 2,197 feet east of the derailment point. The remaining portion of the train stopped with the front end 573 feet east of the derailment point. The first and second cars, which remained coupled to the locomotive, stopped upright, in leaning positions, on and in line with the structure of track No. 2. The other eight cars derailed to the south and stopped upright, in line, adjacent to or on the structure of track No. 2 as shown in the photograph at the front of this report. The first, second and tenth cars were slightly damaged. The other seven cars were considerably damaged.
