RAILROAD ACCIDENT INVESTIGATION

Report No 4013

THE PENNSYLVANIA RAILROAD COMPANY

ORLEANS, N Y

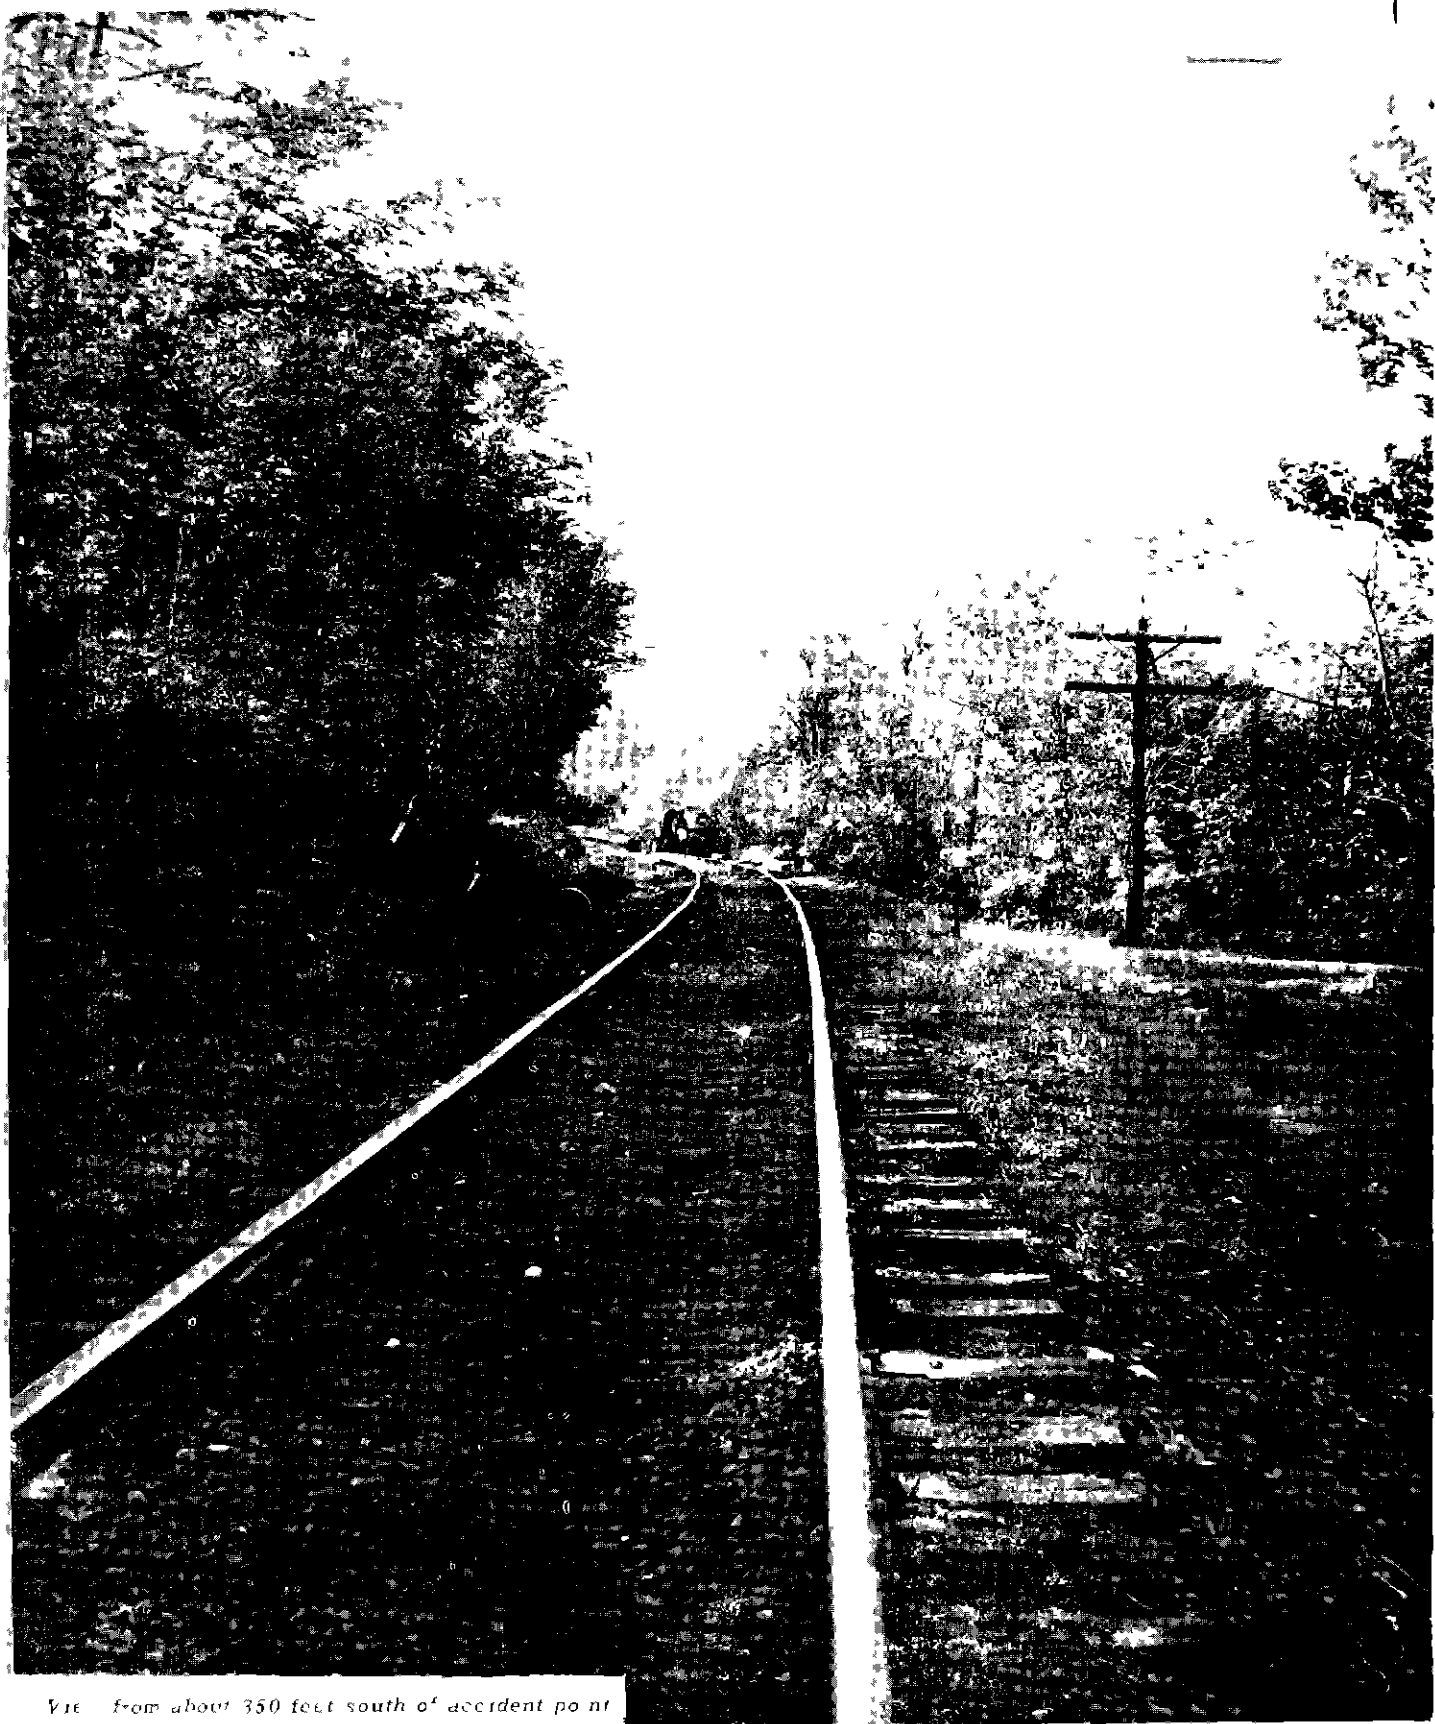
View from about 350 feet south of accident point

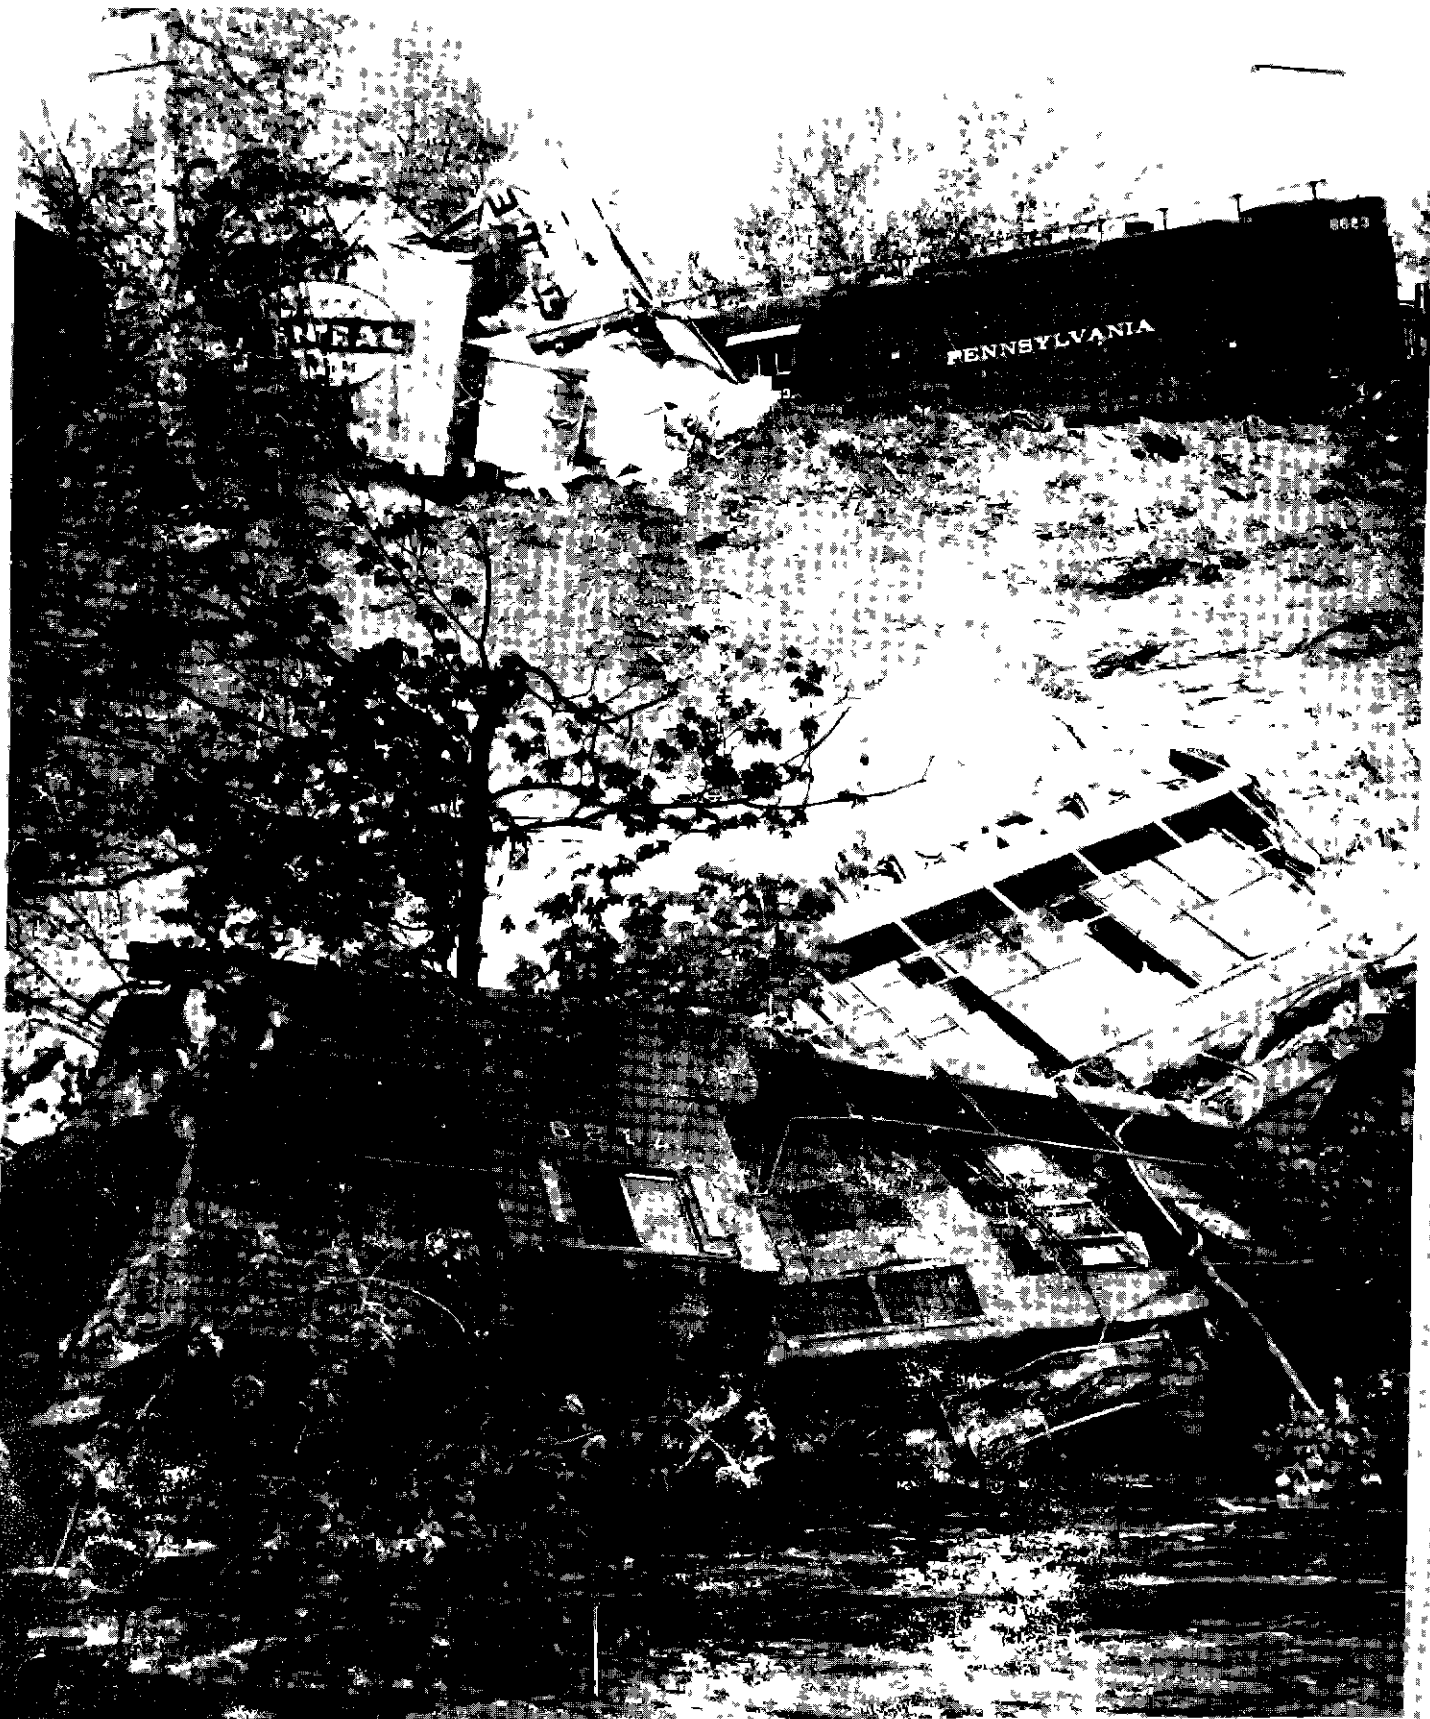
First and second diesel-electric units of Extra 7129 North shown at bottom of photo, with first diesel-electric unit 8623 in tow

The three locomotive units, the diesel-electric unit in tow, and the first to eighth cars, inclusive, of Extra 7129 North were derailed. The first diesel-electric unit overturned to the right and stopped upside-down with the front end on the west bank of Flint Creek about 120 feet north of the accident point. Its rear end extended diagonally southward into the creek and was slightly submerged. The second unit also overturned to the right and stopped on the bank of the creek, adjacent to and above the first unit. The third diesel-electric unit and the unit in tow jackknifed to the right, and each stopped upright with one end on the track structure and the other on the shoulder of the sidehill cut. The derailed cars stopped in various positions on the track structure and the slope to Flint Creek. The first and second diesel-electric units were destroyed, the third unit was heavily damaged, and the unit in tow was somewhat damaged. Of the derailed cars, three were destroyed, three heavily damaged, and two slightly damaged. The ninth and tenth cars were also destroyed.
