RAILROAD ACCIDENT INVESTIGATION

Report No 4042

THE ATCHISON, TOPEKA AND SANTA FE RAILWAY COMPANY

FEBRUARY 27, 1965

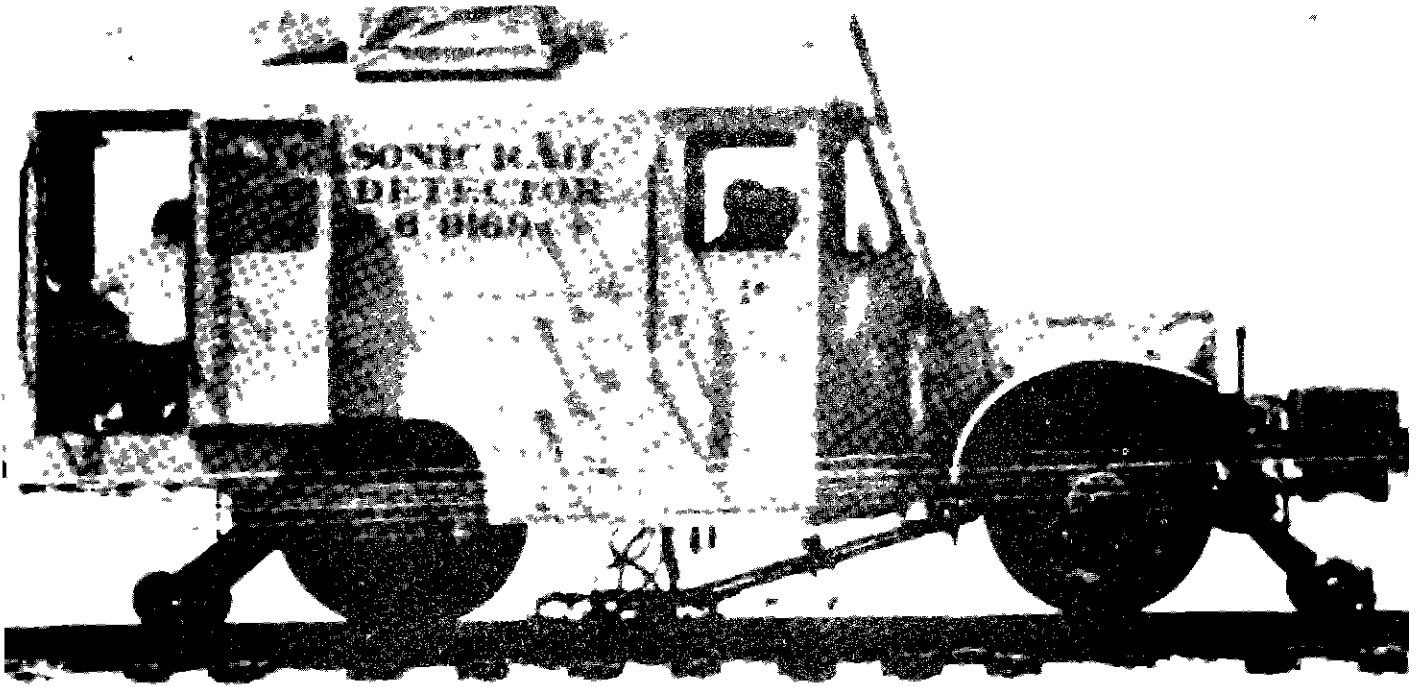
Rail defect detector car 9169 (1959 photo)

The detector car was a 1958 model Dodge motortruck owned and operated by the Atchison, Topeka and Santa Fe Railway Company. It had a special body (see photo appended to this report) and was equipped for movement on both rails and highways. In addition to conventional tire-mounted wheels, it had retractable flanged wheels at the front and rear for guides when operating on rails. The car was provided with ultrasonic equipment for detecting defective rails. It was 17 feet 2 inches long between the front and rear flanged wheels and weighed about 12,500 pounds, with 800 pounds carried on the rear flanged wheels and 600 pounds carried on the front flanged wheels when operating on rails.
