INTERSTATE COMMERCE COMMISSION.

REPORT OF THE CHIEF OF THE BUREAU OF SAFETY COVERING INVESTIGATION OF AN ACCIDENT WHICH OCCURRED ON THE NEW YORK, NEW HAVEN & HARTFORD RAILROAD NEAR EAST PORT CHESTER, CONN , ON JULY 31, 1919

OCTOBER 30, 1919

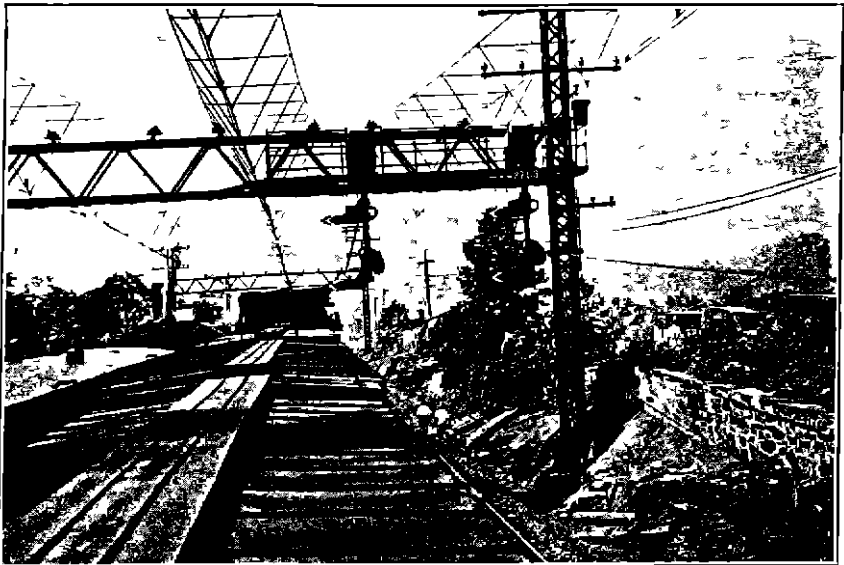
the box car immediately ahead of it. Illustration No 2 is a view taken from the top of the cars composing the rear portion of train MH 3, and gives a general idea of the arrangement of the signals, power transmission wires etc.

No. 2—View of signal 2701, showing general arrangement of signals, power transmission wires, etc
